# Coastal Recreational Track Management Master Plan for the Shires of Coorow, Dandaragan & Gingin

Site Assessment Tables

March 2025 REV-B

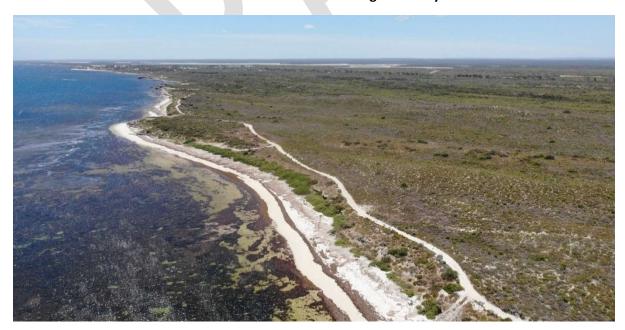
Limestone Headland South of Leeman with rock barricading moved by track users

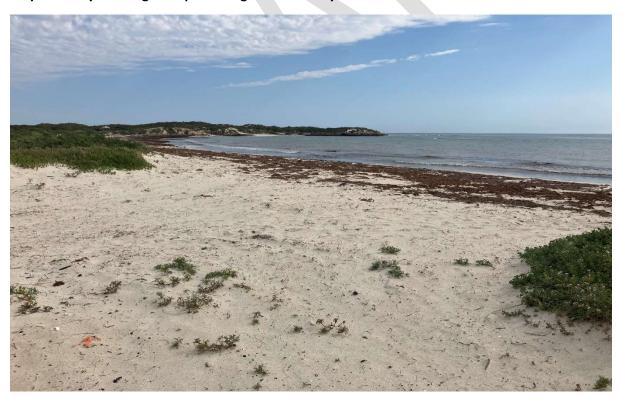
Billy Goat Bay area showing low beach dune profile offering little protection to coastline from super tides and storm surges.

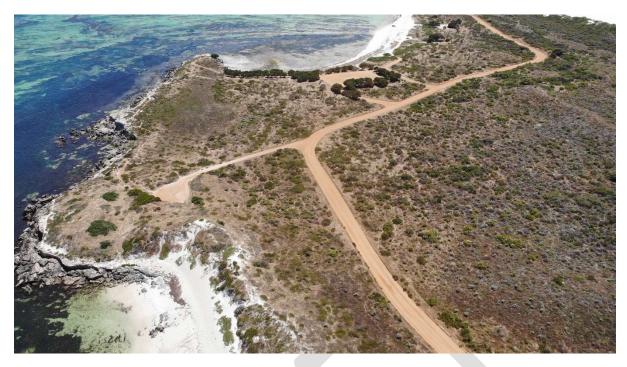
Billy Goat Bay and Harrop Inlet. Pedestrian damage on dunes at Harrop Inlet

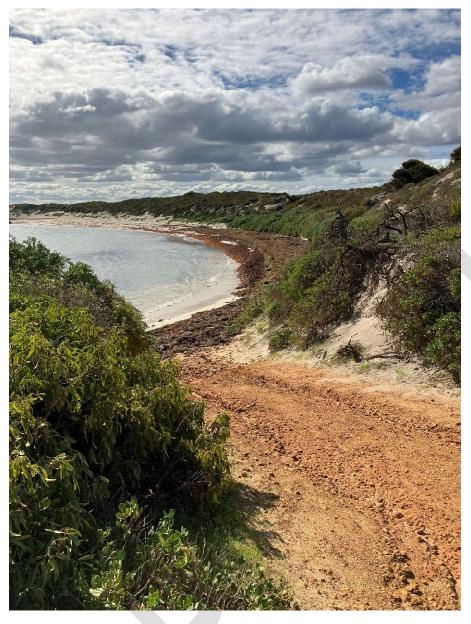
Harrop inlet showing seaweed build up. Steep entry to beach subject to erosion.

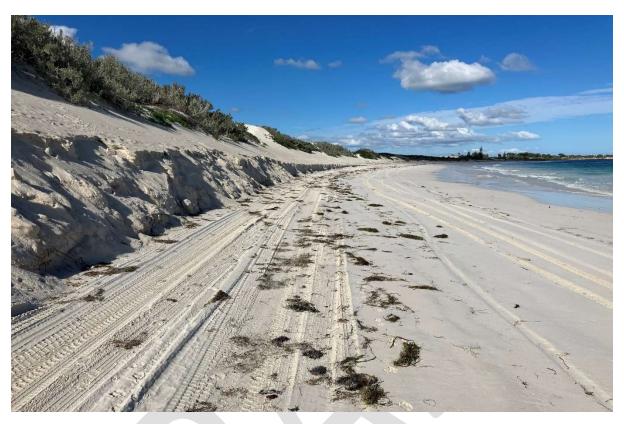
Anchorage Bay beach showing storm surge and super tide impact on beach profile

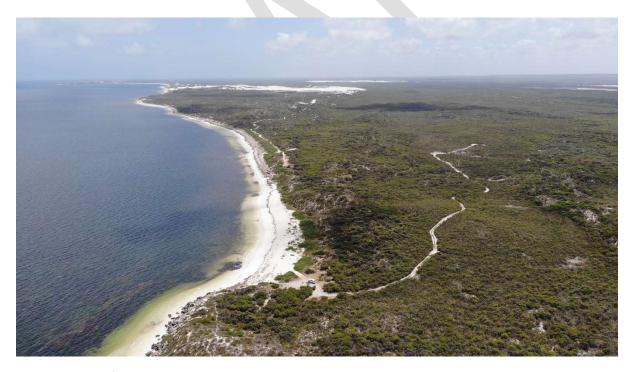
Southern end of South Bay looking North. Tracks in this area appear to be stable with little track growth evident. However considerable items of rubbish are often left in this area.

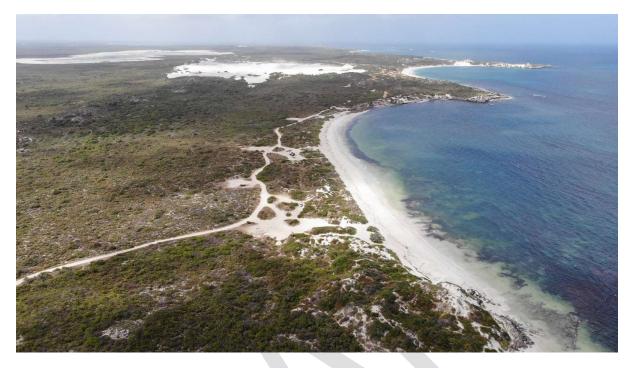
Griswald Bay look South the Sandy Cape. Unrestricted camping access to area has allowed growth in area used for camping. This has also caused a growth in vehicle and pedestrian tracks in the area.

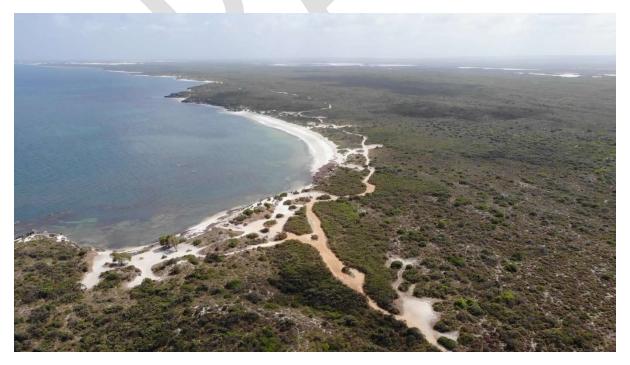
Griswald Bay looking North. Camping area and track growth can be seen across the area.

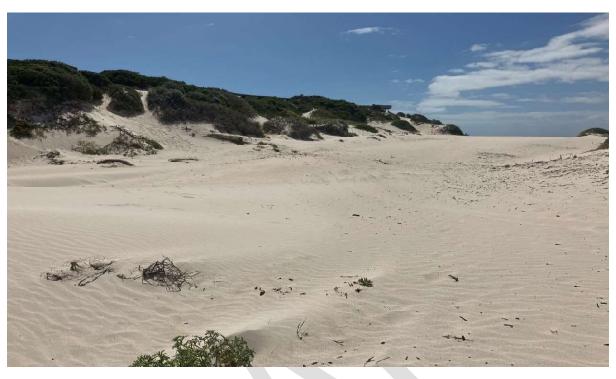
High energy wind erosion path on Sandy Cape. Vehicle and pedestrian use has prevented natural reestablishment of vegetation.

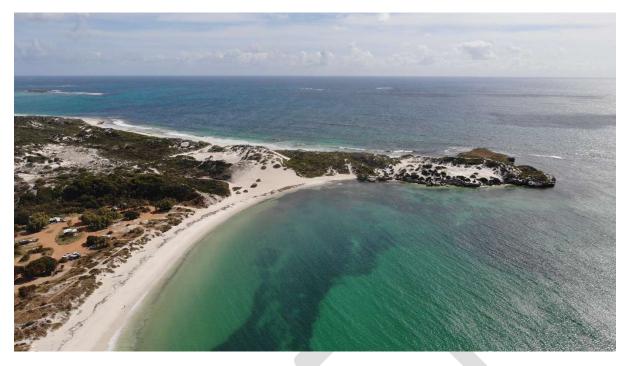
Sandy Cape showing extent of sand movement in the area as a result of dune vegetation being damaged by vehicles and pedestrians

Development potential	High. Implement a structured management plan to effectively manage visitor numbers and the visitor experience. Cleary delineate areas of use. Implement online booking system to control overflow camping at site.
Recommendation	Site Protection (SP): Restrict access to clearly defined areas, tracks and paths. Separate vehicle and pedestrian movements. Use educational signage to define the details of use of the area. Brushing should be installed on all major wind erosion areas.  Site Development (SD): Set up as nature based camping, swimming, fishing area. Delineate car park, caravan parking areas and access ways to Sandy Cape headland. Rehabilitate closed tracks and areas subject to high energy

erosion forces. Create loop walk trail to Sandy Cape proper, this may include wooden stairs and boardwalks to key lookout sites.

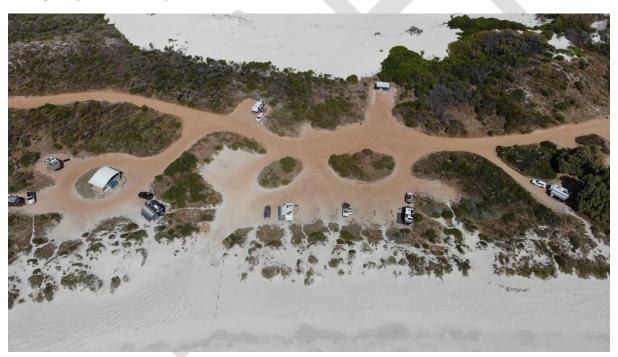
Sandy Cape Campground showing damaged to coastal dune system caused by uncontrolled beach access.

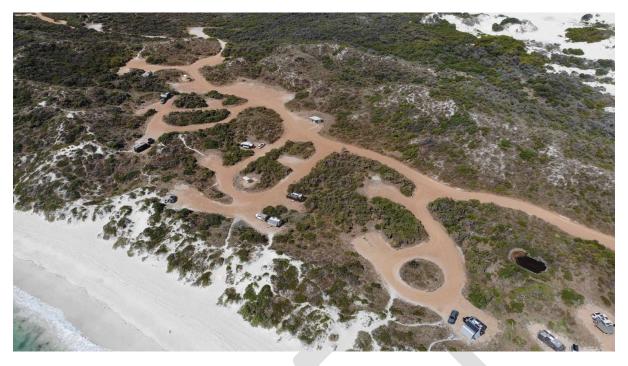
Sandy Cape Campground North end showing damaged to coastal dune system caused by uncontrolled pedestrian beach access.

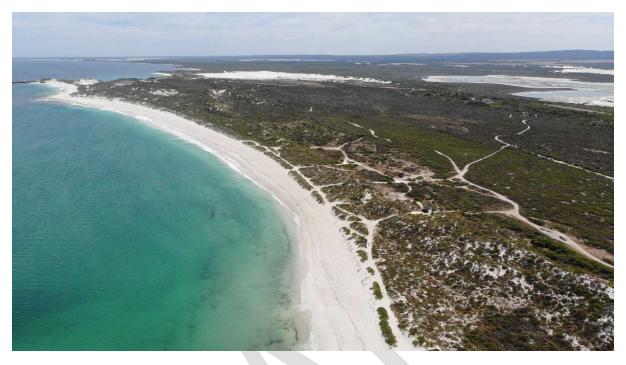
Kingy Bay area showing track growth and multiplication. Coastal erosion and damage can be mitigated by a reduction in beach entry points and tracks.

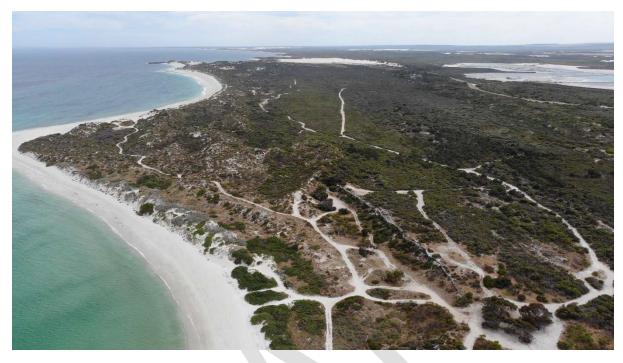
Volcano area showing track growth and multiplication. The area has had significant vegetation damage in the last 10 years because of increased use of the area. Historical satellite images clearly show changes in vegetation density in the area.

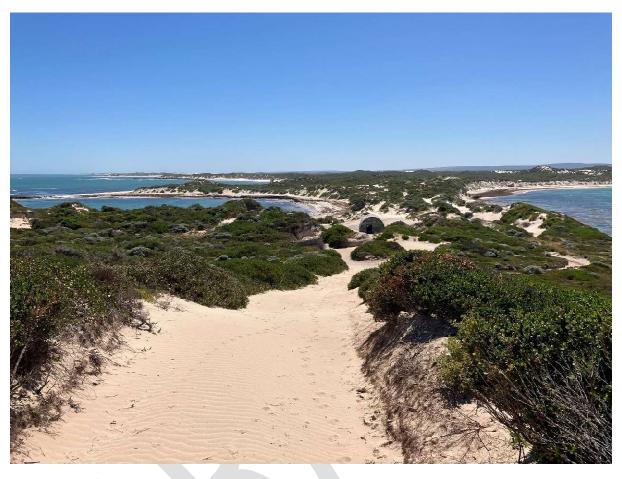
North Head looking back North showing extensive track development beyond the no vehicles sign.

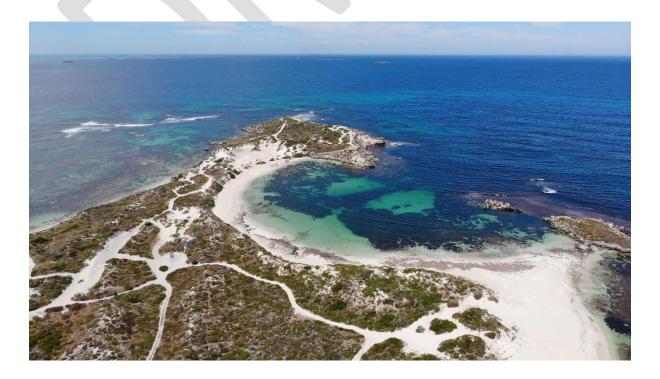
Overview of North Head looking back to the headland. Extensive erosion and track development can be seen on the headland.

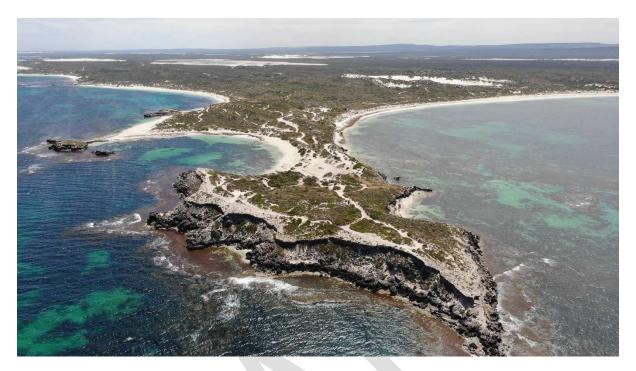
North looking overview of North Head and RS48 historical site. Significant erosion and track development is making the entire area very unstable.

access beyond a designated carpark area. Vehicle access restricted to
	designated track and the beach to defined points.
Development	Minimal due to significant environmental damage over the previous 50
potential	years. Effective control of vehicles and pedestrians required at this site. Site
	requires rehabilitation to slow rate of deterioration of the site from overuse
	by vehicles and pedestrians. Private property boundaries constrain
	development at his site.
Recommendation	<b>Site Protection (SP):</b> Redefine as day use area only. Restrict access to clearly
	defined areas, tracks and paths. Separate vehicle and pedestrian
	movements. Use educational signage to define the details of use of the
	area. Greater presence of rangers and use of CCTV, ANPR and AI to manage
	user behaviour.
	<b>Site Development (SD):</b> Set up as day use area catering for tourist visits to
	RS48 and CW16, swimming, fishing. Delineate car park area and access ways

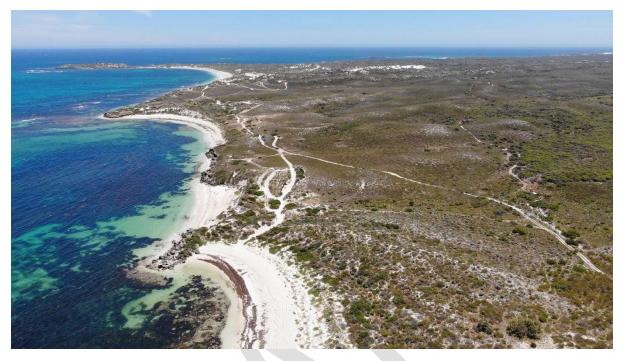
Overview of Pumkin Hollow showing track duplication caused by sever wind and water erosion. The majority of tracks in this area are on private property.

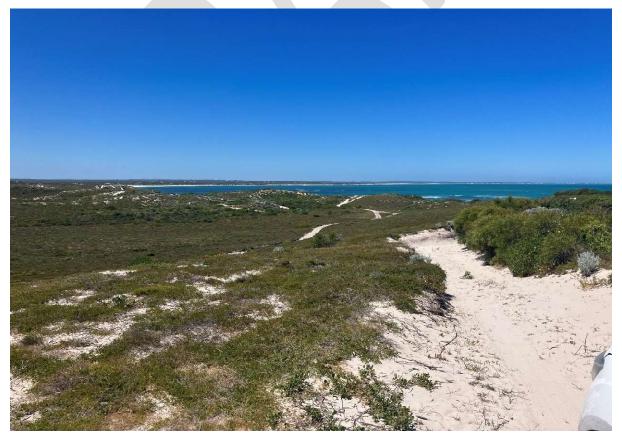
Typical tracks in Pumpkin Hollow area. Majority of track in this area are on private property.

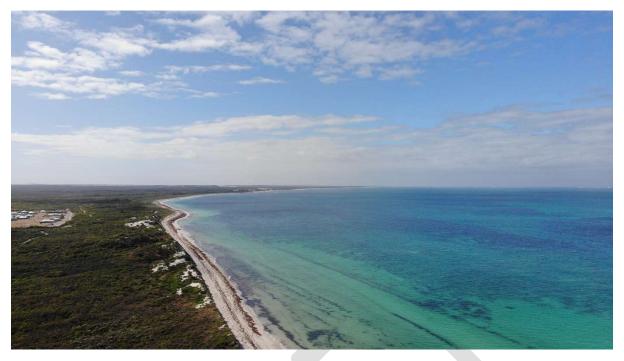
Looking South East from Island Point. Town beaches should be closed to vehicles to prevent vehicle and pedestrian interactions on popular swimming and fishing beaches within the town limits.

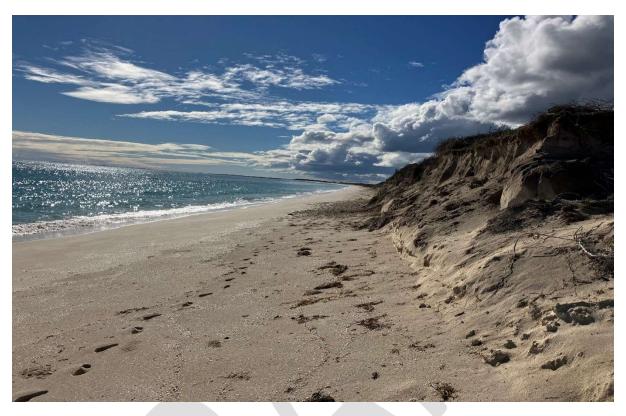
Unstable coastal dunes in the Hill River area. High Energy coastline with relatively low dunes with no vegetation cover on the dune face. Vehicle and pedestrian access through the dune leaves a erosion vulnerable break in the dune structure. Good example of narrow winter beach backed by short steep dune.

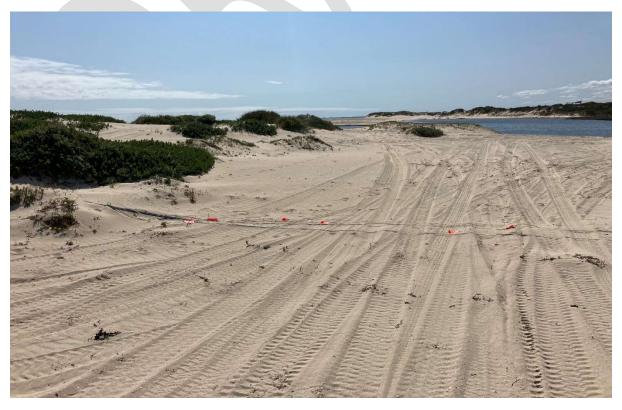
Hill River Mouth. Vehicle tracks in the dune system after a long weekend give an indication of the high level of vehicle use in the area.

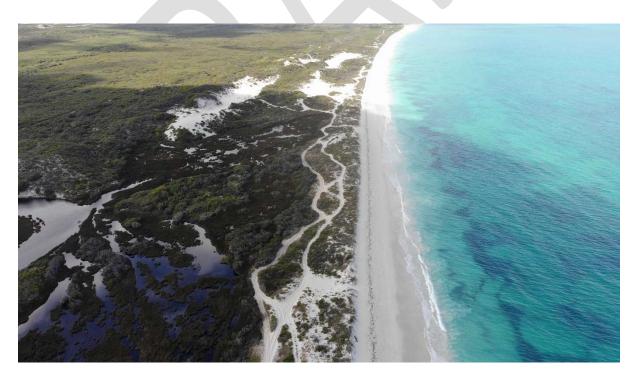
Hill River Moth looking South. Multiple tracks through narrow high erosion risk area. Tracks need to be consolidated to use a low erosion risk path through the land scape. Consider making the beach the main access path to Hill River mouth from Hill River Beach car park.

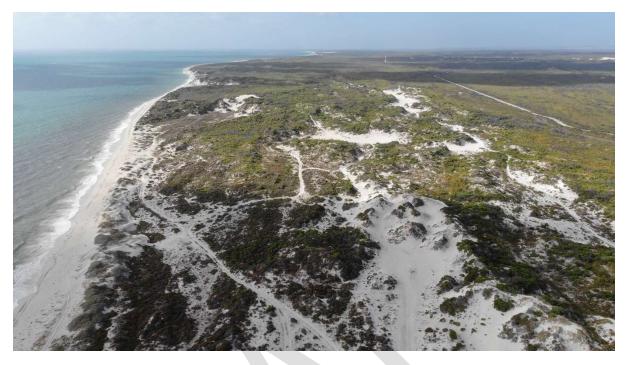
Deflation basin North End. Area has multiple tracks that can be consolidated to reduce damage to vegetation.

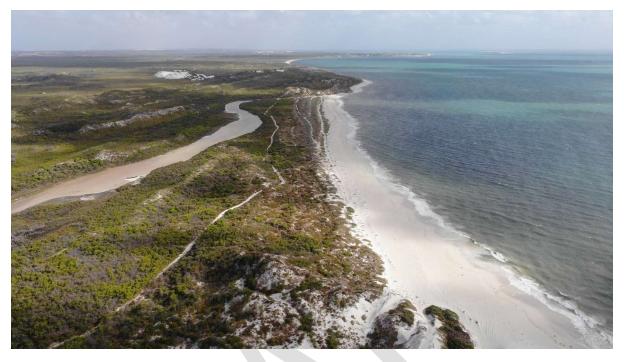
Black Point Area looking South showing multiple tracks through area. Tracks to be consolidated through area to reduce damage to vegetation.

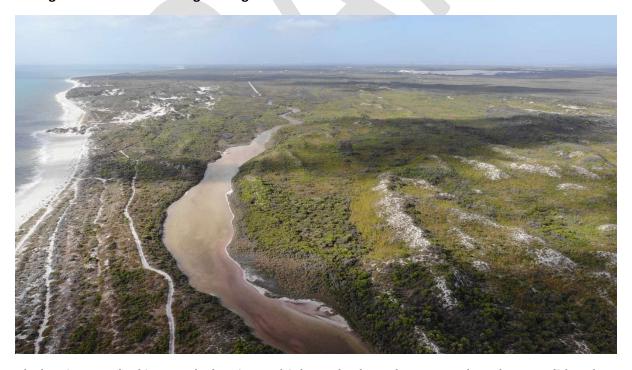
Black Point Area looking North showing multiple tracks through area. Tracks to be consolidated through area to reduce damage to vegetation.

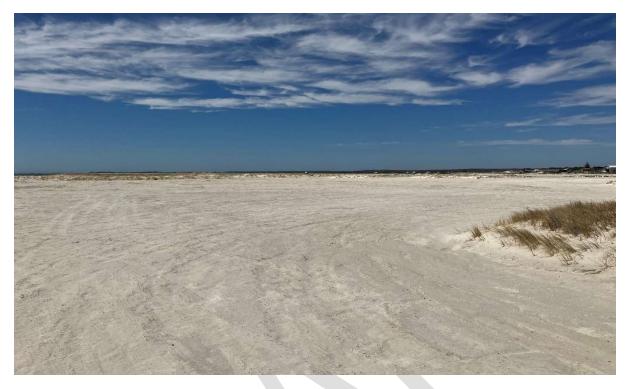
New coastal spit developed from the eroding Thirst Point spoil. Aera used by vehicles to drive on and launch boats. This prevents establishment of early dune coloniser species across the area to reestablish new dune systems to resist super tides and storm surges in the area. Spit needs clearly defined vehicle access paths to allow early colonisers to establish and help build a resilient dune structure.

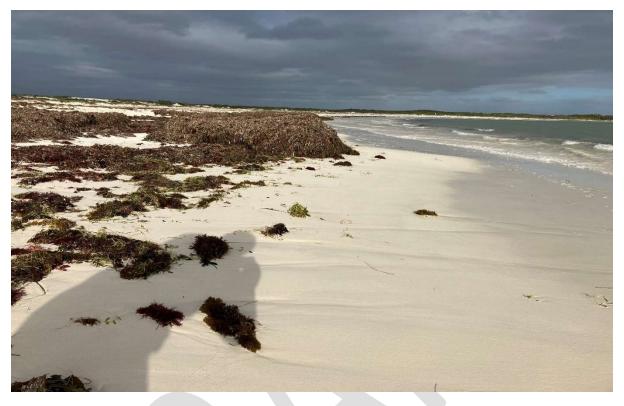
Picture showing the depth of seaweed deposits in the Hansen Bay area. Deposits of this depth make beaches impassable to vehicles.

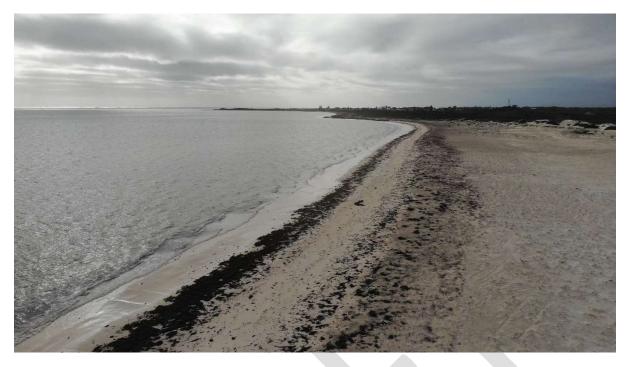
Hansen Bay looking North West towards Thirsty Point. Aera used by vehicles to drive on. This prevents establishment of early dune coloniser species across the area to reestablish new dune systems to resist super tides and storm surges in the area.

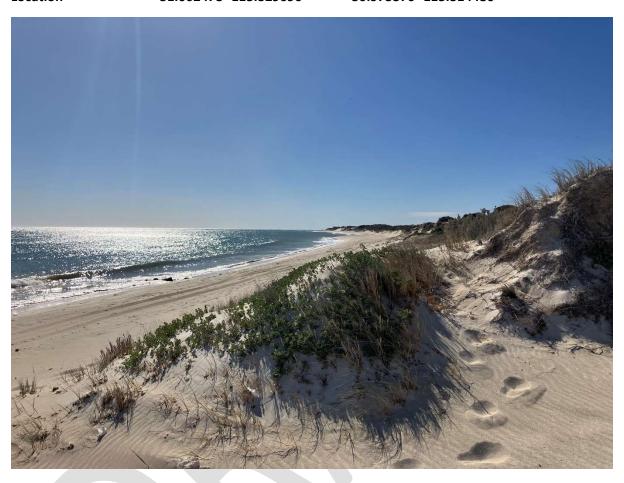
High energy narrow beach with very soft sand. Beach is adjacent to Lancelin Off Road Vehicle (LORVA) area. Often vehicles drive on to the beach from the LORVA. Very high vehicle use on beach due to ease of access and proximity to Perth. Popular fishing access beach. Access to areas North of Lancelin via the beach can be quicker than driving on coastal tracks.

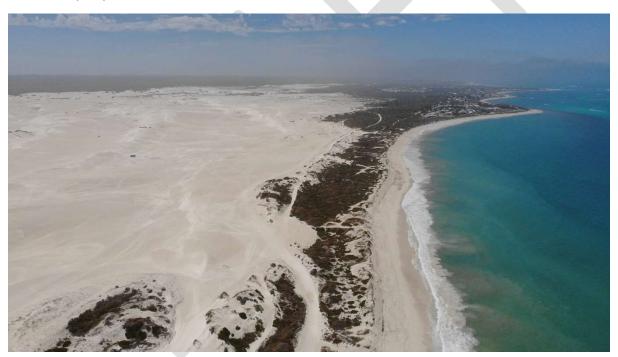
North End Off Road Vehicle Area looking south to Lancelin. ORV's and vehicles encroach into coastal dunes damaging vegetation that is protecting coastal landforms. Track guidance and education to be implemented to manage coastal vegetation damage.

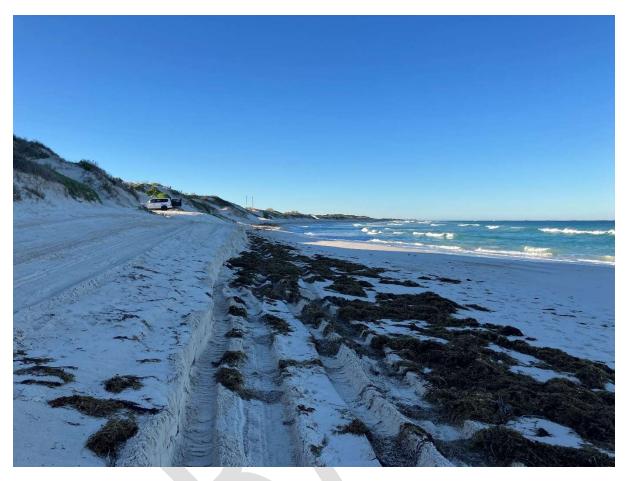
High energy beach with constantly changing beach profile. Sand bench is clearly visible in the picture. Vehicle users drive onto the beach and through dune system with little regard to vegetation and erosion risks. Beach is used as access track to areas South of Lancelin.

hazardous to vehicle users.
Recommendation	Site Protection (SP): Rehabilitation of dune near beach entrance, exclude
	vehicles from dune system.
	Site Development (SD): Delineation of pedestrians and vehicles.
	Educational signage on use of area.

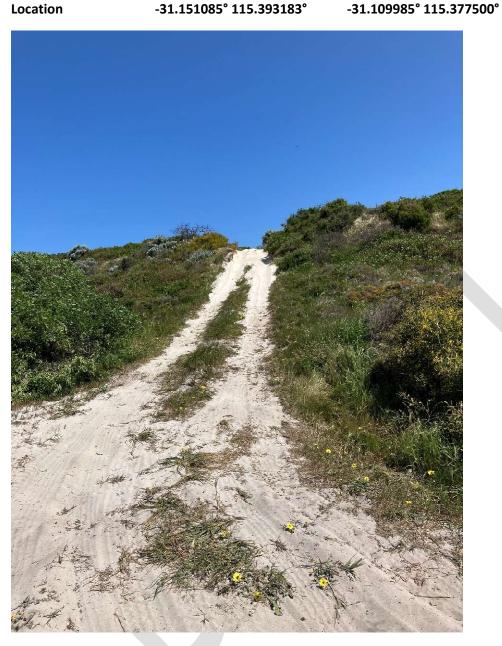
Typical coastal track around the Mankoora Sand Patch area. If the track becomes impassable 4WD user will make a new branch track to be able to drive over the dune.

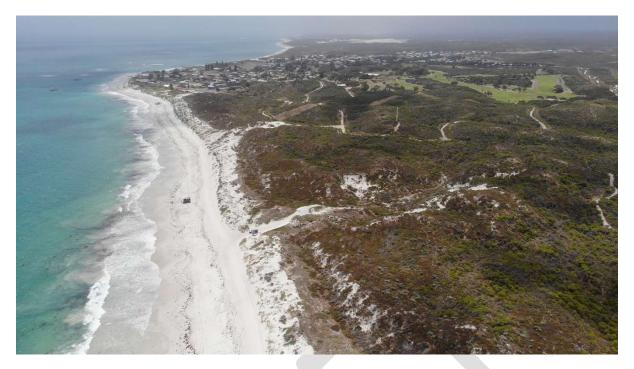
South Ledge Point looking North toward Ledge Point. Multiple tracks in the area that need to be reduced to reduce vegetation damage in the area and protect coastal dunes.

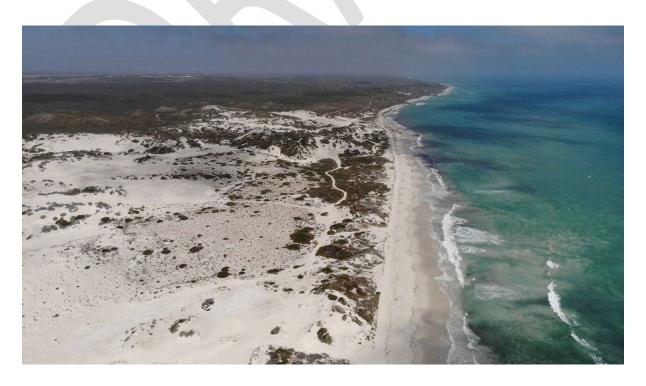
Looking South from Manakoora Sand Patch toward Breton Bay. Multiple tracks and beach entry point in the area. Track marking will reduce tracks and beach entry points to allow natural process to stabilise sand dunes in the area.

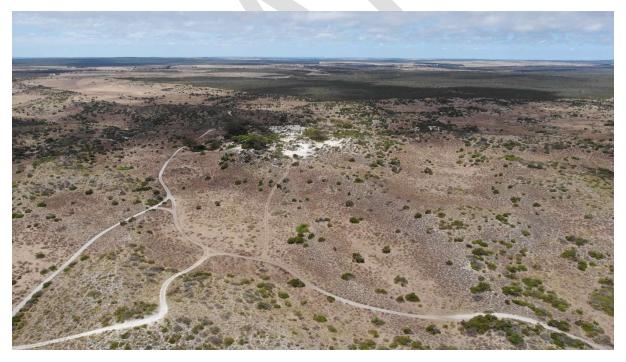
Breton Bay East access through private property. Coastal track users often ignore No Entry to Private Property signs and gates. These are regularly vandalised.

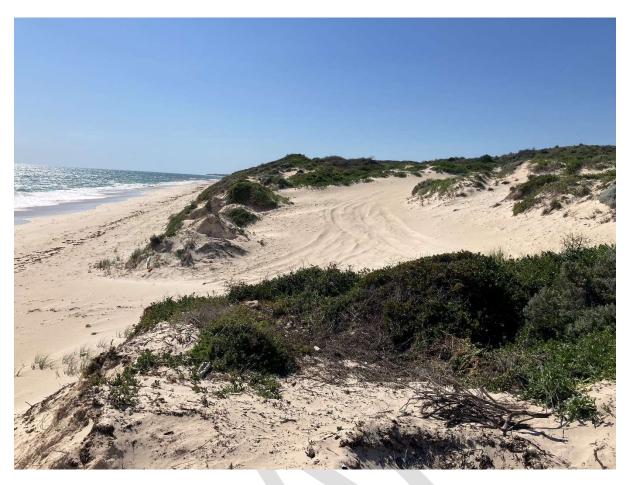
Looking North toward Mission Beach. Beach entry track into prevailing wind resulting in high energy erosion point on coast.

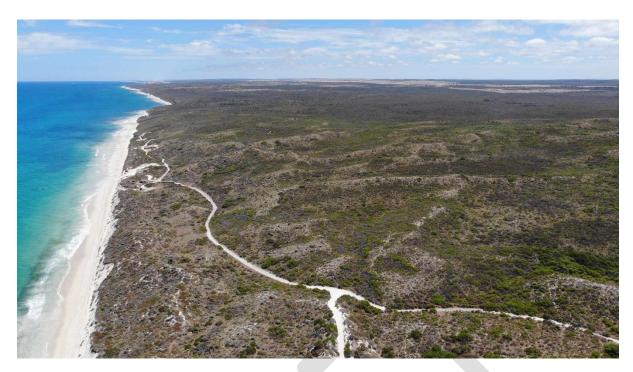
Mission Beach looking North towards Eagles Nest Bluff. Track development and vegetation damage surrounding old rail carriage squatters' settlement. Area of use around rail carriages to be defined by barrier system to limit vegetation damage in the area.

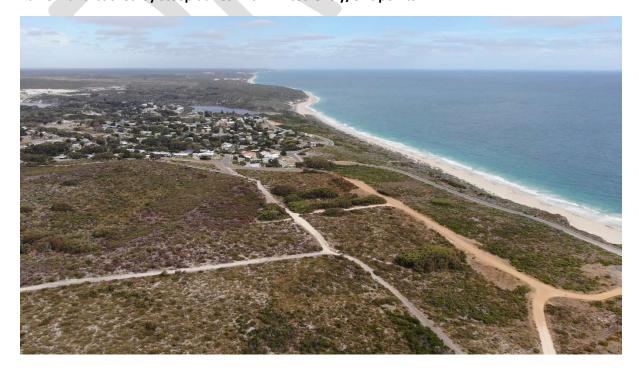
Tracks from Guilderton town into coastal dunes North of town near the Guilderton Lighthouse.

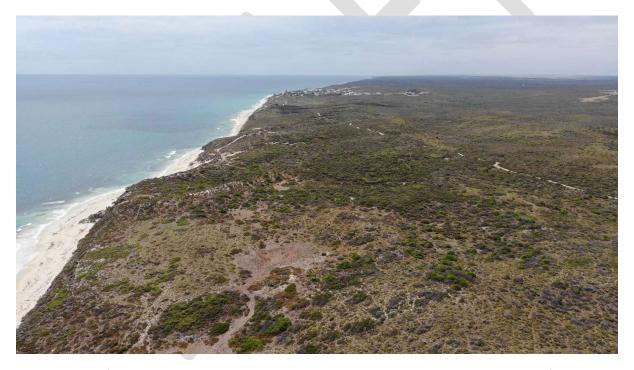
Tracks North of the Seabird coastal navigation beacon. This is near the North junction of the coastal track and the inland track. There are both management and recreational tracks through this area. Track marking will reduce track multiplication through the area.

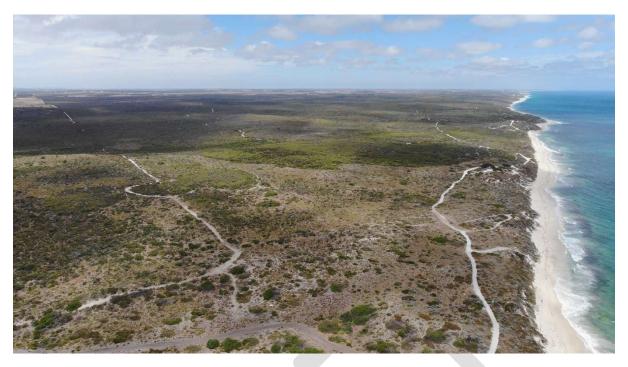
Looking South at coastal tracks South of Seabird. There are both management and recreational tracks through this area. Track marking will reduce track multiplication through the area.
