# 10800-S-Report

## STRUCTURAL ASSESSMENT

Jurien Bay Town Hall

Corner of Bashford St &  
Nineteenth Avenue.

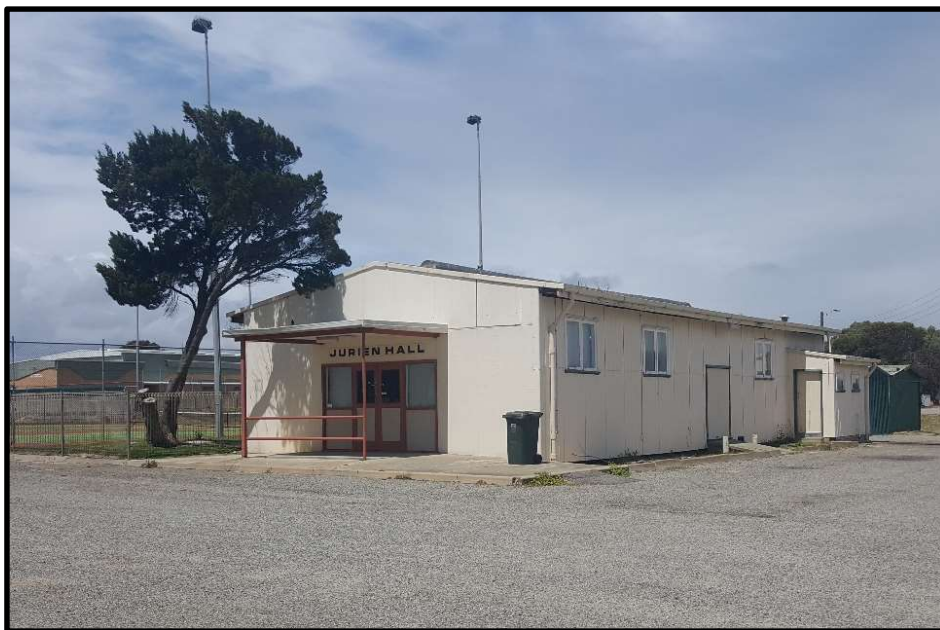
Figure 1 : Photograph of the town hall taken during WML Consultants inspection.

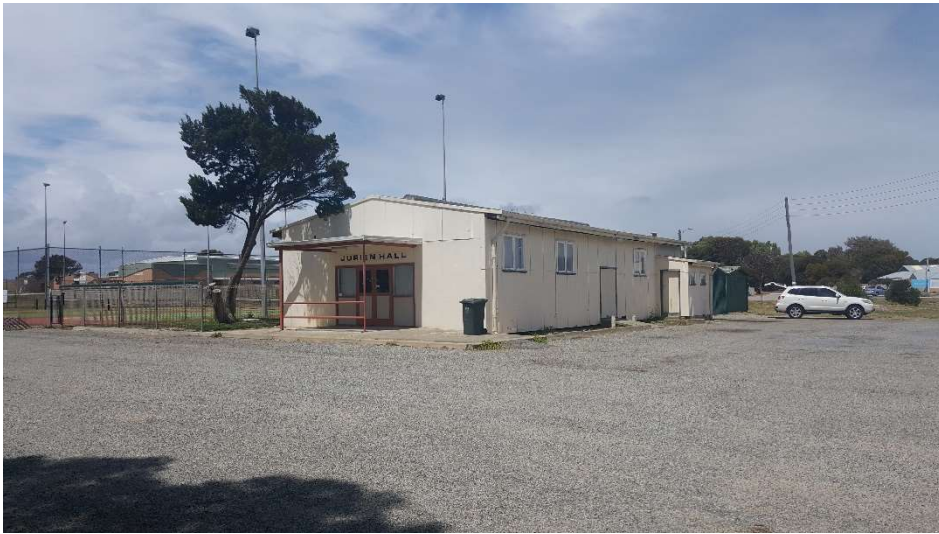
On reviewing photographs 1 – 5, 7, 12 & 14 it is clear the hall requires a lot of general maintenance attention, this has been covered elsewhere and is mainly cosmetic.

**Photograph 1 – Overall view of the hall looking toward the Northeast**

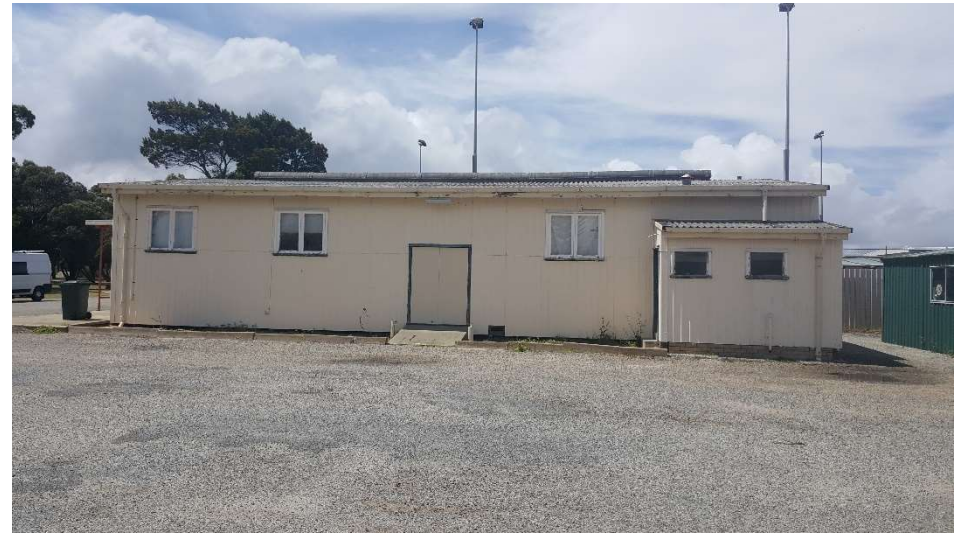
There are a number of ruptures to the exterior asbestos sheeting throughout the hall see photographs 2-3, 12 & 14 within Appendix C.

**Photograph 2 – Overall view of the hall looking toward the North**

It is therefore our opinion that the sheeting is to be removed in accordance with the appropriate WorkSafe regulations, by a licenced contractor and a modern equivalent installed.

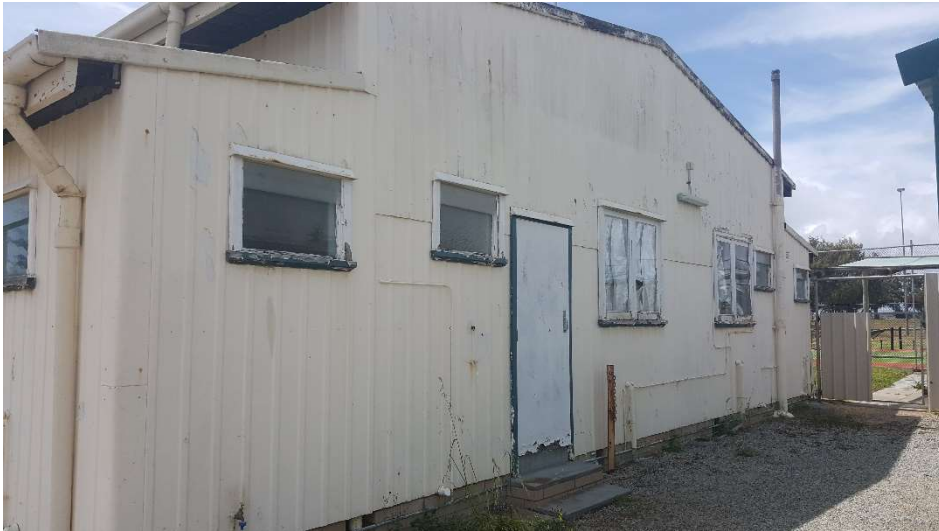
**Photograph 3 – Overall view of the hall looking toward the Northwest**

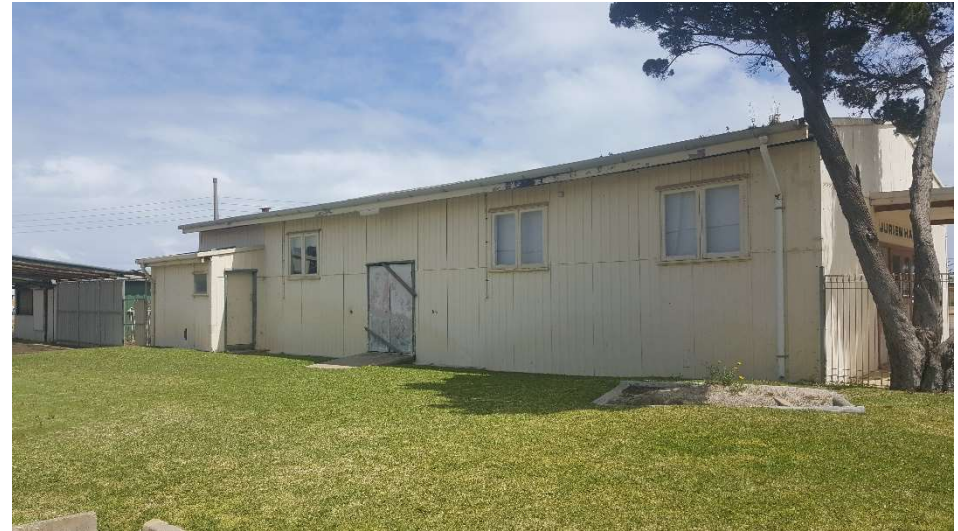
**Photograph 4 – Overall view of the hall looking toward the South**

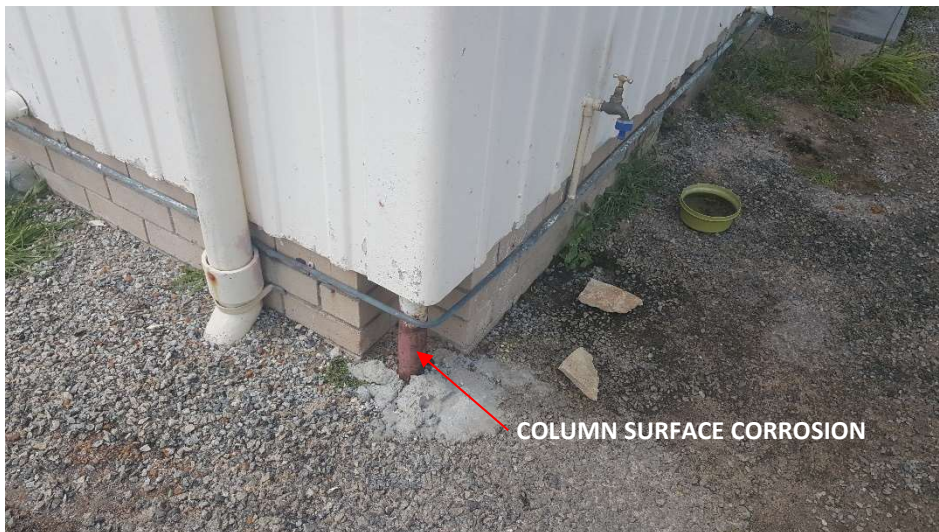
Photograph 5 – Lower sections of the roof supporting columns (Minor Surface corrosion)

- The minor areas of surface corrosion to the roof trusses, supporting columns is to be removed either manually or by mechanical means, treated with a high zinc primer and then a suitable topcoat. Given the location of the site in proximity from the sea, it is advised that Dulux special coatings (Or similar) are contacted to provide recommendations for treatment (This is a free service Dulux provide).
- Although not critical to the structure, the roof bracing should be hung where possible to reduce the self-weight deflections.
- The new untreated pine sections (See photographs 9 - 10 within Appendix B) need to be adequately treated for durability and termites.
- A termite inspection of all the timber is recommended.

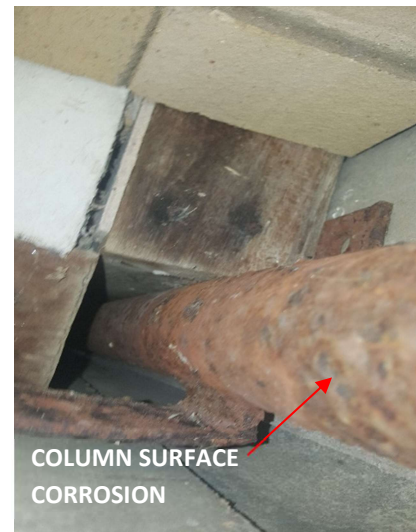
The roof structure is in good condition considering the buildings age, there is evidence of minor corrosion to the surfaces of the structural members that form the main structural frame (trusses and associated column sections) both within the roof space and exterior to the building as can be seen within photographs 6, 11, 13 and 16 located within Appendix C.

Photograph 6 – Minor surface rust to the lower section of column.

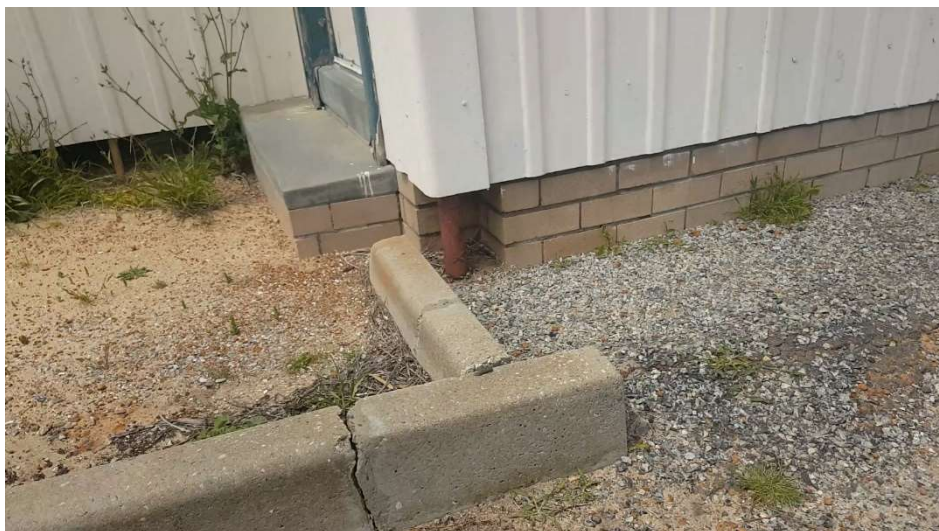
Photograph 7 – Column support for upper roof at toilet external entrance.

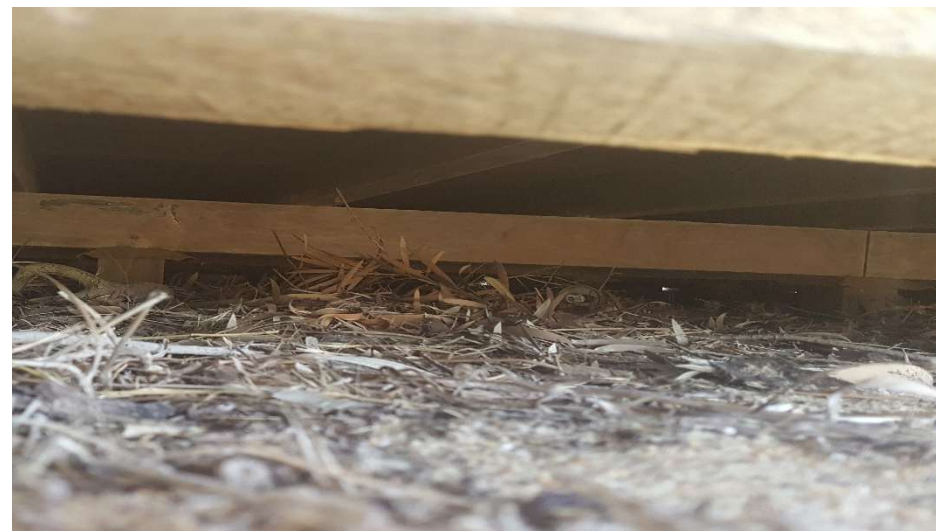
During the inspection a camera was placed to the underside of the building to determine the condition of the sub-structure (floorboards, associated jarrah support structure and stumps). On reviewing photographs 8-10 within Appendix C, the Jarrah support sections appear to be in good condition and there are no visible signs of excessive deflections or over stressing.

Photograph 8 – Floor joists supported on secondary Jarrah beams seated on stub supports

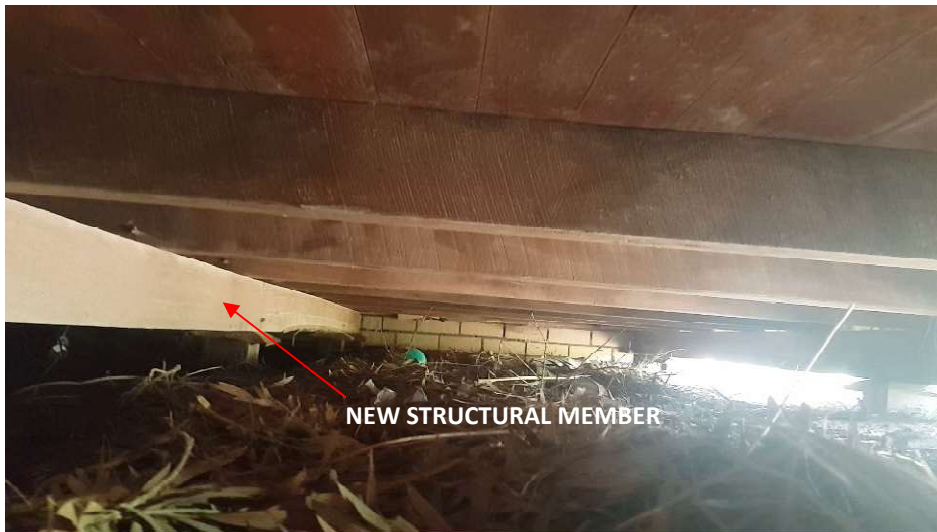
It was noted during the inspection of the substructure that some of the timber sections appeared to be new and an untreated seasoned pine had been installed see photographs 9-10 within Appendix C.

Photograph 9 – View to the underside of the Hall floor looking East

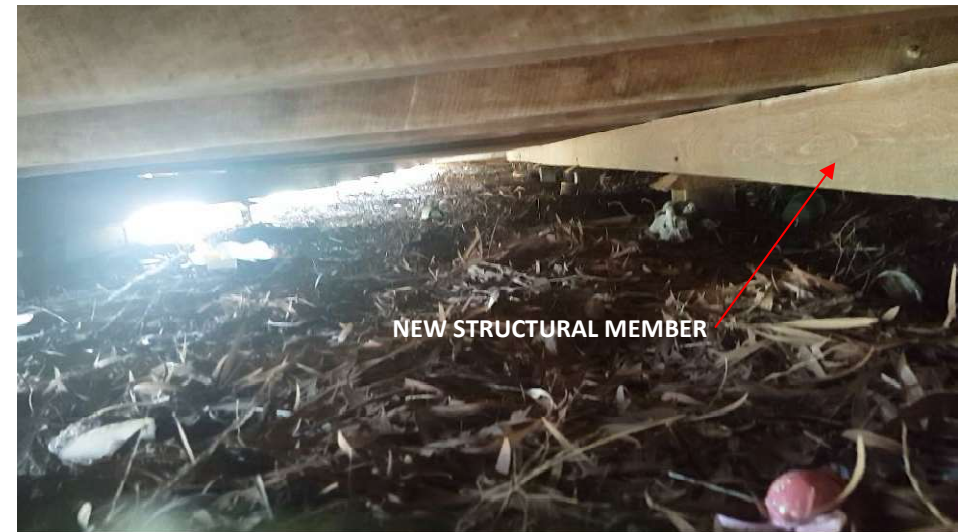
Photograph 10 – View to the underside of the Hall floor looking West

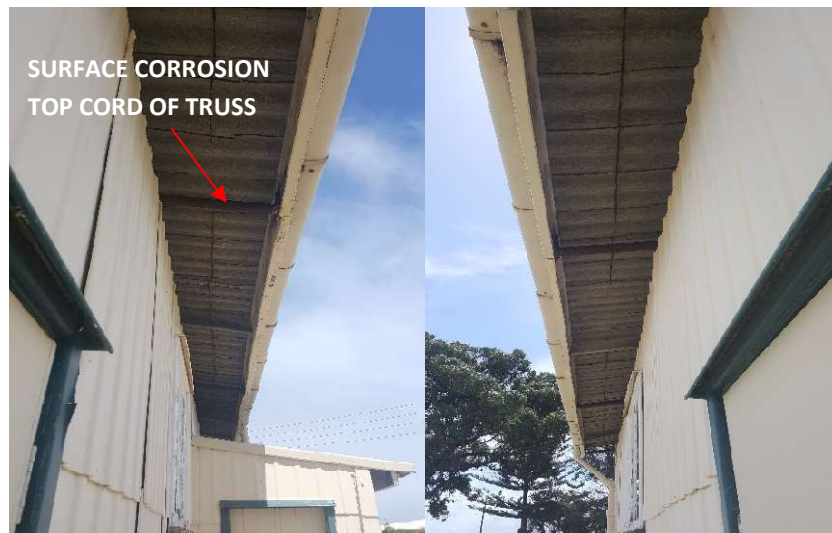
The mesh located at the eaves, that is visible from the outside of the building has rusted away in sections, it is assumed that the mesh serves to restrain the Anticon insulation sheeting located within the roof and not present within the eaves.

Photograph 11 – Corroded mesh detail within eaves & Surface corrosion to the top cord of the roof truss that supports the timber fascia board

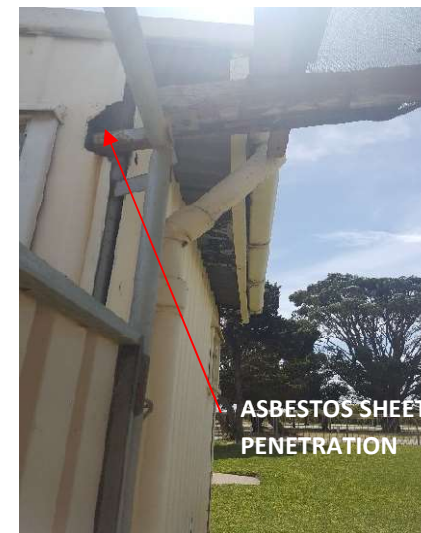
Photograph 12 – Penetrated sections of asbestos outer wall sheeting.

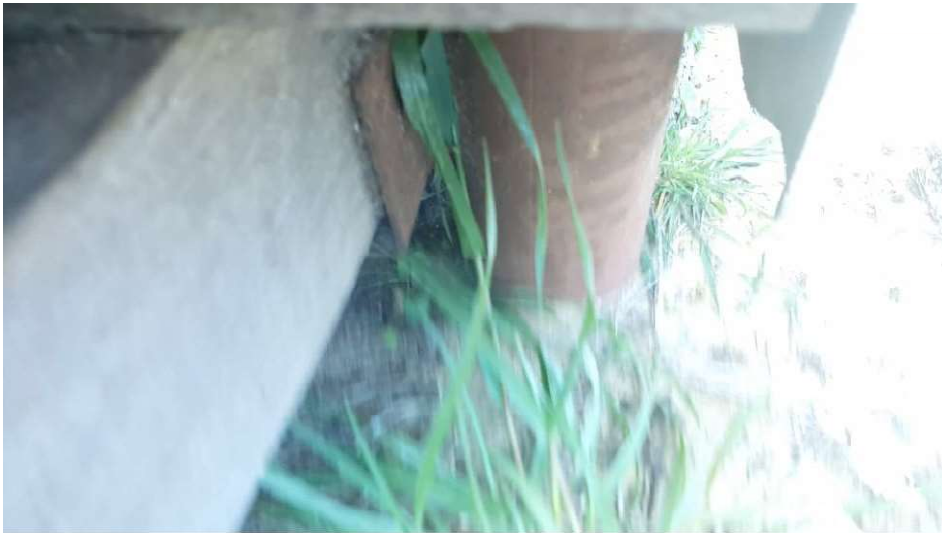
Photograph 13 - Lower sections of the roof supporting columns (Minor Surface rust)

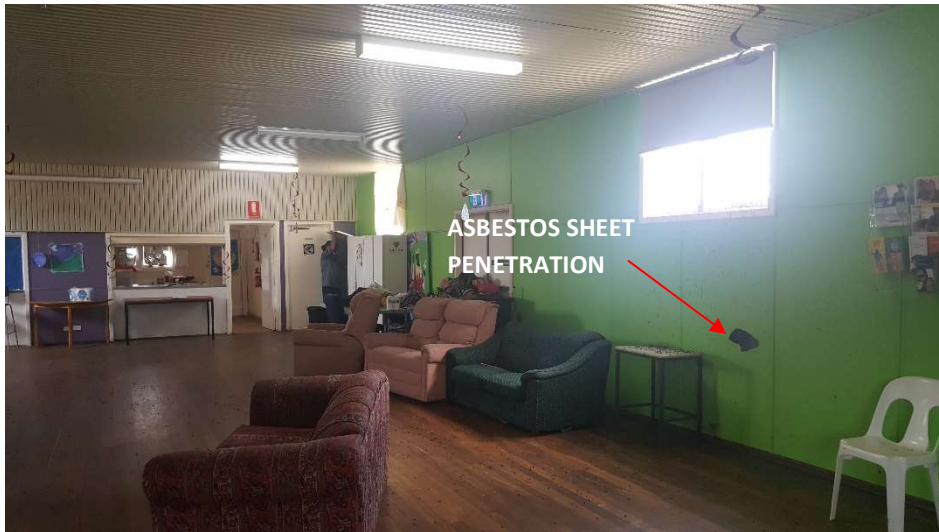
The main hall, Kitchen and associated rooms are generally in good condition, the inner asbestos wall sheeting has been ruptured in a few locations throughout the hall see photographs 15 & 16 within Appendix C.

Photograph 15 – Penetrated sections of inner wall sheeting.

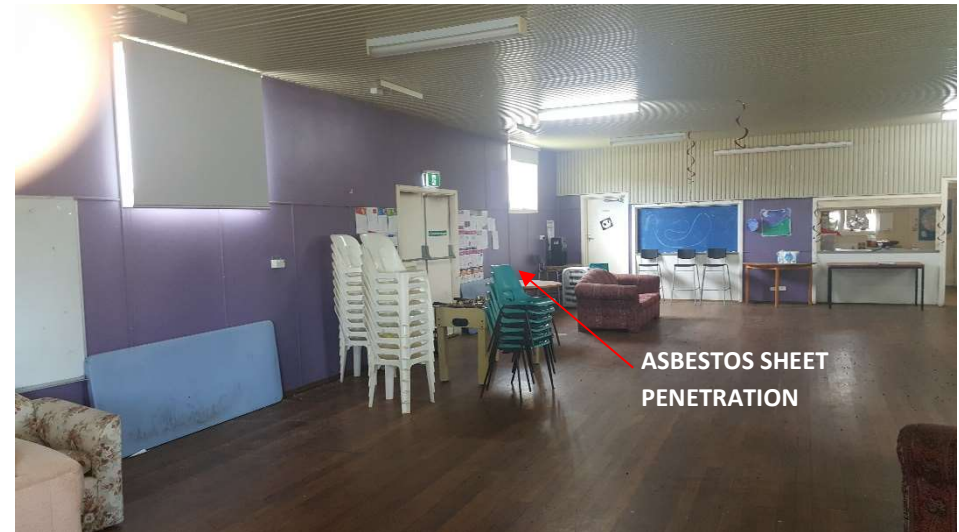
Photograph 16 – Penetrated sections of inner wall sheeting.

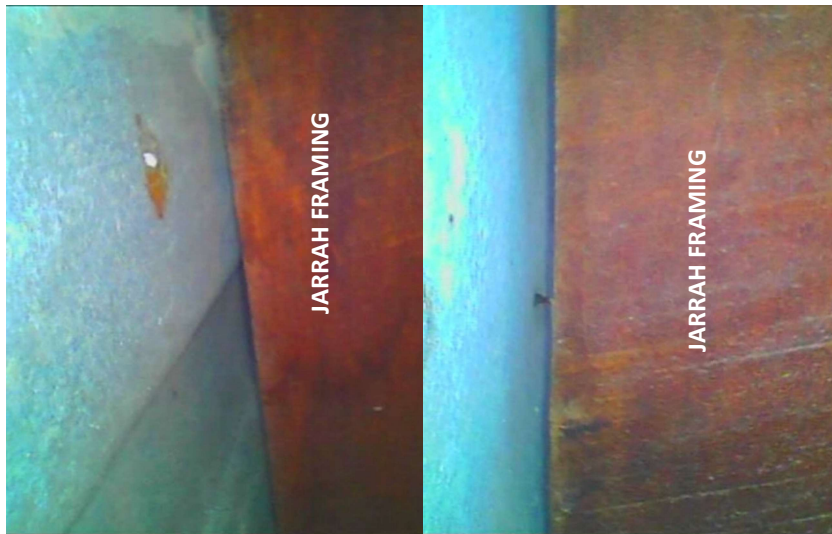
There is a large penetration to the internal face of the South facing wall within the hall, during the inspection a bore scope camera was placed within the depth of the wall to determine the condition of the structure see photographs 17 - 18 within Appendix C. It may be observed that the Jarrah stud framing is in good condition, however the asbestos sheeting has numerous ruptures throughout.

Photograph 17 – Bore Scope placed within the wall (Penetrated sections of wall sheeting).

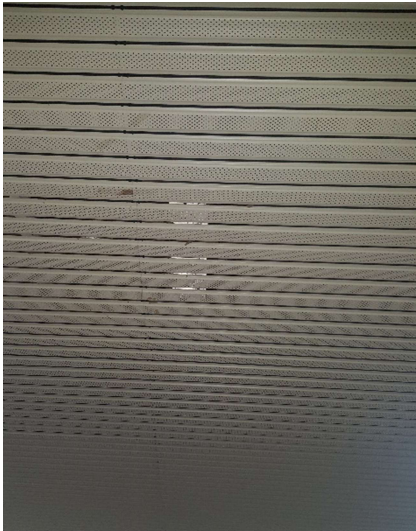
It was observed during the inspection that there appears to be no physical barrier between the ceiling cladding and the upper roof structure, suggesting material within the roof may filter through to the hall see photograph 19 within Appendix C.

Photograph 19 – Perforated ceiling cladding viewing to the roof structure

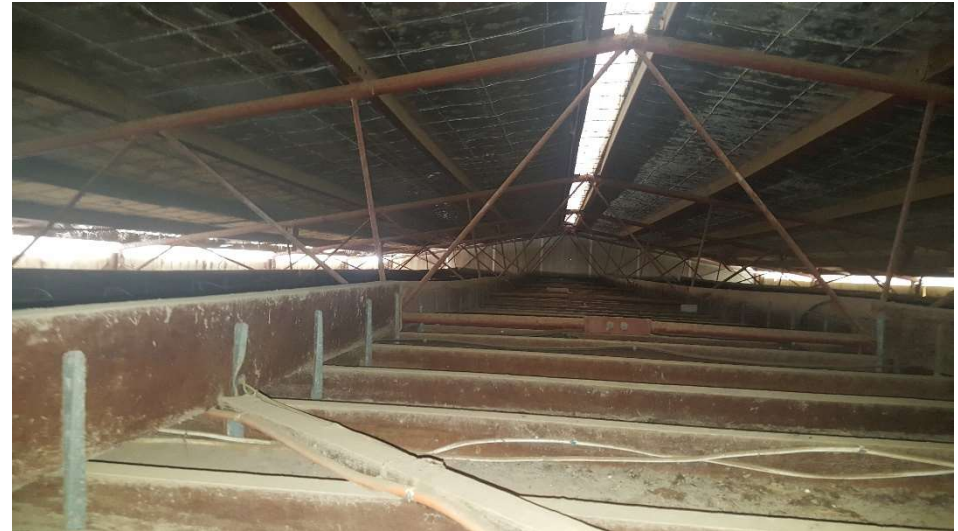
There are no visible signs of excessive deflections or over stressing within the roof purlins, trusses and ceiling support structure see photographs 20 – 24 within Appendix C.

Photograph 20 – Within the roof space viewing toward the West.

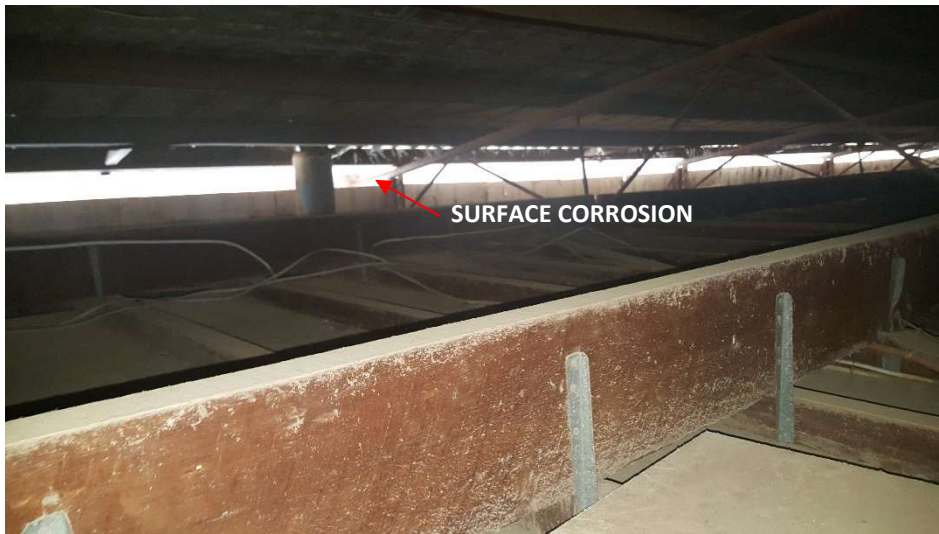
Photograph 21 - Within the roof space viewing toward the Southwest.

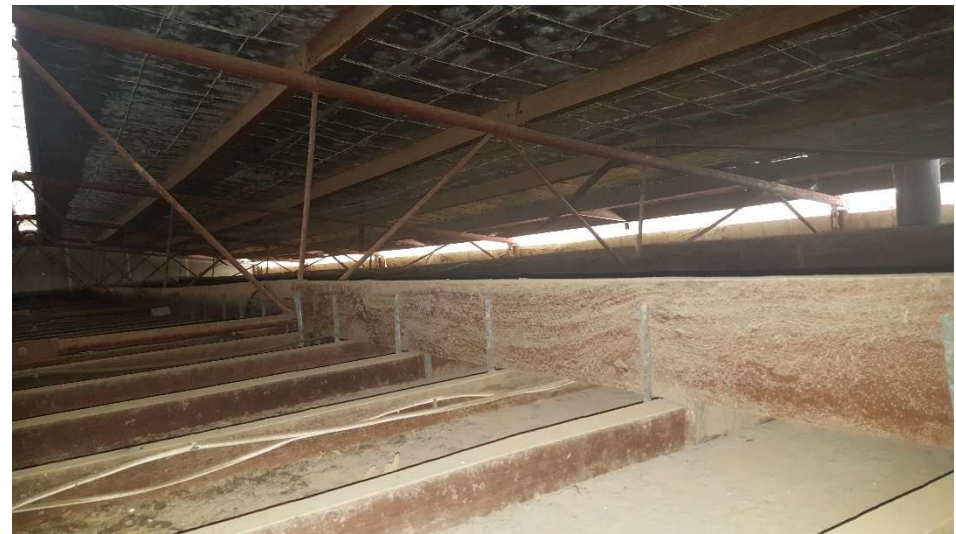
It was noted during the inspection that the roof bracing did appear to be excessively sagging as seen within photographs 22 & 23 within Appendix C.

Photograph 22 – Within the roof space viewing toward the Northwest.

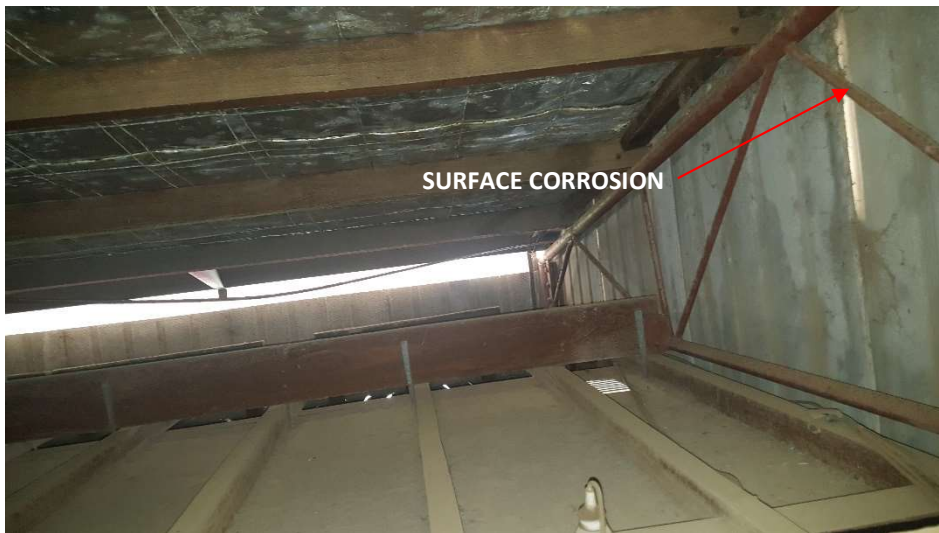
Photograph 23 – Within the roof space view on the gable facing the Northeast

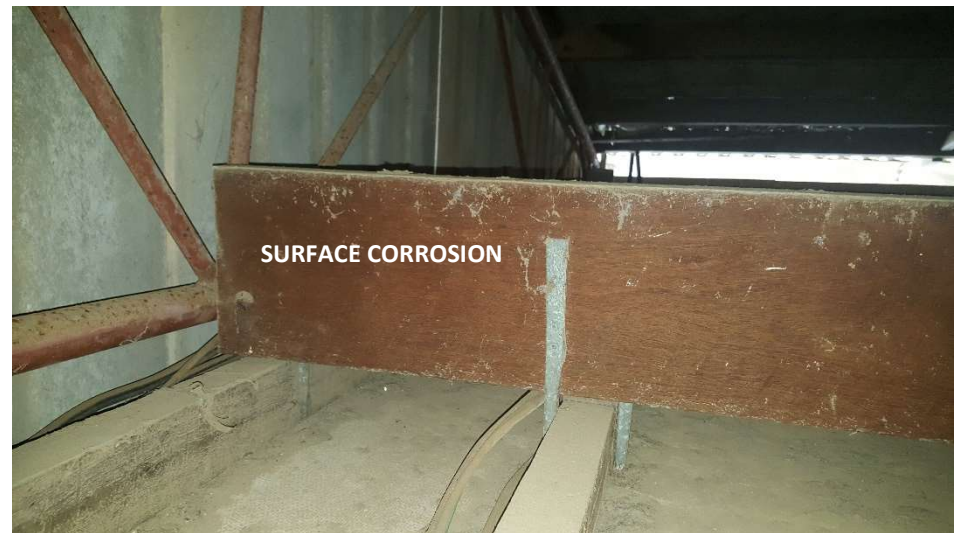
Photograph 24 – Within the roof space view on the gable facing the Southeast
