Report on a heritage survey of Radar Station 48, North  
Head, Jurien Bay for the Shire of Dandaragan

April 2016

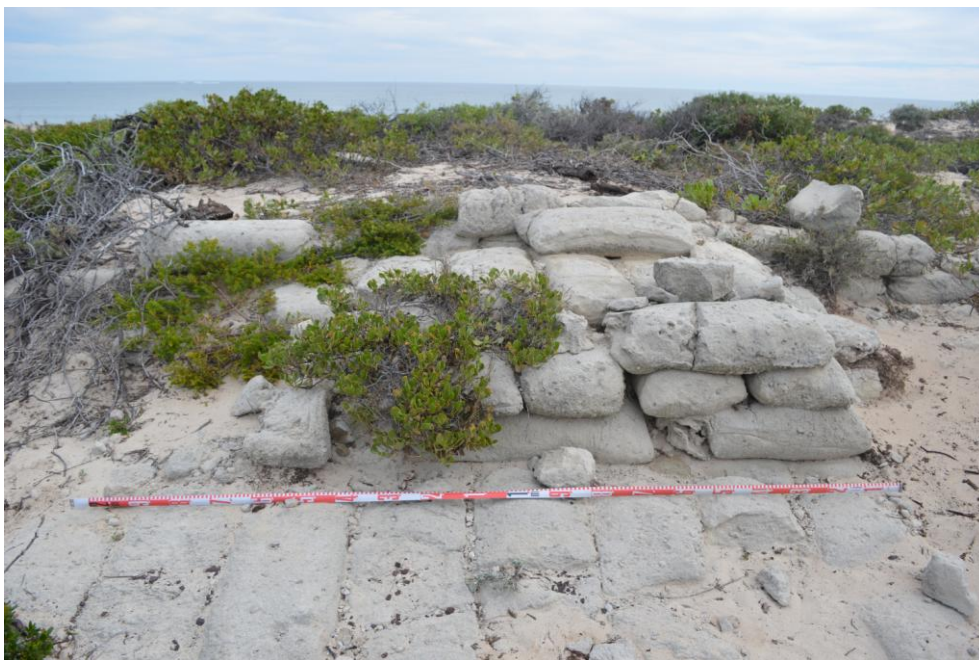
The Radar Station is located at the highest point of the North Head peninsula (approximately 19.80m ASL) with 360 degree views of the coast. What remains of the Radar Station are concrete sandbags (figure 5) stacked at least five layers high (upon visual inspection) where the sandbags form a series of steps on the northern side of the foundations.

**Figure 5: Concrete sandbags on radar station site. Photo facing South.**

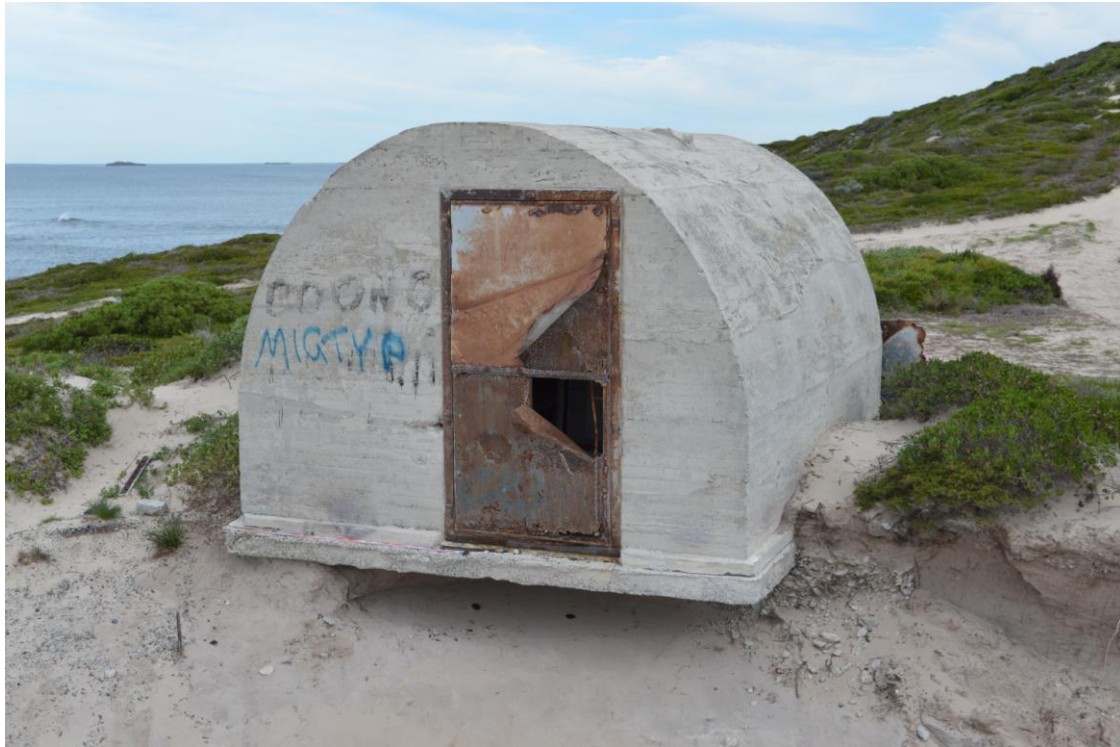
The structural integrity of the Igloo is relatively intact, however this is likely to be compromised due to the degradation of the supporting sand dune the foundations rest on (see figure 6). Graffiti and vandalism has also had a negative impact on the preservation of Igloo. Sections of the iron door and window have been destroyed and the structure contains beds, a refrigerator and rubbish. The concrete engine bed has been removed.

Figure 6: Igloo A. Photo facing south.

Not all damage to Radar Station 48 and North Head can be interpreted as deliberate acts of destruction. The 4WD track leading from the beach to the Igloos has caused the dune to become heavily deflated and hollowed-out the foundations of Igloo A which is at risk of collapsing. HDA believes this structure is in imminent danger. The loss of this Igloo would dramatically affect the future heritage status of the site.

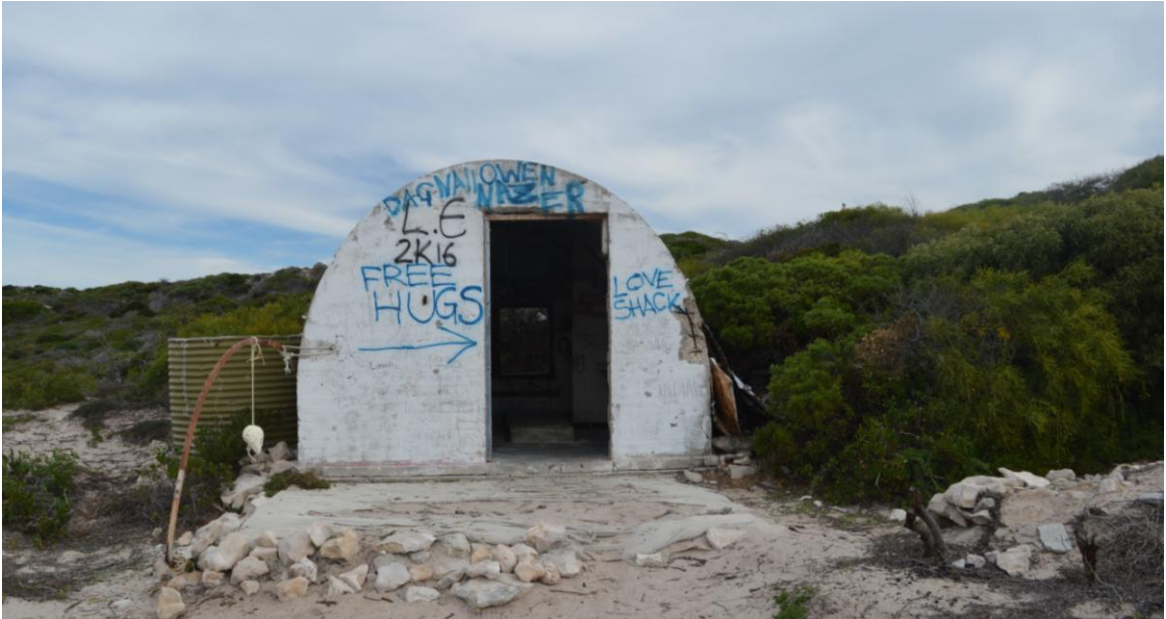
Igloo B (figure 7) is located to the WNW of Igloo A on a more elevated section of the peninsula. Igloo B has the same purpose and construction style as Igloo A. Igloo B is more structurally stable than Igloo A. Its foundations rest solidly on stable ground. The concrete engine bed remains (figure 8).

Figure 7: Igloo B facing south.

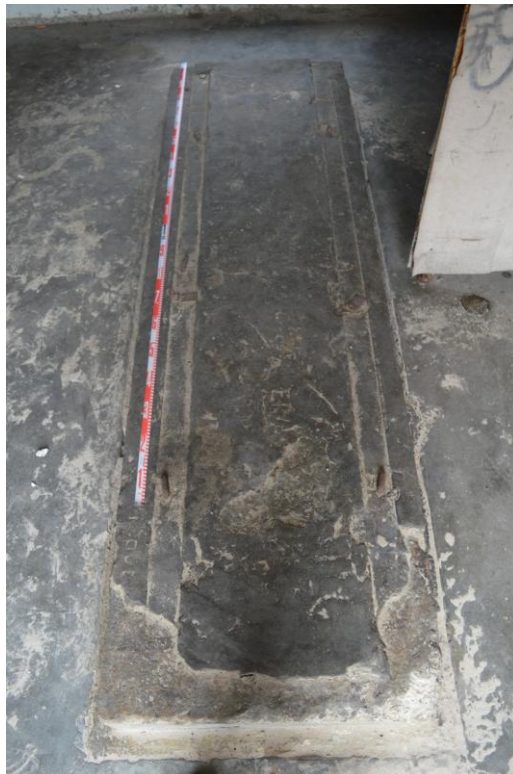
Figure 8: Generator engine bed inside Igloo B. Scale 2m. Photo facing south.

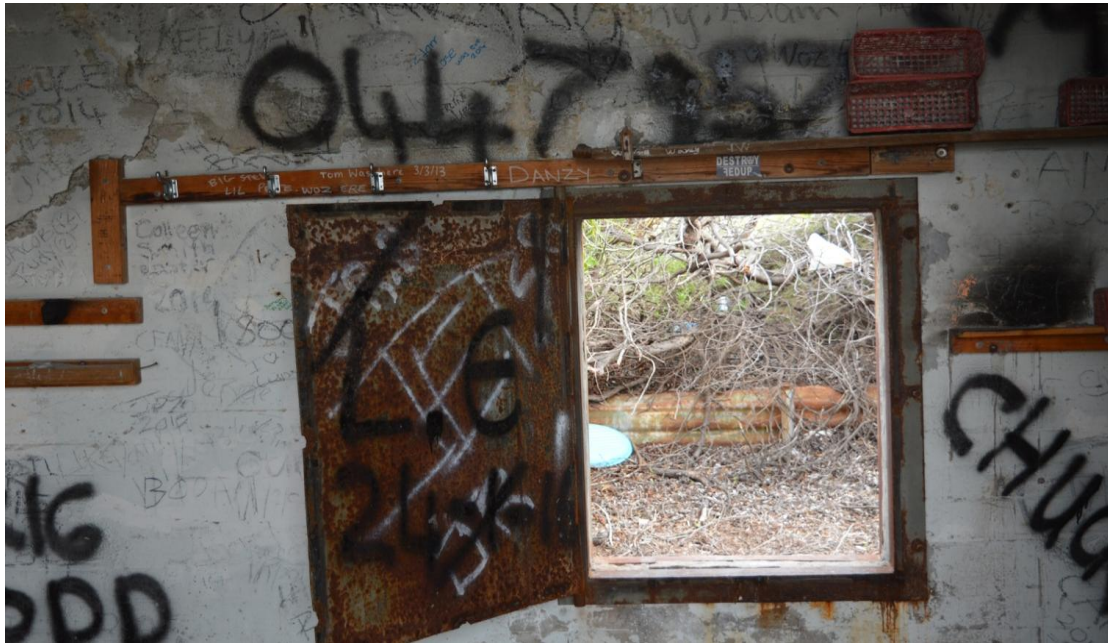
Vandalism and graffiti have also extensively impacted Igloo B (figures 9 & 10). This hut has been used in recent times as a fisherman's/campers hut. A fire pit (figure 11), water tank, fishing buoys and sandbags have been added to the sides and front edges of the Igloo.

Figure 9: Graffiti on southern interior walls of Igloo B. Photo facing south.

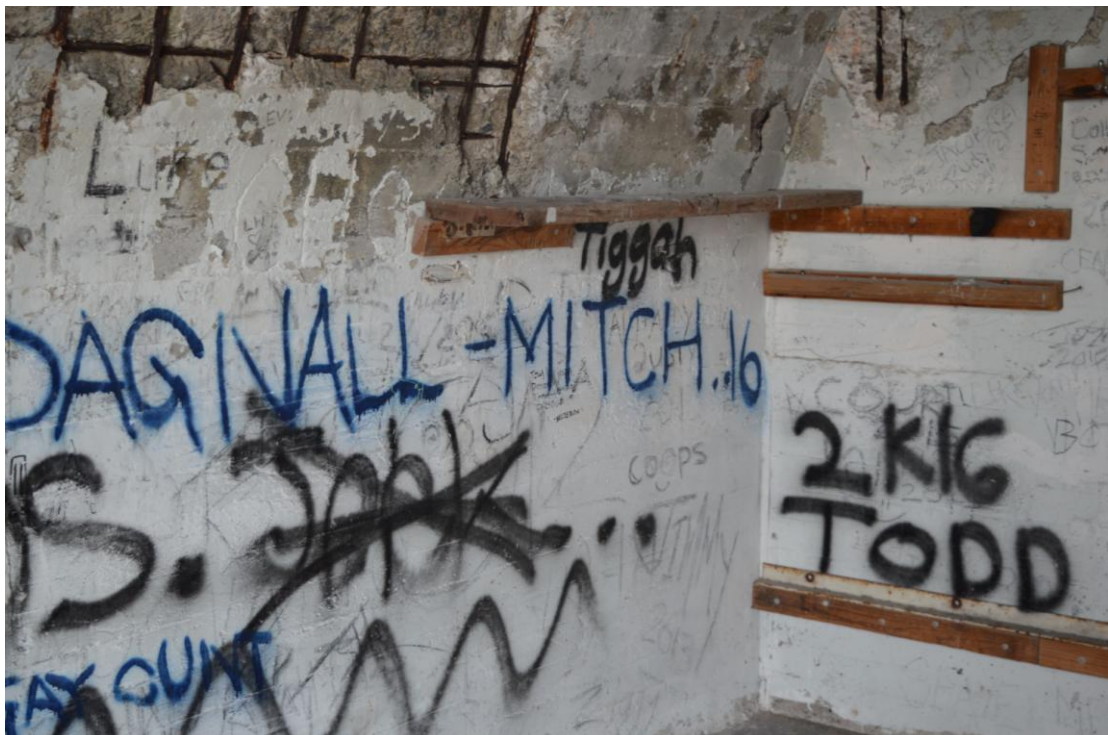
Figure 10: Graffiti on southern and eastern interior walls of Igloo B.

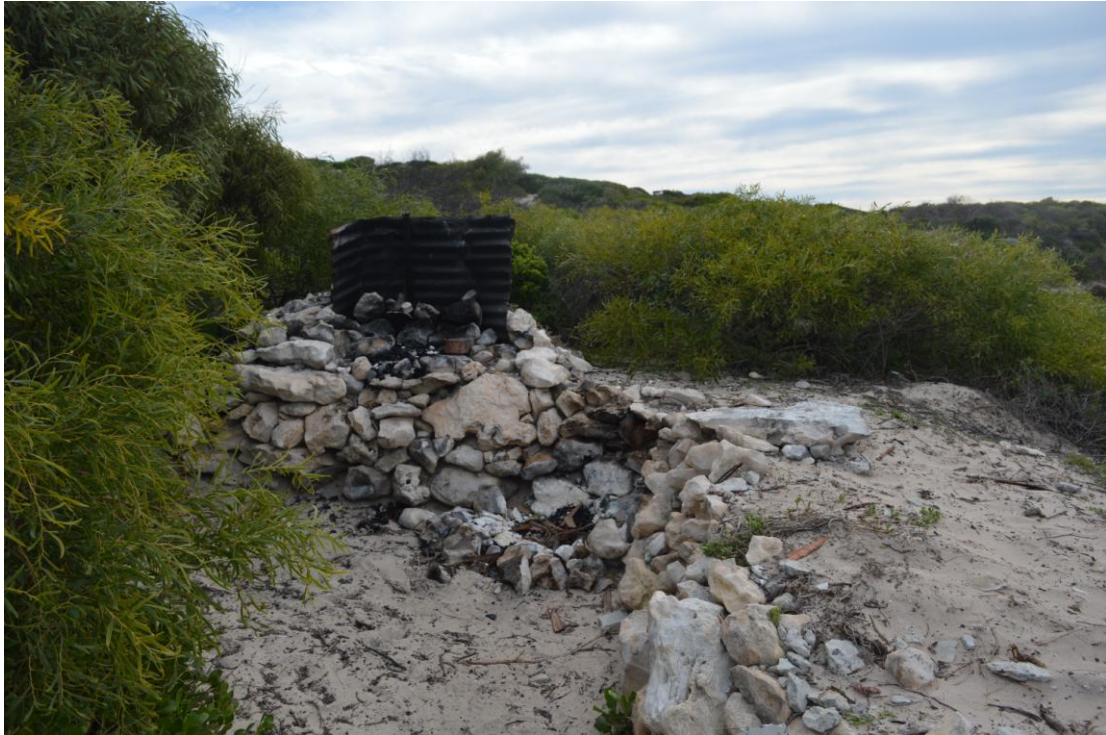
**Figure11: Fire pit outside and west of Igloo B.**

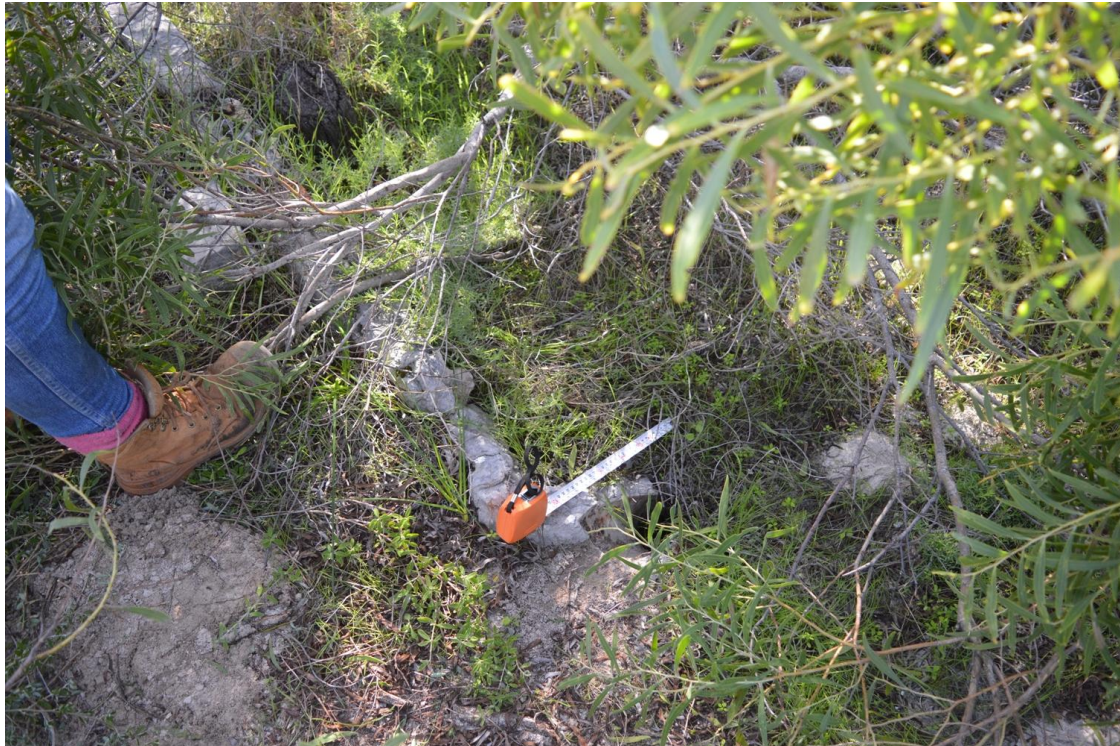
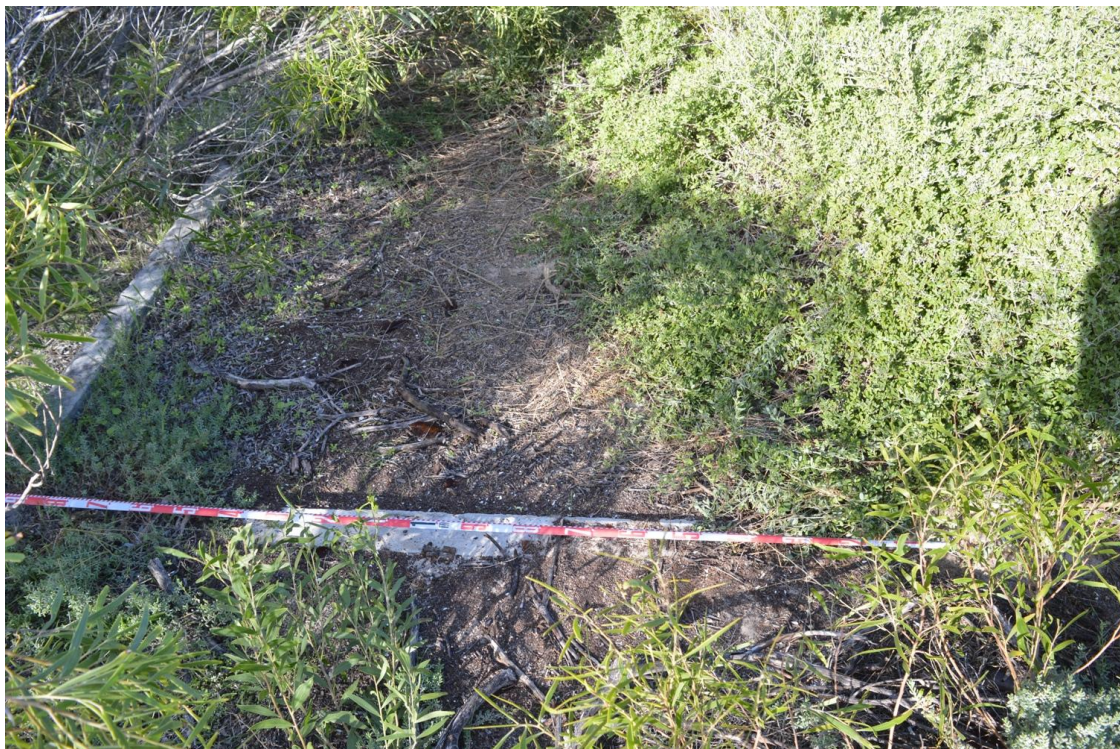
Foundation one consists of a concrete floor with a raised concrete lip around the extremities (figures 12 & 13). The concrete was constructed in a similar fashion to the Igloos and other foundations believed to be related to Radar 48.

The concrete lip appears to be a later addition to the foundations. Local resident John Grigson informed the survey team that this lip was used to channel water run-off from the slab into the nearby underground tank and was added post war by fishermen who built camps nearby (pers. comm. John Grigson 2016).

**Figure12: Foundation One concrete foundations. Scale 30cm.**

**Figure13: Foundation One concrete foundations. Scale 2m. Photo facing west.**

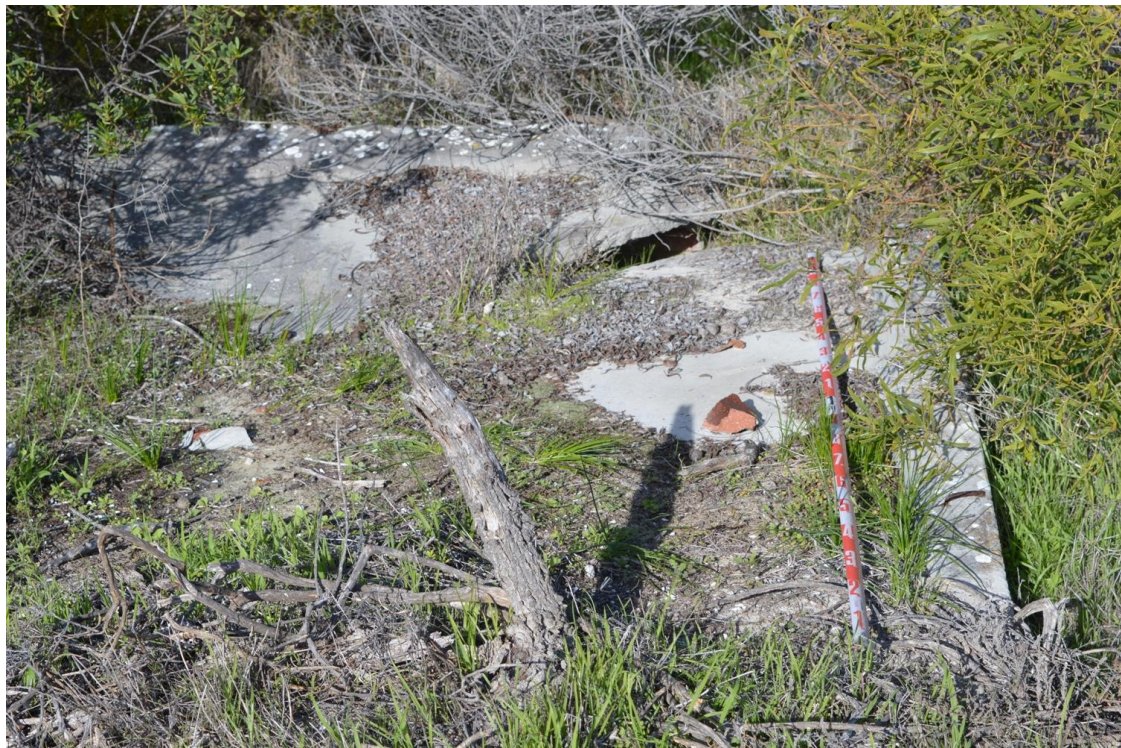
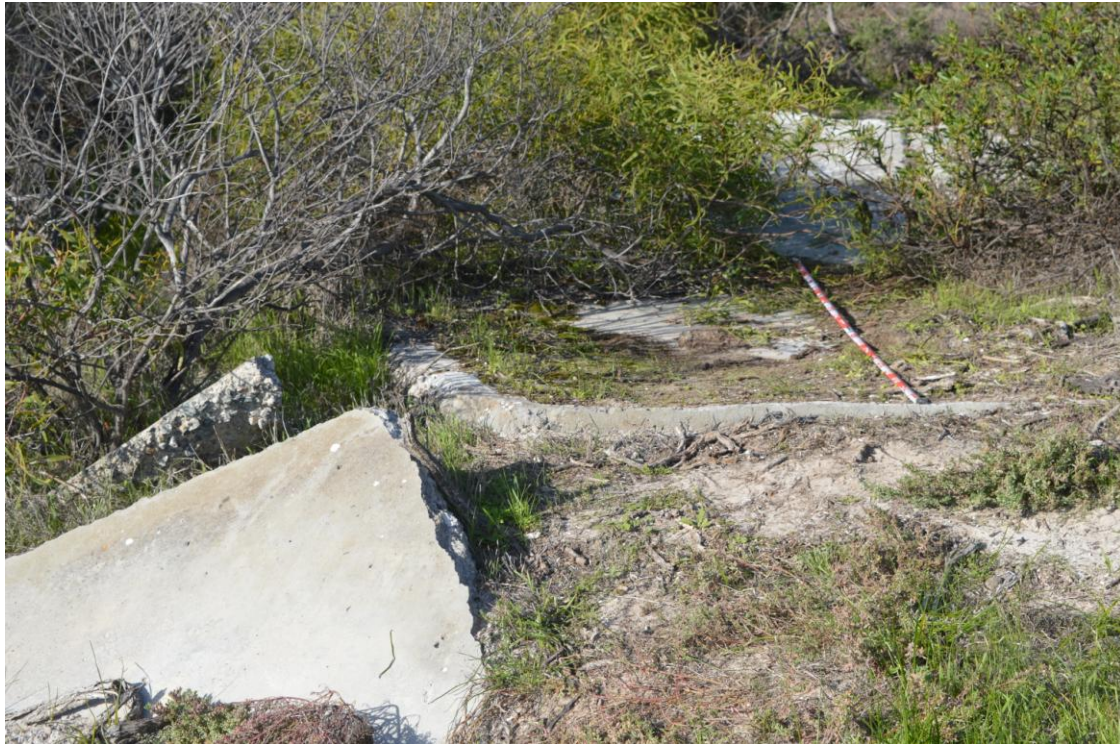
Foundation two consists of a concrete floor with a raised concrete lip around the extremities (figures 14 & 15). The concrete was constructed in a similar fashion to the Igloos and other foundations believed to be related to Radar 48. These are the foundations of the largest building so far located. It is not possible to determine the original dimensions as the corner of the structure has been damaged by machinery.

Similar to Foundation one, the concrete slab has a lip around the edge used to channel water into the nearby underground tank. The structure is linked to the tank by earthenware pipes and there are a series of man holes nearby which indicate an extensive water or drainage system.

**Figure 14: Foundation Two concrete foundations. Scale 2m. Photo facing east.**

**Figure 15: Foundation Two concrete foundations. Scale 2m. Photo facing north.**

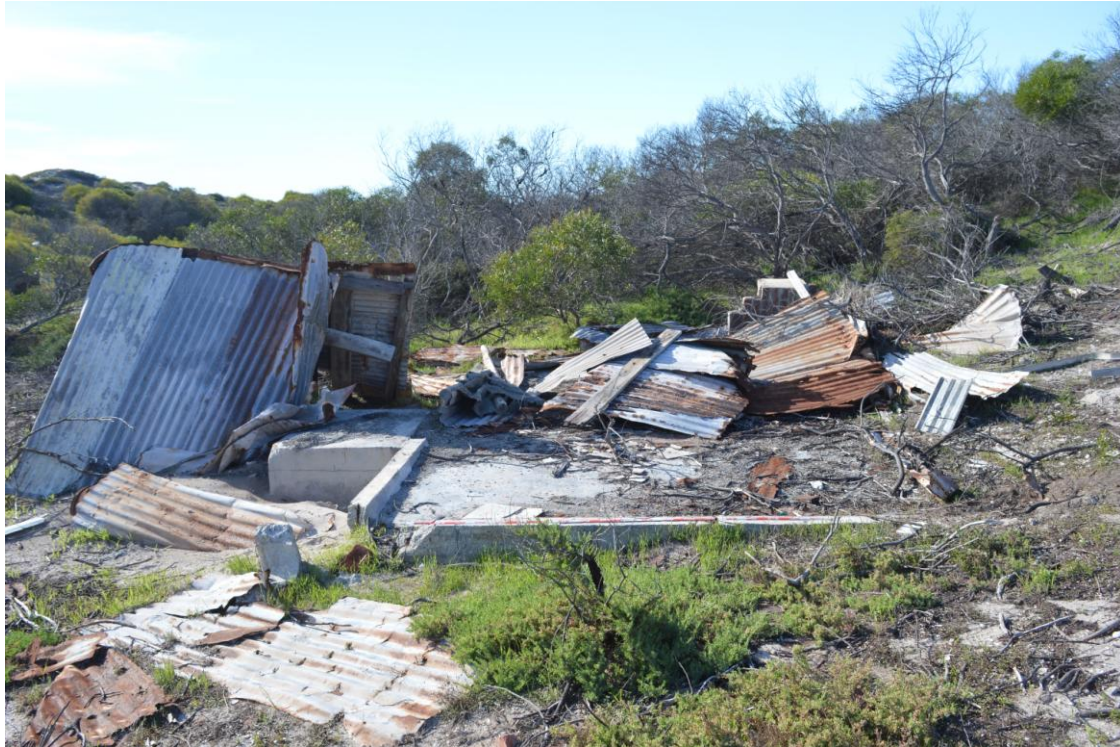
Foundation three consists of a concrete floor (figure 16). Overlying this are sheets of rusted corrugated iron that have collapsed into a pile, along with broken brickwork. It appears the foundations have been reused as a fisherman's hut some time after WWII.

**Figure 16: Foundation 3 concrete foundations overlain by rusted iron corrugated sheets. Scale 2m. Photo facing north.**

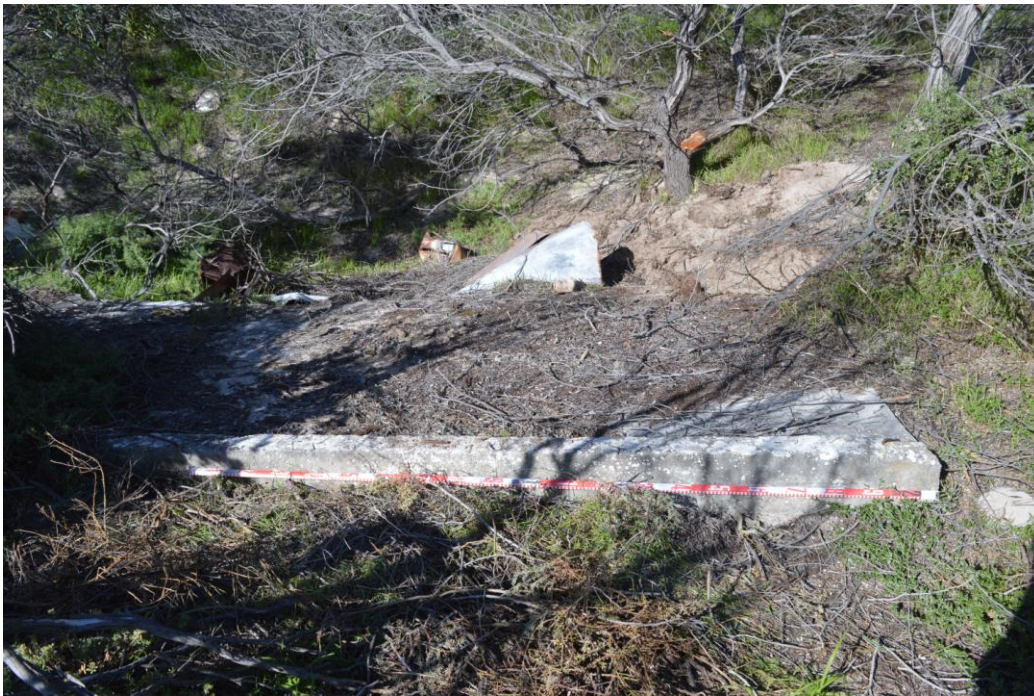
Foundation four is the northern most structure so far discovered and is not clearly visible from the track as it is obscured by dense bush and trees. Foundations consist of concrete flooring which has collapsed slightly on the eastern side. The concrete work appears of the same style of construction as the Igloos and other nearby structures (figure 17).

**Figure 17: Foundation 4 concrete foundations overlain by vegetation debris. Scale 2m. Photo facing east.**

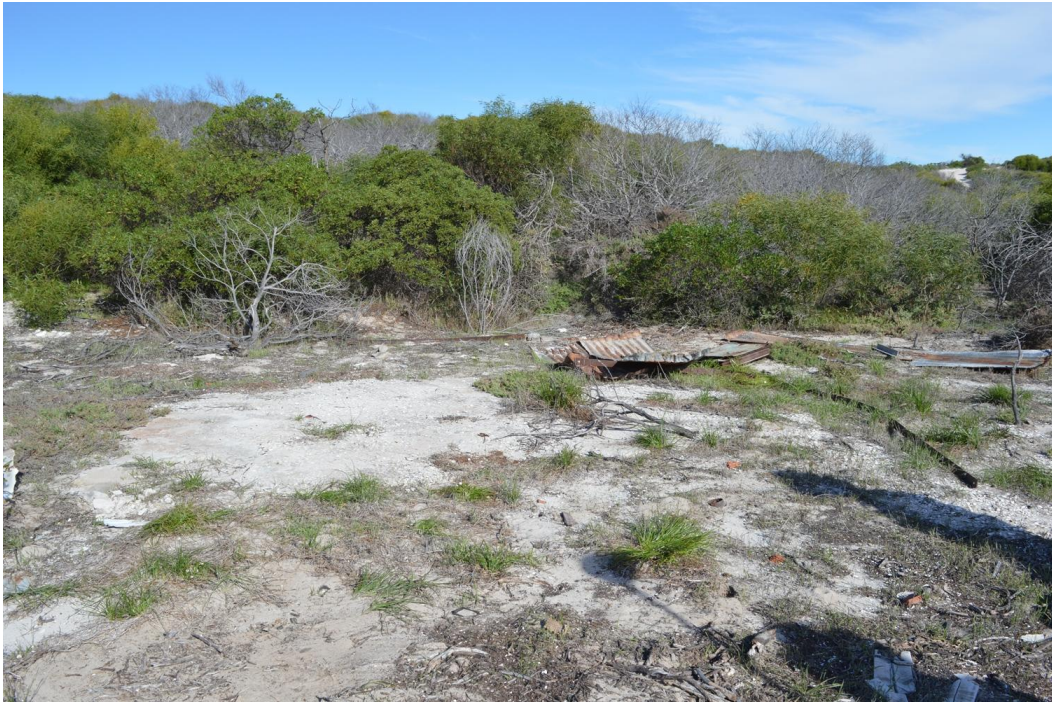
Foundation five was most likely constructed post-war and used as the foundations of a fisherman's hut. It is located in an area that is sparsely vegetated. The concrete foundations of foundation five are clearly different from those of the other foundations linked to war-time use (fig.20).

The concrete is composed of a mixture of shell grit (there is a shell quarry in the vicinity) and cement and the edges have become degraded and indistinct.

**Figure 20: Foundation 5 looking east.**

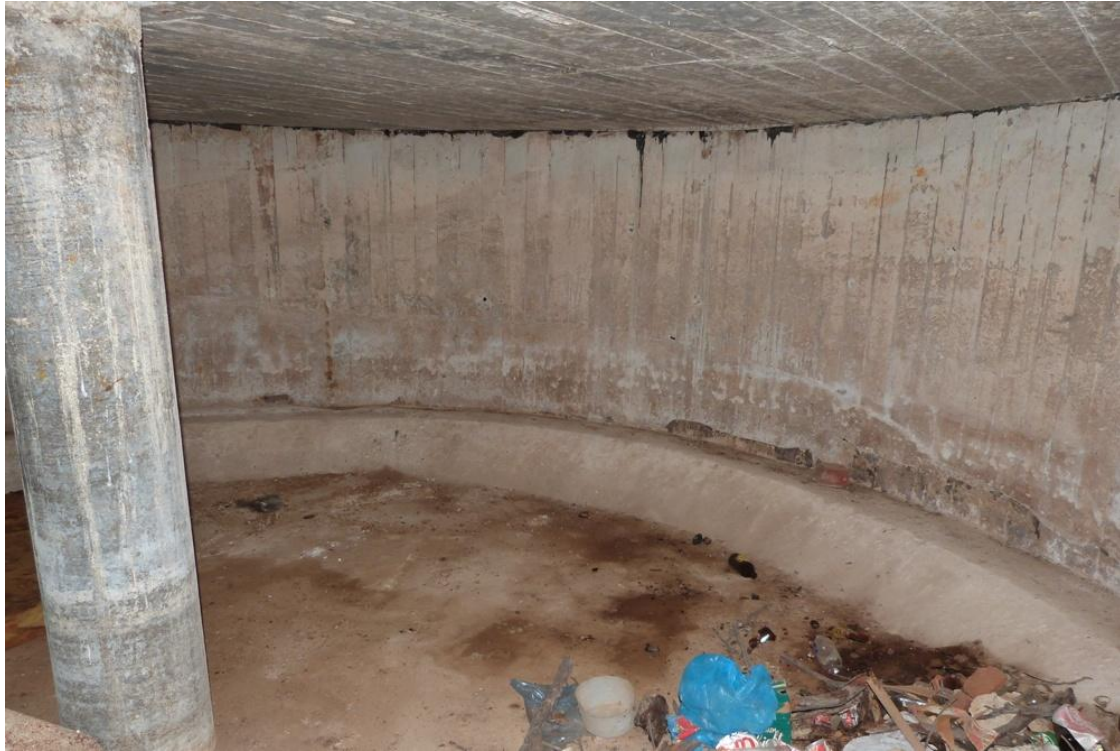
**Figure 21: Interior of water tank. Facing northwest. Rubbish has since been collected by volunteers.**

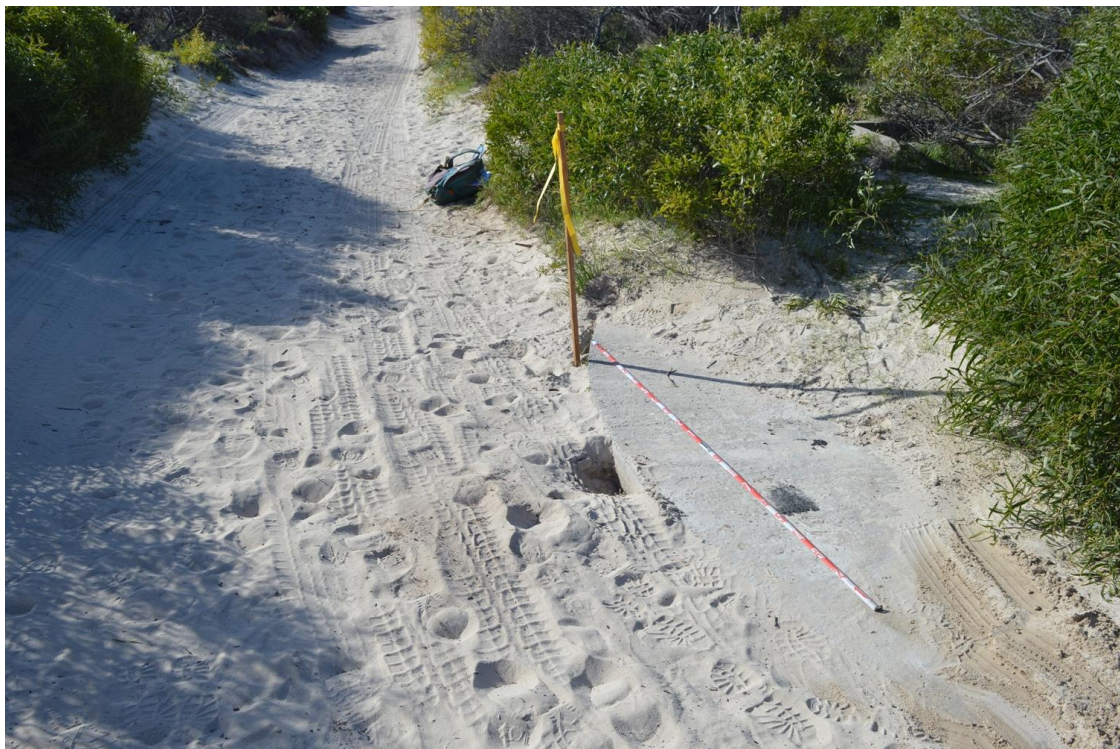
Nearby there are a series of pipes, both metal and earthenware, and a covered drainage system. The tank is in good condition. John Grigson suggests this tank was filled by run off from the rooves of the nearby military buildings and fishermen later adapted the exposed nearby foundations to enable water to be diverted into the tanks (pers. comm. John Grigson).

**Figure 22: Water tank located on, and to the east of the main vehicle track. 2m scale. Photo facing north.**

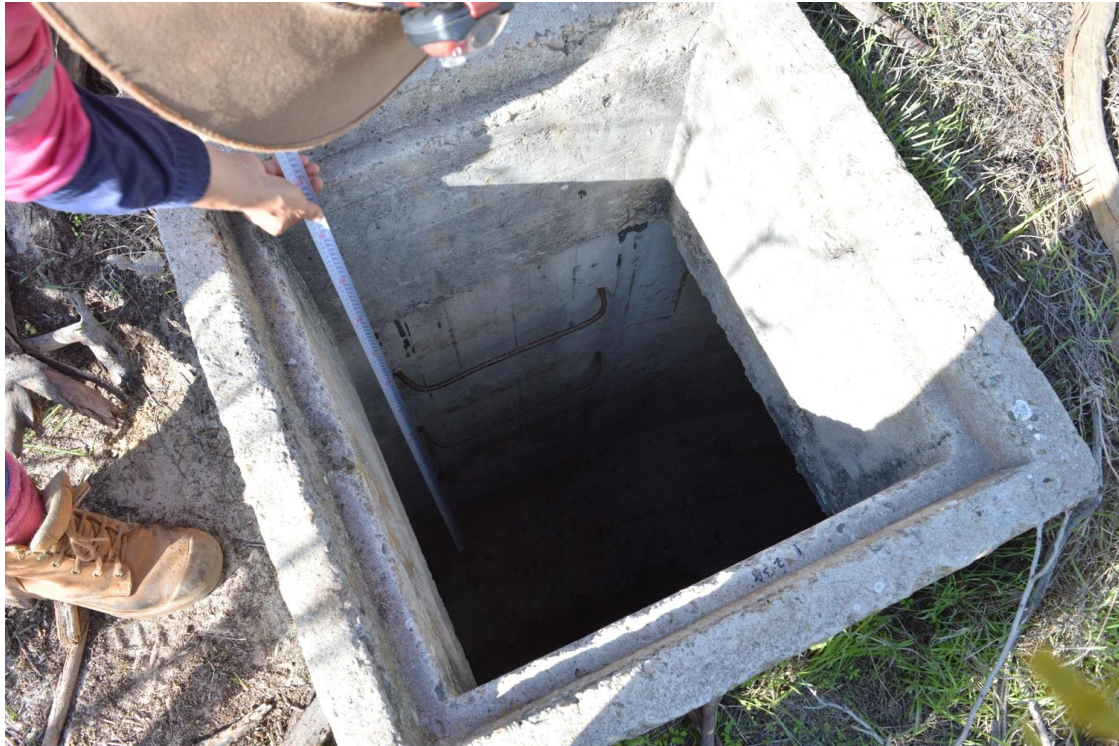
Figure 23: Manhole to water tank, located east of the vehicle track. Scale reaches down 2m. Photo facing east.

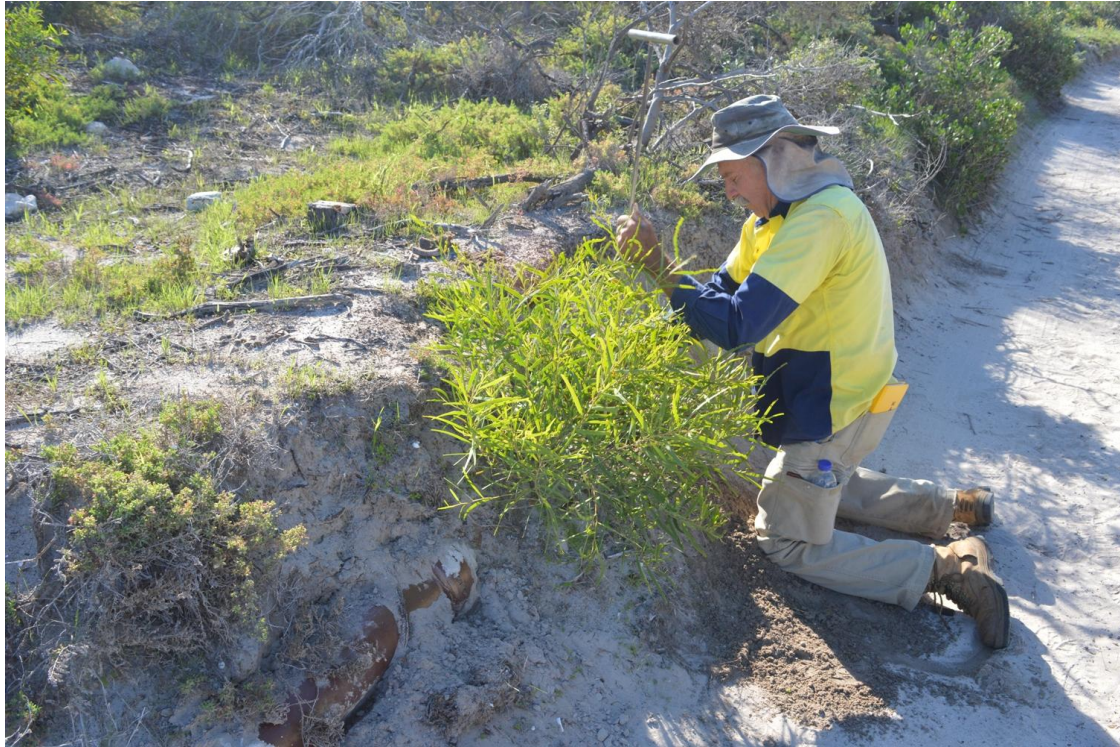
Along the main track and adjacent to S6 is a section of earthenware pipe, which appears to be intact, but also may have been moved by track maintenance or earthmoving (figure 24). Local informant John Grigson informed to team this pipe took sewerage from the camp ablution block to an ocean outlet (pers. comm. John Grigson 2016).

**Figure 24: Geoff Royce inspecting the section of earthenware pipe that is visible from the vehicle track. Photo facing northwest.**

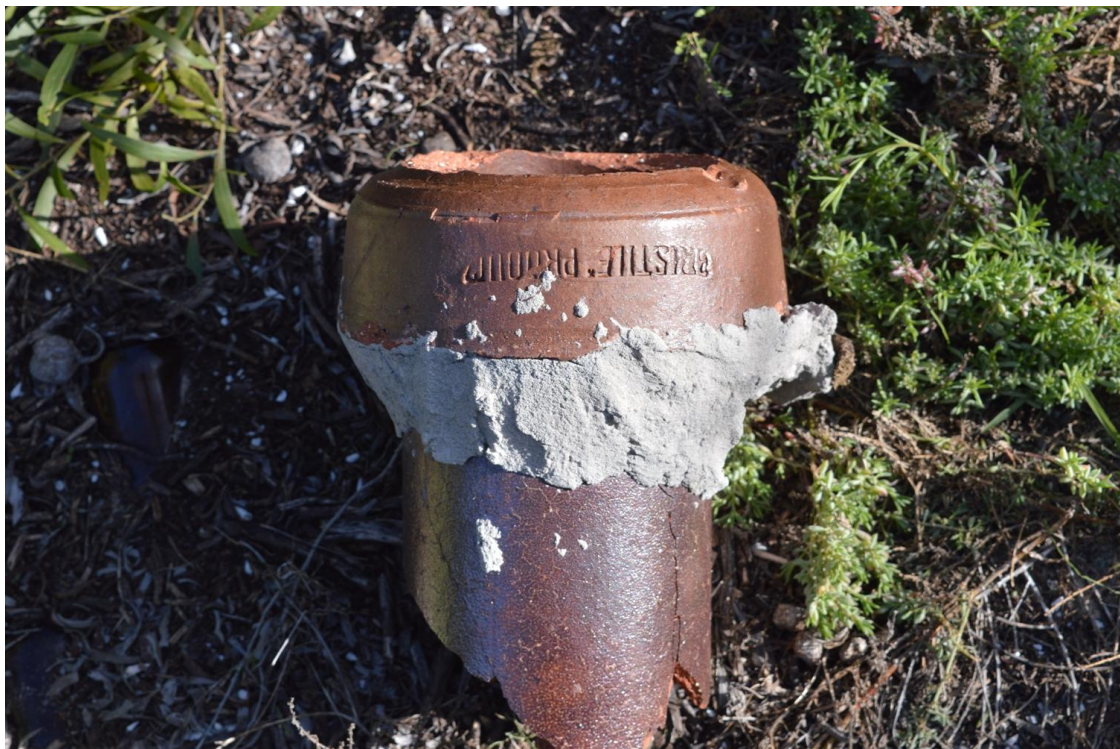
The location of the remainder of the buried pipe and the outlet is unknown but is likely to be found outside the survey area. There are numerous pieces of earthenware pipe scattered around the area (figure 25). Some of this may have been reused by shack builders.

**Figure 25: Section of earthenware Pipe.**
