# Report on the archaeological investigations of Radar Station 48, North Head, Jurien Bay for the Shire of Dandaragan.

## May 2018

Bob Sheppard  
Zack Sheppard  
Steve Wells

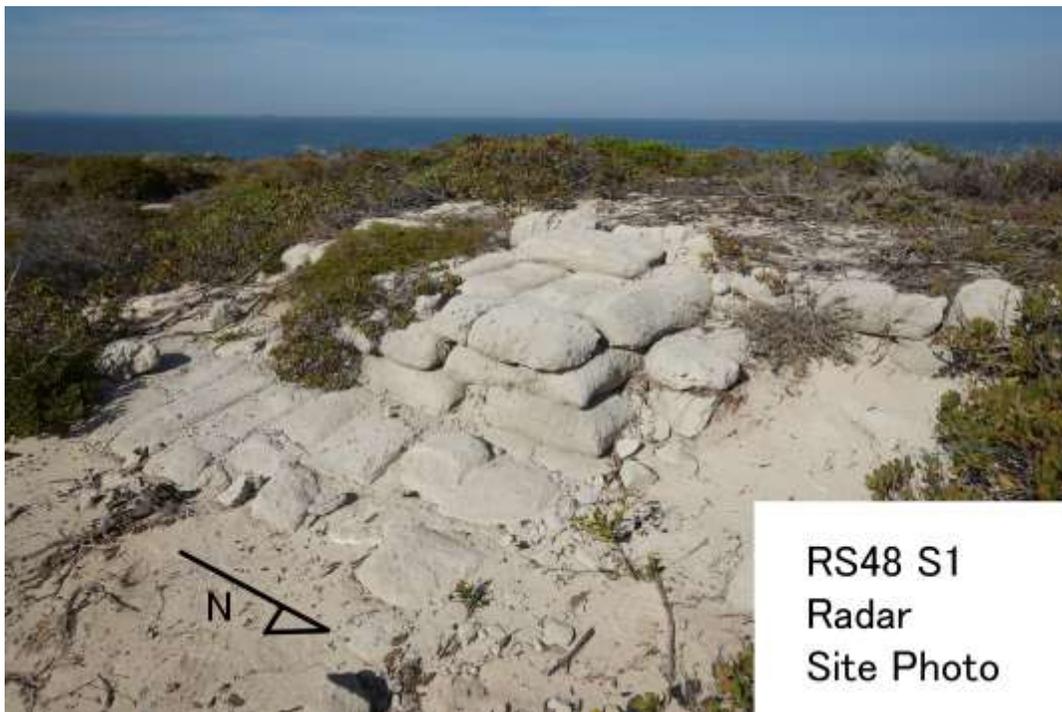
Figure 5. Sand bag steps and Dover' foundations at S1. Looking south. HDA image.

The foundations are in fair condition.

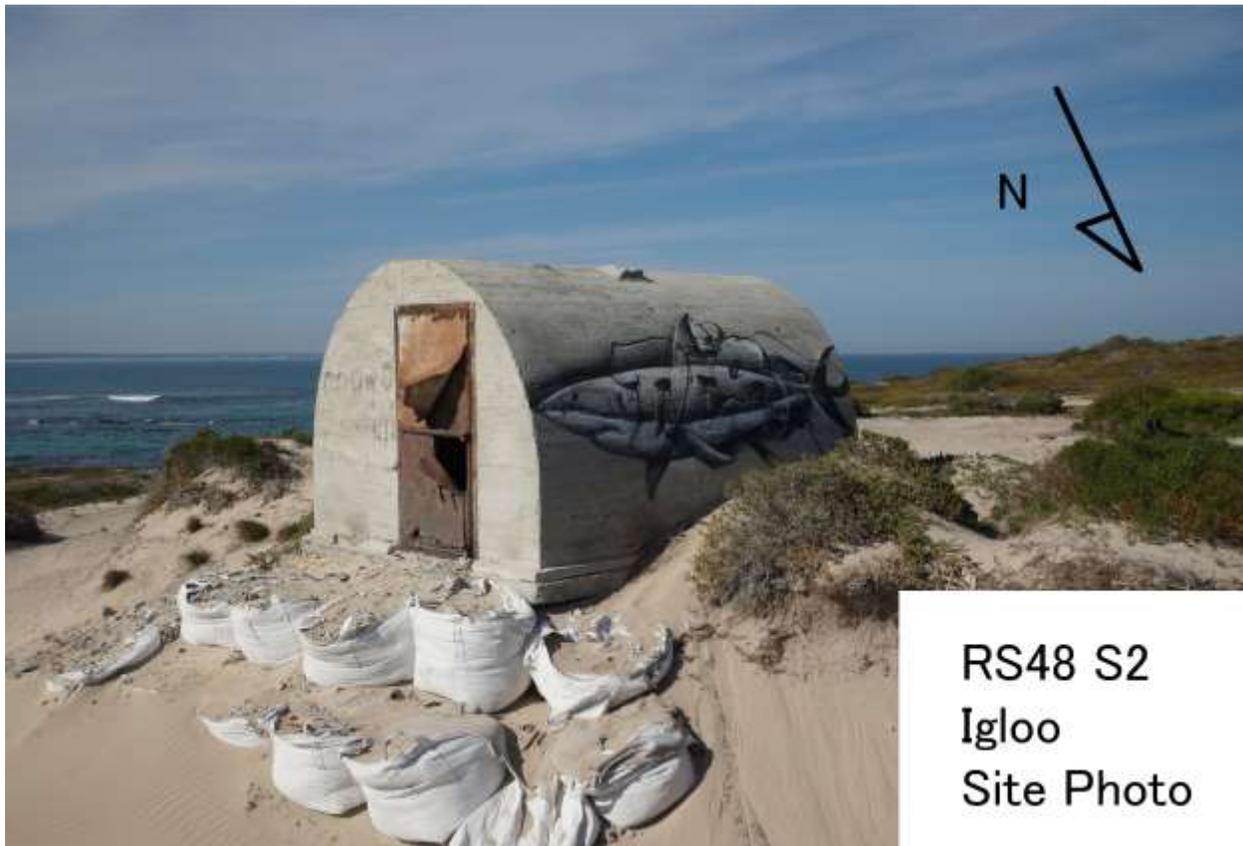
*Figure 10. S2 Generator room (Igloo) looking south east. HDA photo.*

The structure is a north-facing Nissen hut shaped building made of steel reinforced concrete. The roof and floor is 300mm thick and the north and south walls 250mm thick. It is 5m x 4.1m with the longer sides facing east and west. The building is 3.3m at its highest point. It has a metal door at the front (north), a window at the rear (south) and an exhaust point in the roof. The north west corner of the structure has been compromised by sand dune degradation and remedial action using bagged sand has been undertaken to protect the structure. Graffiti and vandalism have had a negative impact on the preservation of the building. Sections of the iron door and window have been destroyed and the structure contains beds, a refrigerator and rubbish. The interior has been modified by campers. A concrete engine bed has been removed.

The generator room is in fair condition.

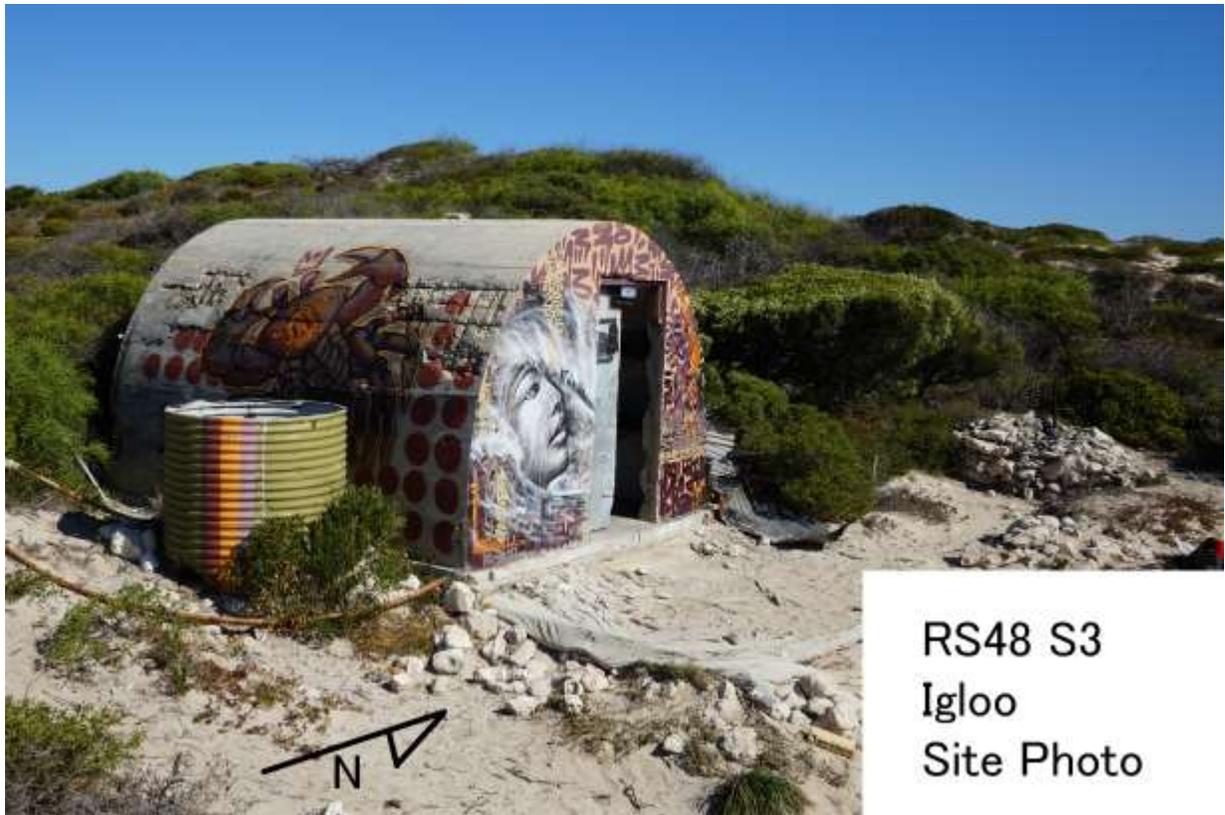
The structure is a north-facing Nissen hut shaped building made of steel reinforced concrete. The roof and floor is 300mm thick and the north and south walls 250mm thick. It is 5m x 4.1m with the longer sides facing east and west. The building is 3.3m at its highest point. It has a metal door at the front (north), a window at the rear (south) and an exhaust point in the roof. Graffiti and vandalism have had a negative impact on the preservation of the building. Sections of the iron door and window have been destroyed and the structure has been modified by campers. A concrete engine bed remains inside the structure.

Figure 11. S3 Generator room (Igloo) looking south west. HDA photo.

The generator room is in fair condition.

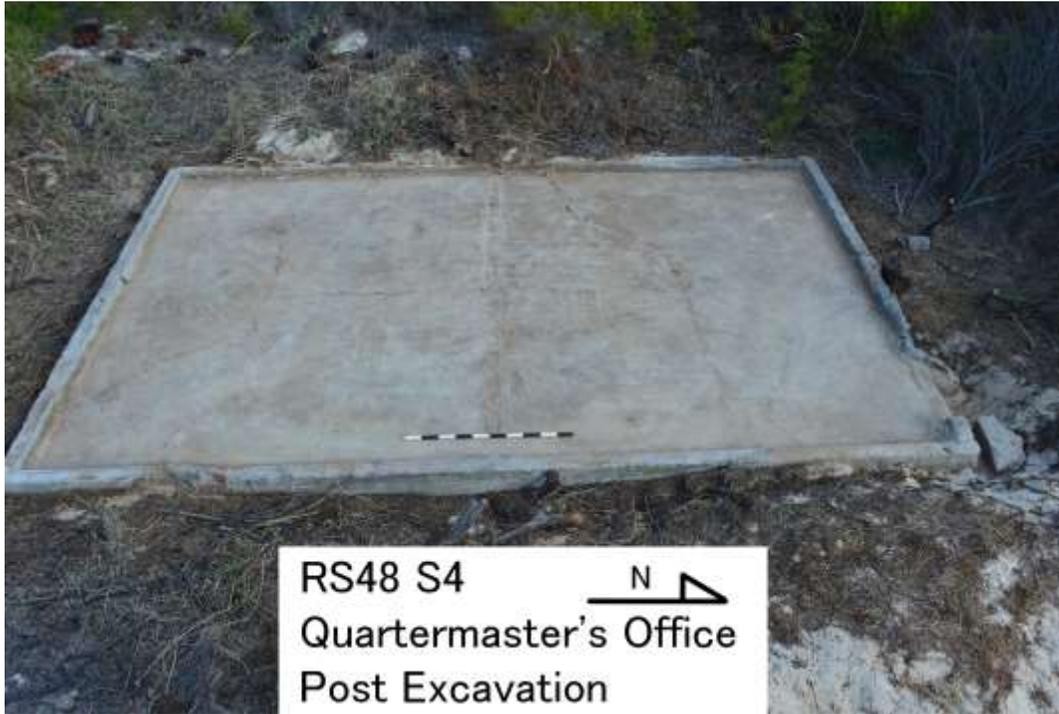
Figure 19. S4 after clearing for interpretation. HDA photo.

The foundations of S4 are in good condition.

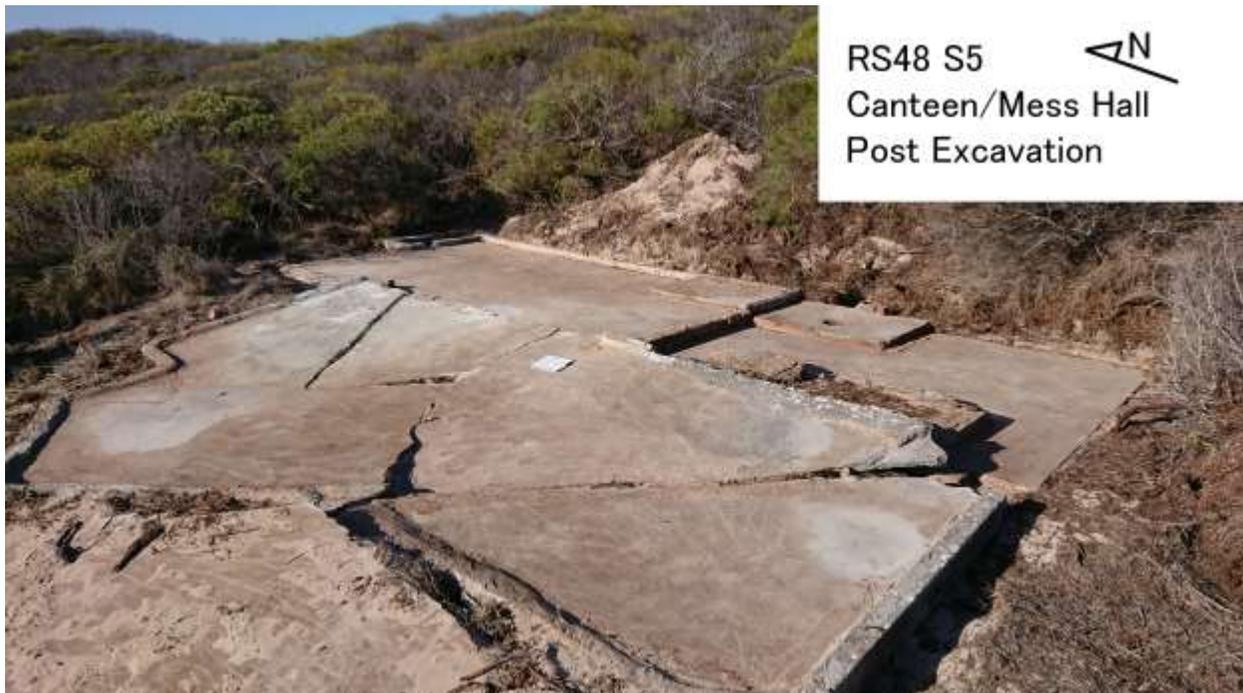
It is difficult to determine the dimensions of section B, the western section. The concrete floor is broken and the western edge is covered by deep sand. The edge of the slab and cracks have been modified post World War 2 using concrete in an effort to channel water off the broken slab into the nearby underground water tank.

Figure 23. S5 post clearing for interpretation. HDA photo.

Section A of the structure is in good condition with some minor modifications post World War 2.

Section B has been damaged by demolition and has been modified post WW2.

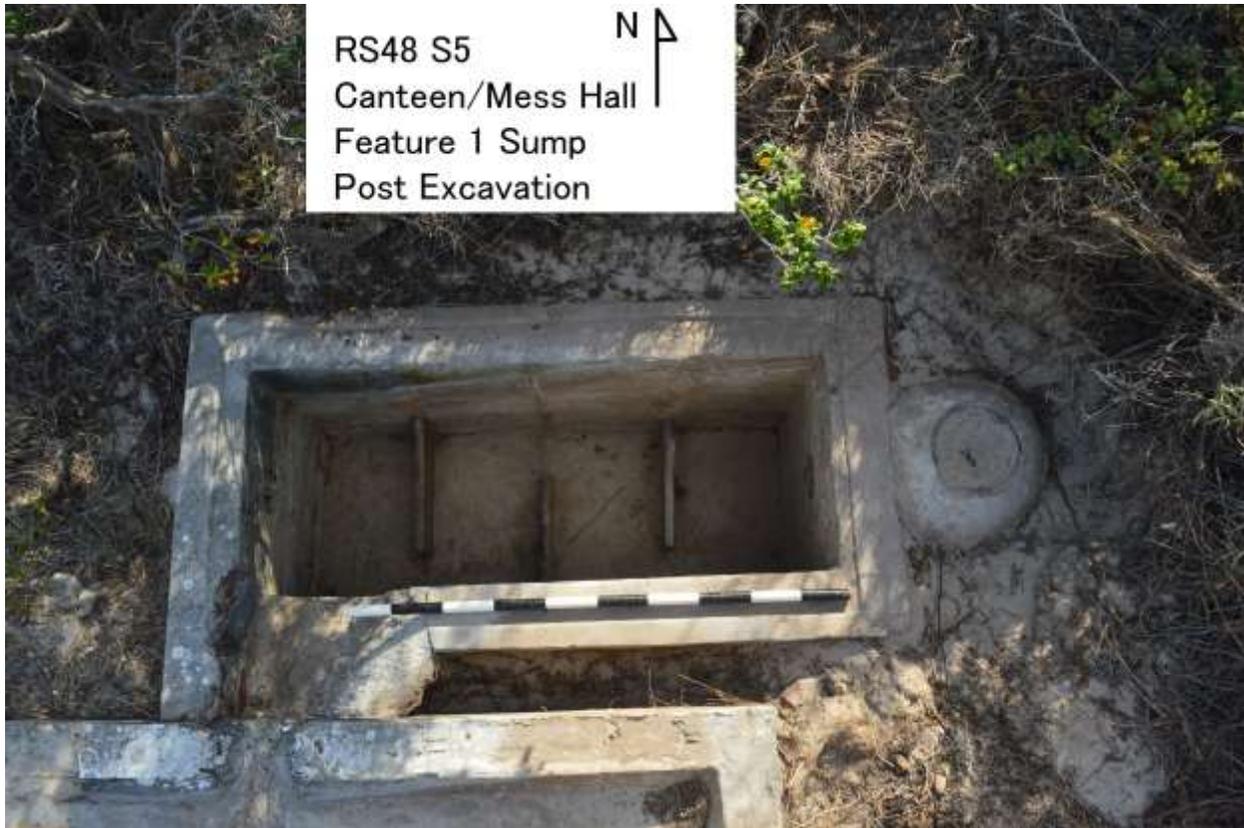
*Figure 24. S5 Feature 1 water sump, post excavation. HDA photo.*

F1. Water sump. F1 is a rectangular brick and concrete feature located on the north east corner, and external to, the kitchen and mess hall. The external measurements are 1465mm x 710mm. Excavation began after surface soil and leaf litter was removed at around 150mm from the top edge of the brick work. Samples were sieved using a 5mm sieve as excavation continued to the final depth of 610mm. Finds consisted of small pieces of post war glass and metal and included a modern small beer bottle at 380mm. No material related to the RS48 camp was located. The feature contained three broken slate baffles and it

was determined these served as a silt trap for storm water passing from roof (and gutter) drainage to the underground water tank nearby. The outlet of this feature was at one time linked to the underground water tank by an earthenware pipe. It appears this has been replaced using galvanised pipe post WW2. Using a metal detector the team tracked the galvanised pipe to an additional storm water drain located between S5 and the underground water tank. Test pitting at this drain uncovered a cool drink bottle from circa 1966. F1 had been damaged by salvage, and modified to allow water from the slab to be channelled into the nearby underground water tank. This modification was post demolition and related to the holiday camps built nearby post WW2.

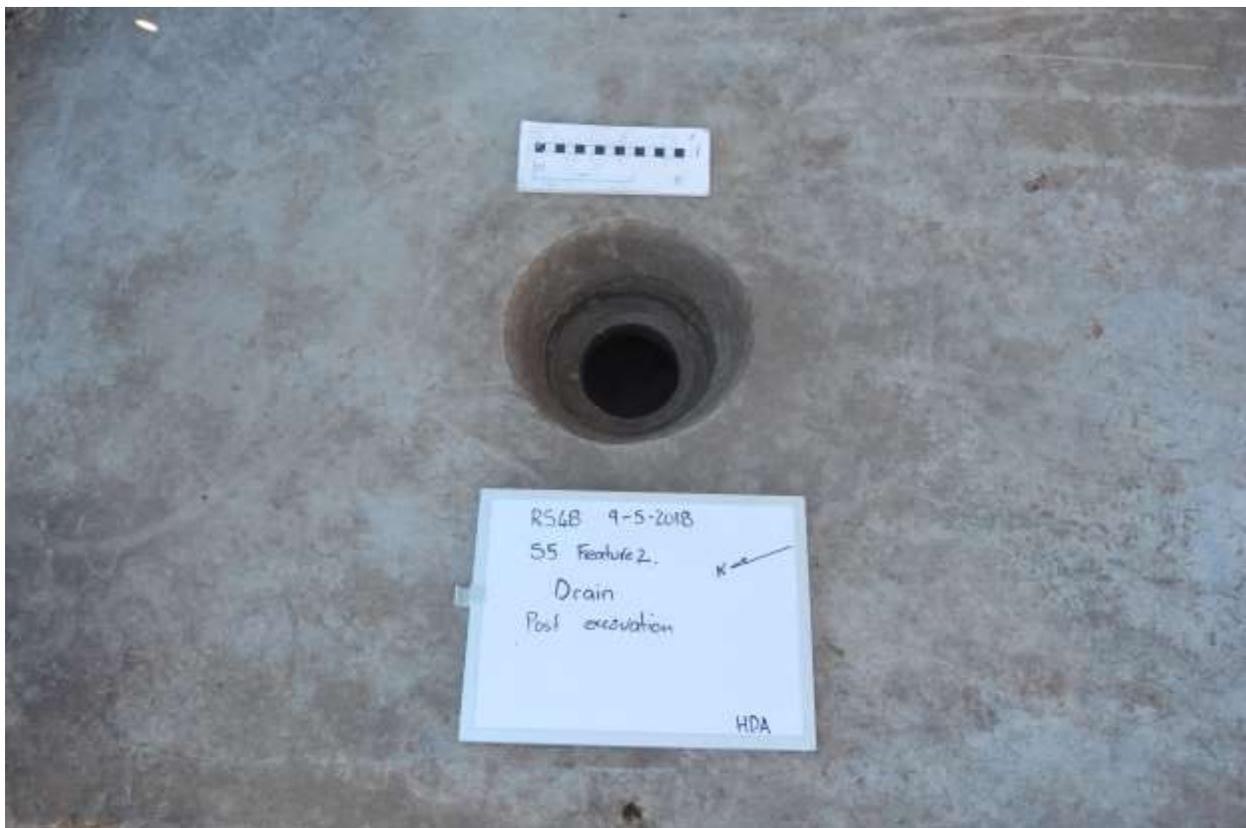
F2. Drain. The drain is a 300mm hole at surface to 100mm below. It is on a raised elevated concrete pad 1m x 1.6m. The contents of the drain hole were sieved using a 5mm sieve. No cultural material was located. The drain takes waste water to an external drainage system which runs along the eastern side of the structure.

*Figure 25. S5 Feature 2 drain, post excavation. HDA photo.*

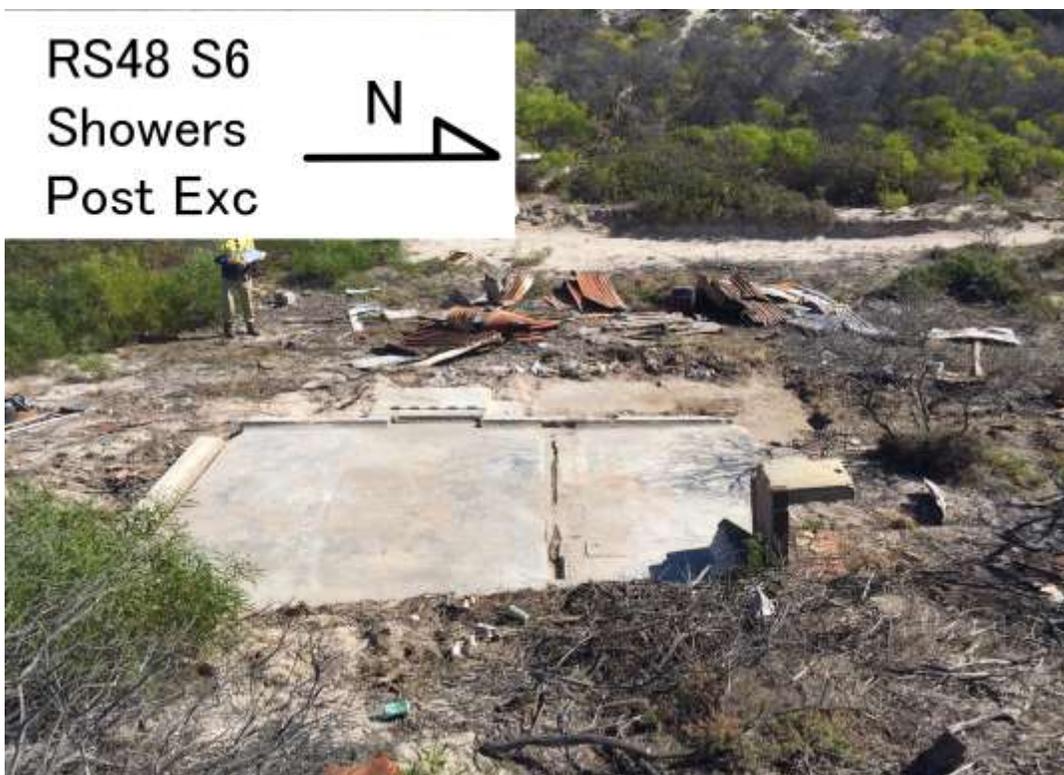
Running east – west a 'crack' traverses the foundation approximately one third of the distance from the southern edge. This may be the remains of a more intact original drain cemented over by campers after the abandonment of the building by the RAAF. A second 'crack' also running east – west, runs across the foundation at approximately two thirds of the distance from the southern edge. This crack may also be the remains of a drainage channel associated with the building's original use. On the western end of the foundation where this channel originally exited the building there is evidence of it having been either cemented over or modified in more recent times.

Figure 30. S6 after clearing for interpretation. Photo looking west. HDA photo.

The channel contains a coiled wire and fibre pipe which has been partially cemented in place. The enclosure of the channel and pipe inclusion are post WW2. They are believed to be associated with water collection by later users of the foundation.

Internal junctions of wall remains, with the floor of the foundation have been modified by a cement 100mm concrete lip running along the internal perimeter of the foundation. This modification is believed to be associated with water collection subsequent to the building's use as a shower block. Evidence of an internal wall running east to west is also evident. This consists of the remains of a brick and concrete feature protruding up to 10mm above the foundation and located immediately to the north of the northern 'crack'. Attached to this wall on its northern side are two raised concrete beds approximately 250mm x 250mm. One pad is located on the eastern corner of the wall and the eastern end of the foundation separated by approximately 500mm from the other.

The concrete foundation is in good condition with minor modifications post WW2. Despite the building being subjected to salvage pressures the outlines of some functional elements are still evident including an internal wall, internal drainage channels, concrete pads and steps. The addition of a post WW2 pad on the western edge of the structure may have assisted to maintain the integrity of part of the concrete foundation, forming a buffer from erosion or sand collection.

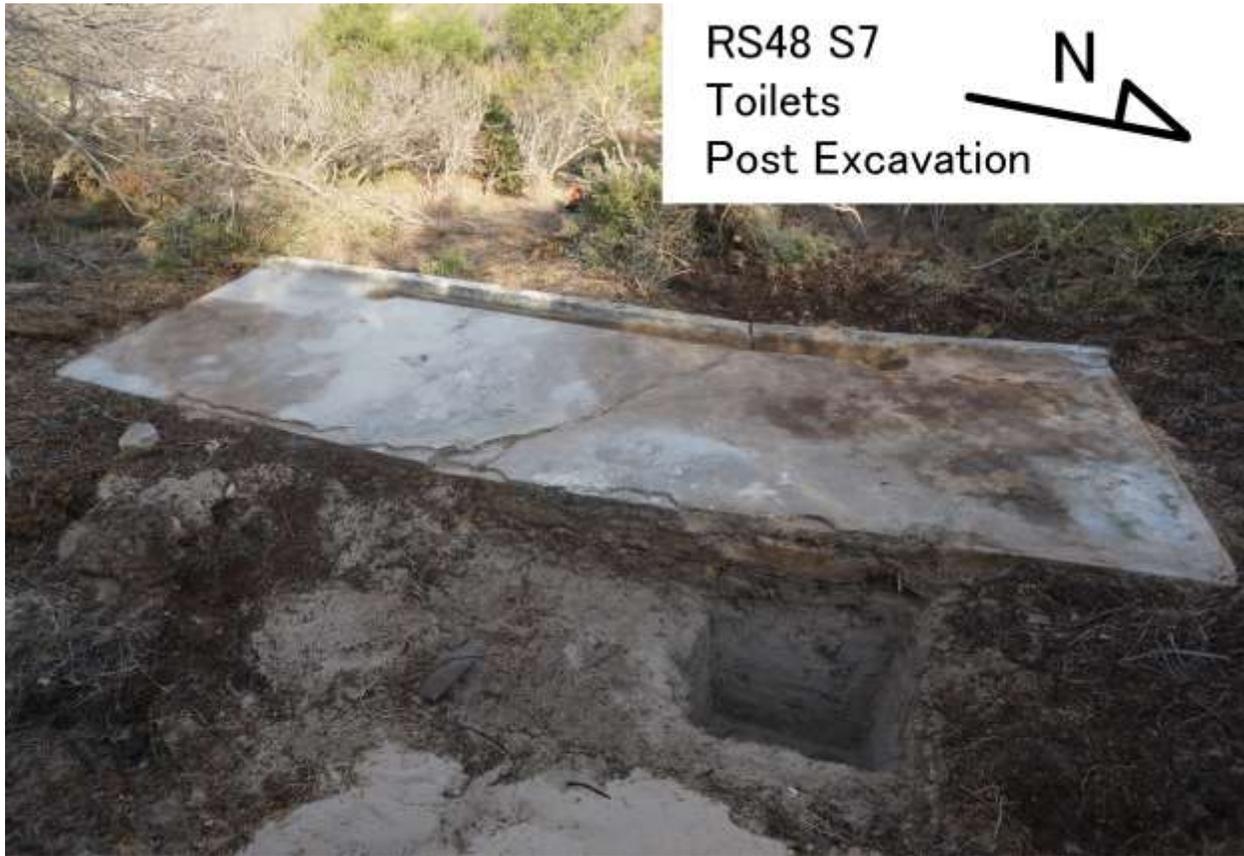
*Figure 34. S7 after clearing for interpretation. Photo looking to the west. HDA photo.*

The concrete foundations is in good condition with some minor modifications post WWII. The depression immediately east of the concrete foundation may be relatively intact but filled with post WWII refuse with its eastern periphery covered by a sand dune.

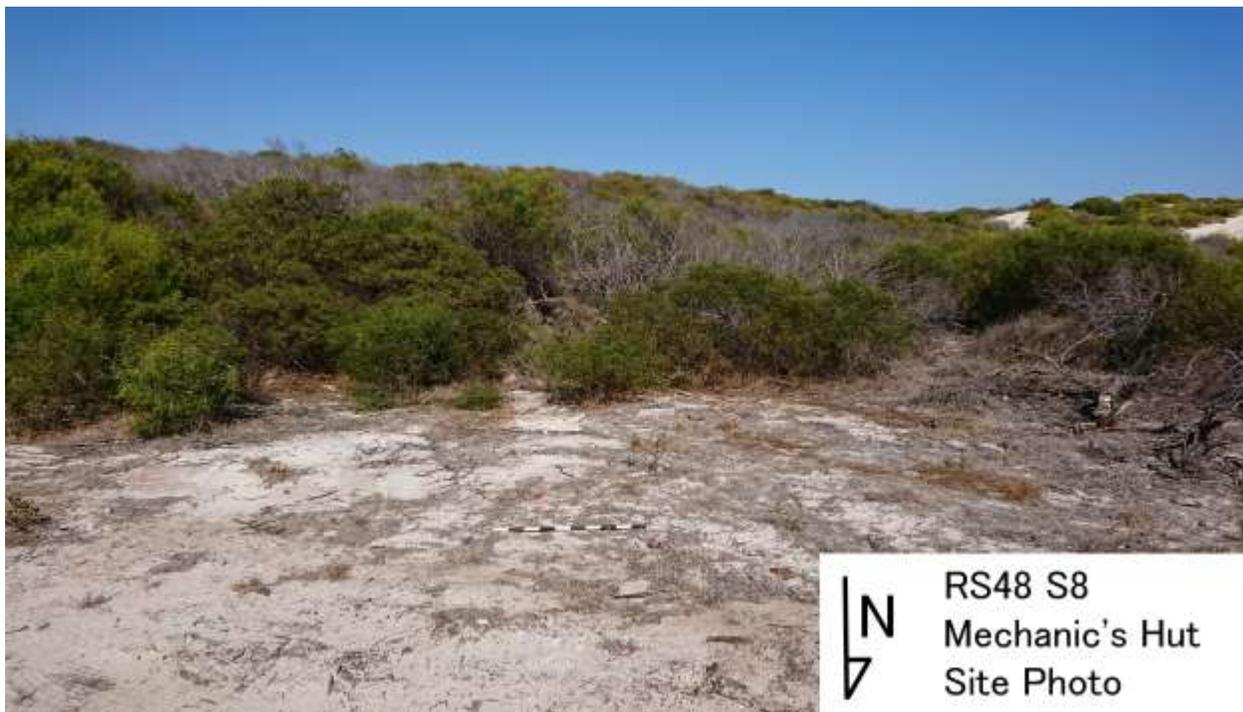
Figure 38. Site of S8. Facing south east. HDA photo.

S8 is in poor condition, due to low quality design and materials. However, due to not being WW2 related, its condition and protection are outside of the scope of this report.

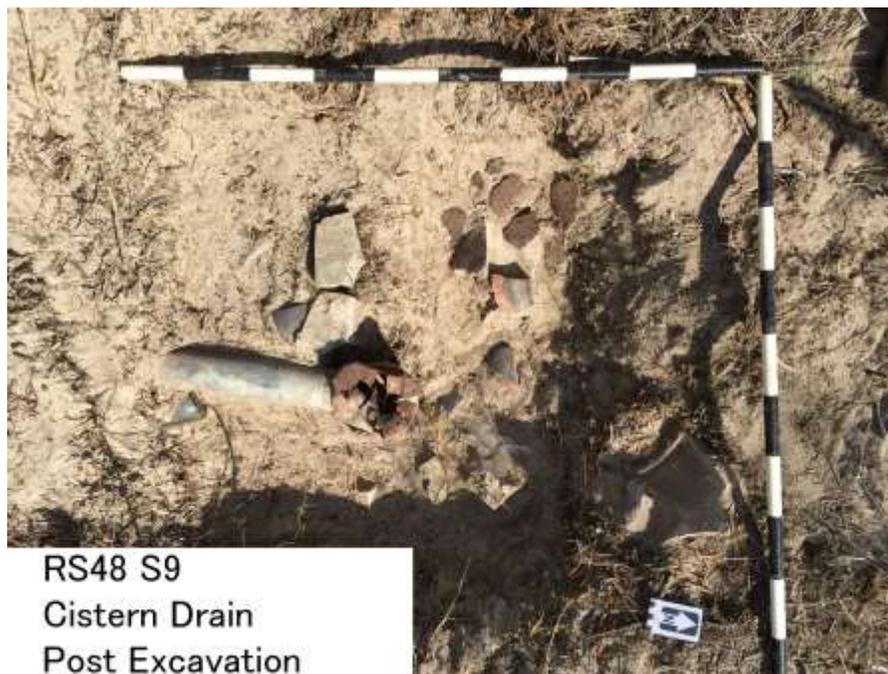
At 280mm the vertical pipe fitted into the flanged end of an earthenware plumbing pipe. Cultural material remains found from 250mm to the end of excavation at 300mm consisted of corroded iron fragments possibly from a can, fragments of concrete and earthenware plumbing pipe.

Figure 43. S9 drain post excavation. HDA photo.
