## Jurien Hall

### HERITAGE OPTIONS – SUMMARY OF COMMUNITY SURVEY

# Routine Inspection Report

**Date:** Thursday, 10 December 2020

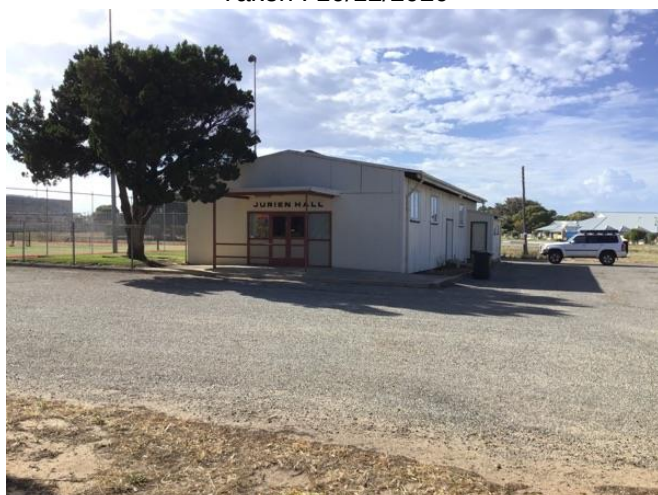
Exterior of Building  
Taken : 10/12/2020

| Area | Clean | Maintenance<br>Required | Renew Within<br>5 Years | Compliance<br>Concern | Comments/Notes |
|---|---|---|---|---|---|
| <b>Exterior of Building</b> | | | ✓ | | Building has multiple issues. However, requires a strategic review of its future before works are scoped. |

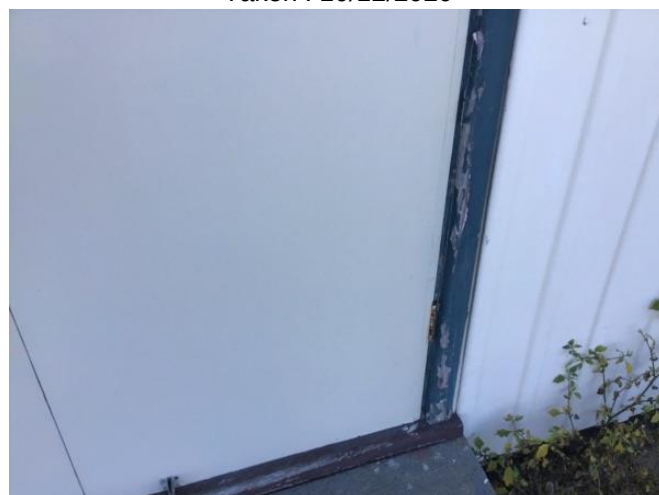
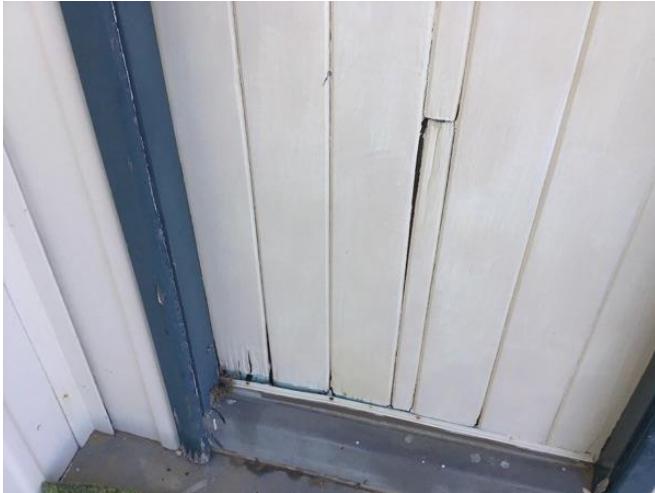
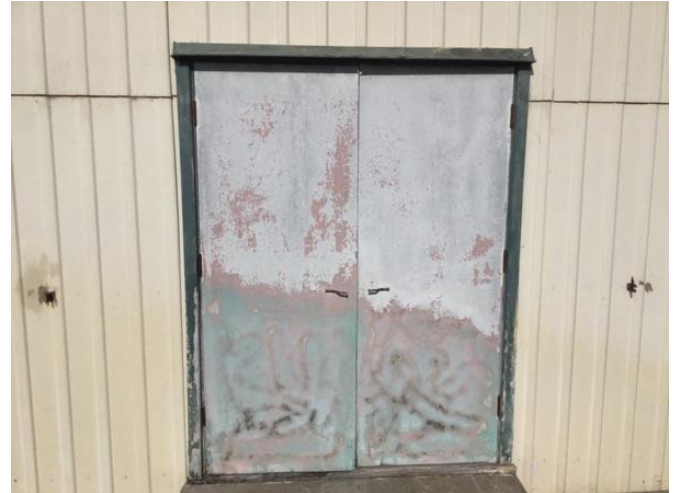
Exterior of Building - Doors  
Taken : 10/12/2020

| Area | Clean | Maintenance<br>Required | Renew Within<br>5 Years | Compliance<br>Concern | Comments/Notes |
|---|---|---|---|---|---|
| Doors | | ✓ | ✓ | | All external door frames require localised repairs, stripping and repainting. Some parts, such as frame base, will need replacing.<br>Eastern rear door needs replacing.<br>Side doors to tennis courts need renewal.<br>Very poor condition. |

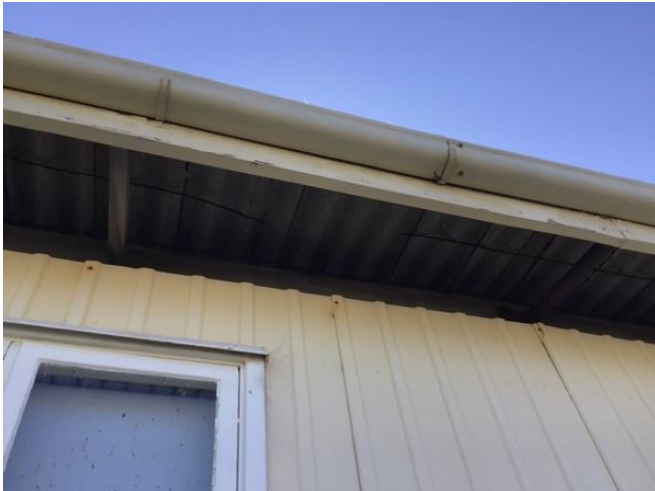
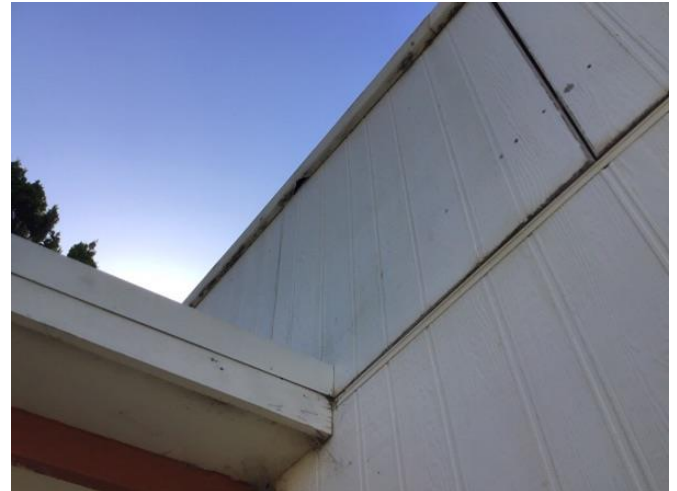
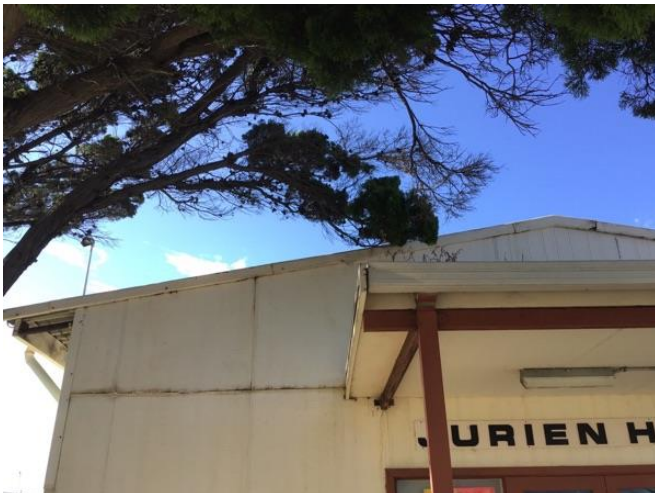
Exterior of Building - Roof  
Taken : 10/12/2020

| Area | Clean | Maintenance<br>Required | Renew Within<br>5 Years | Compliance<br>Concern | Comments/Notes |
|---|---|---|---|---|---|
| Roof | | ✓ | | | Timber frame with ACM panels and steel mesh.<br>All mesh is corroded, with failures that have occurred.<br>All exposed timber elements require painting.<br>Bees nest located in roof, entry in north west corner.<br>Localised areas of failure to roof.<br>Tree at front needs pruning away from roof.<br>Average condition. |

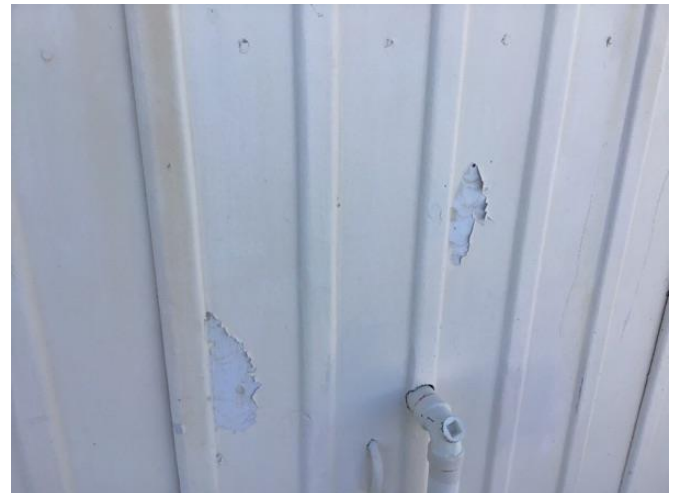
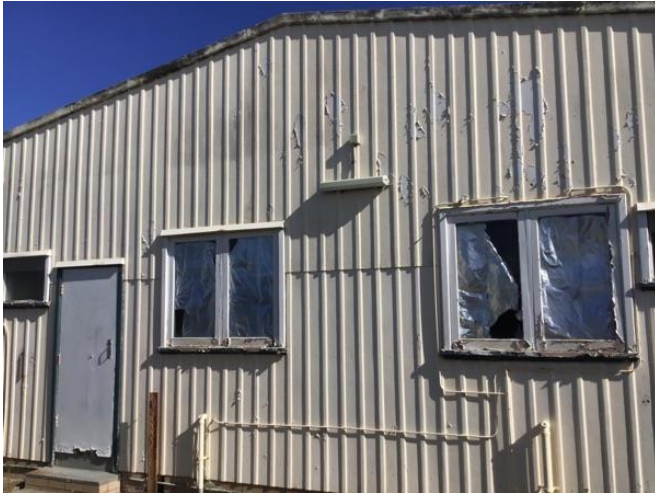
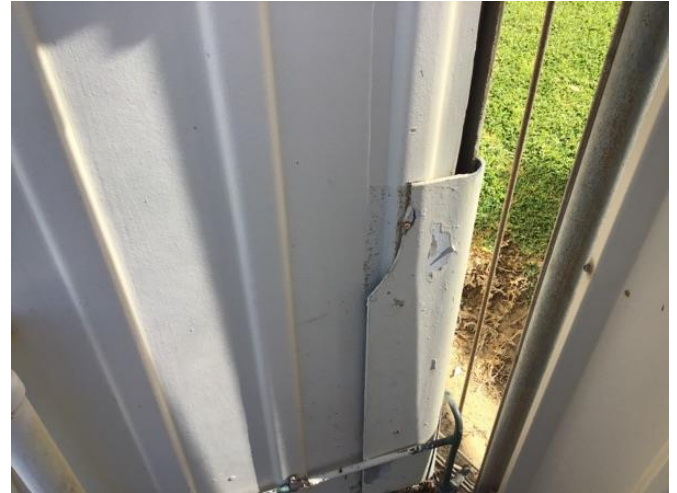
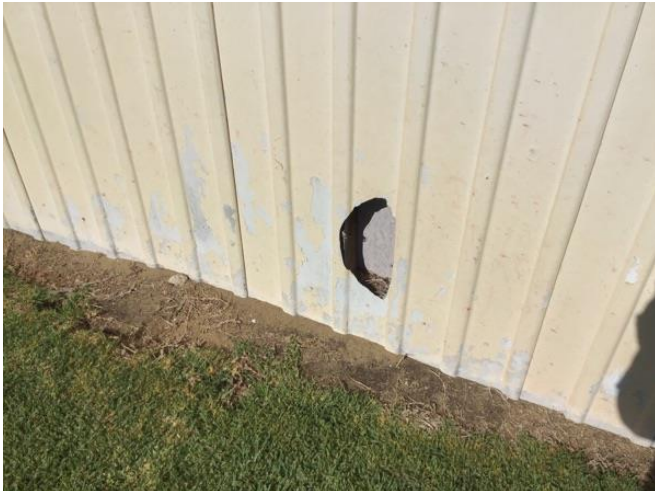
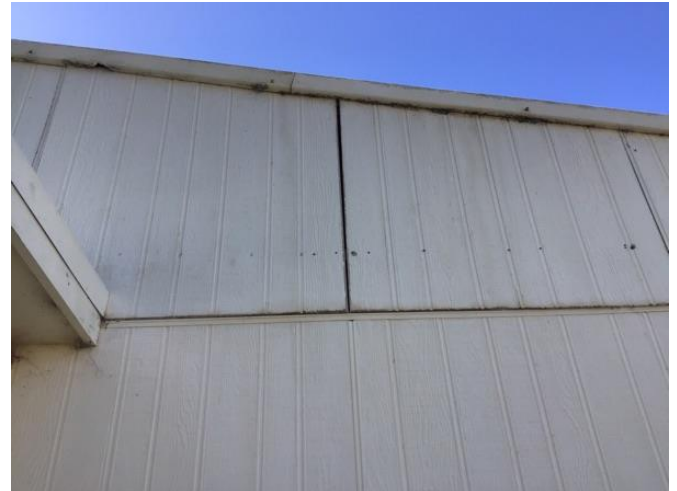
Exterior of Building - Walls  
Taken : 10/12/2020

| Area | Clean | Maintenance<br>Required | Renew Within<br>5 Years | Compliance<br>Concern | Comments/Notes |
|---|---|---|---|---|---|
| Walls | | ✓ | ✓ | | ACM panelling. All exposures require painting.<br>Localised areas of damage noted in several places. Will require replacement of some panels.<br>Poorly fitted panels, such as by main entrance, will be allowing water ingress.<br>Average condition. |

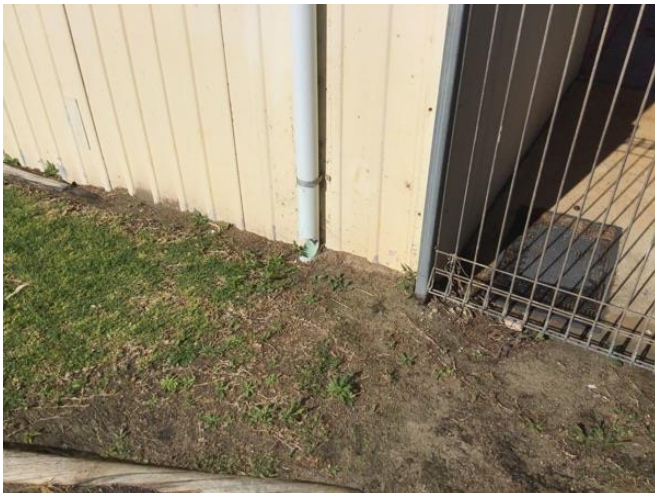
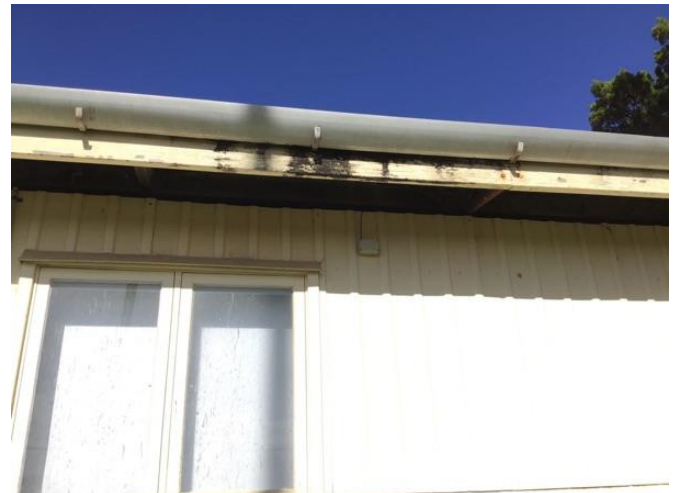
Exterior of Building - Gutters/ Downpipes  
Taken : 10/12/2020

| Area | Clean | Maintenance<br>Required | Renew Within<br>5 Years | Compliance<br>Concern | Comments/Notes |
|---|---|---|---|---|---|
| Gutters/<br>Downpipes | | ✓ | | | Gutters require cleaning, all elements require repainting.<br>Gutter in north west corner needs replacing due to failure.<br>Northern gutter appears to be overflowing backwards, causing damage to the roof.<br>Poor condition. |

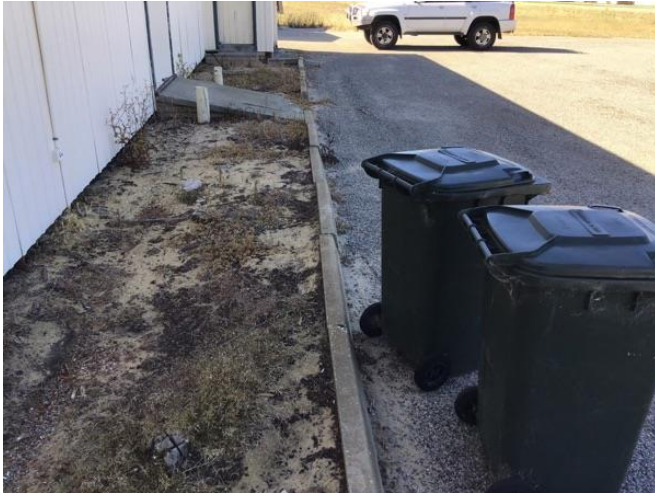
Exterior of Building - Parking  
Taken : 10/12/2020

| Area | Clean | Maintenance<br>Required | Renew Within<br>5 Years | Compliance<br>Concern | Comments/Notes |
|---|---|---|---|---|---|
| Parking | | ✓ | | | Precast concrete kerb in car park is misaligned and requires resetting. |

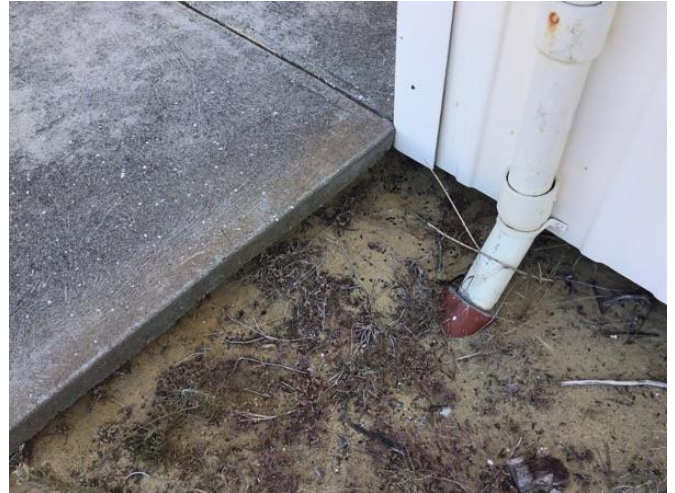
Exterior of Building - Common Areas  
Taken : 10/12/2020

| Common Areas | | | | | Slight undermining of entry path noted. |

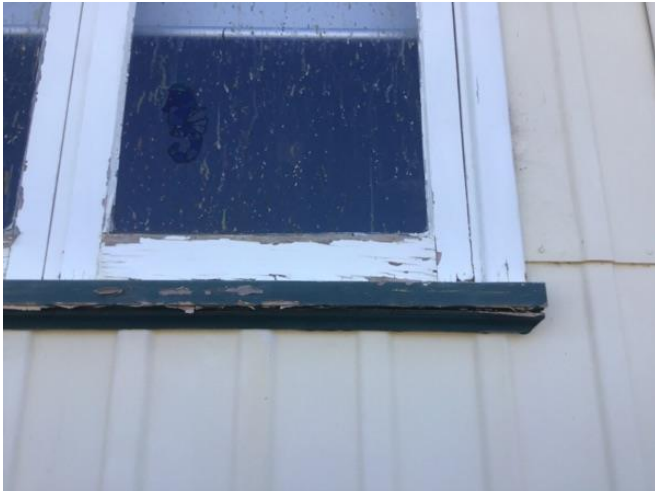
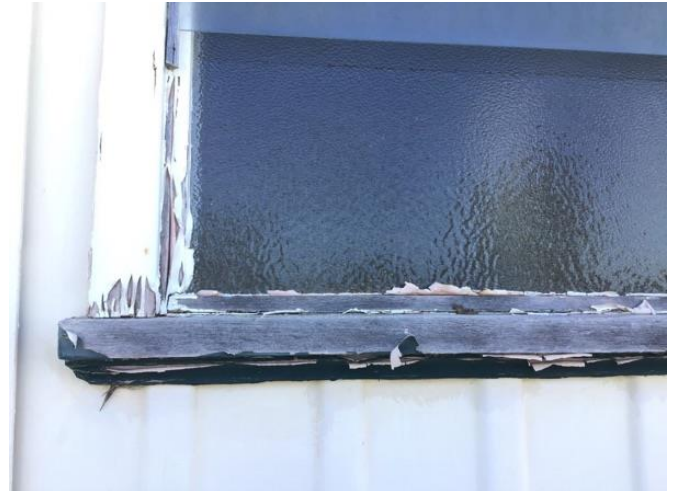
Exterior of Building - Windows  
Taken : 10/12/2020

| Windows | | ✓ | | | Timber framed windows. All require strip and repaint. Some windows require refixing prior to painting.<br>Poor condition. |

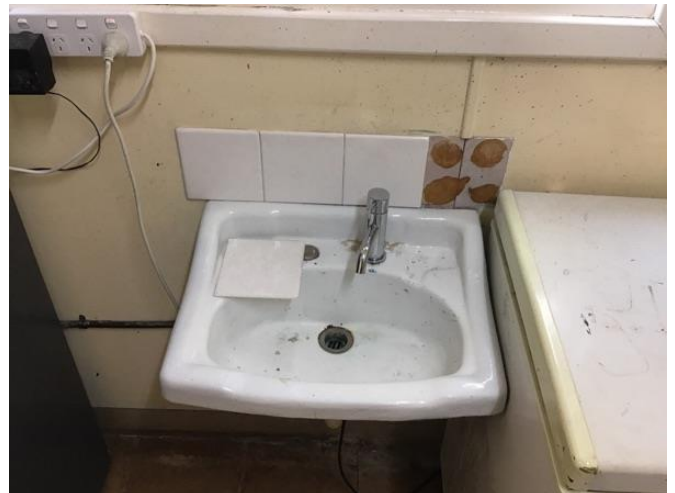
Kitchen/Lunchroom - Sink & Taps  
Taken : 10/12/2020

| Sink & Taps | ✓ | ✓ | ✓ | | 1x old stainless steel sink. Rear edge needs new silicon. Cold tap is seized. Needs cleaning. Average condition.<br>1x ceramic sink, poor condition, and 1x splashback tile has failed, replace. |

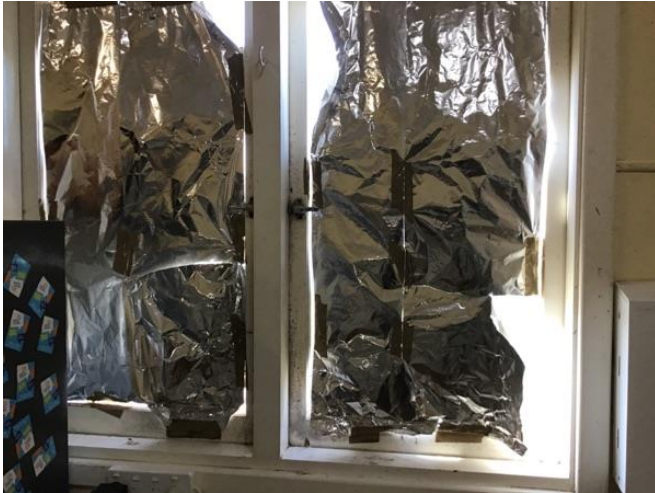
Kitchen/Lunchroom - Windows  
Taken : 10/12/2020

| Windows | | ✓ | | | Both windows need repair and repainting. Also suggest removal of foil and application of tinting film.<br>Average condition. |

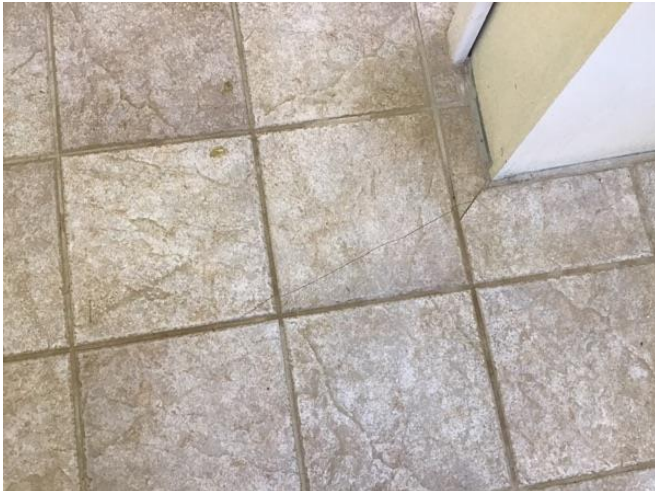
Toilet (Male) - Floors  
Taken : 10/12/2020

| Floors | | | | | Tiled. Single movement crack noted, average condition. |

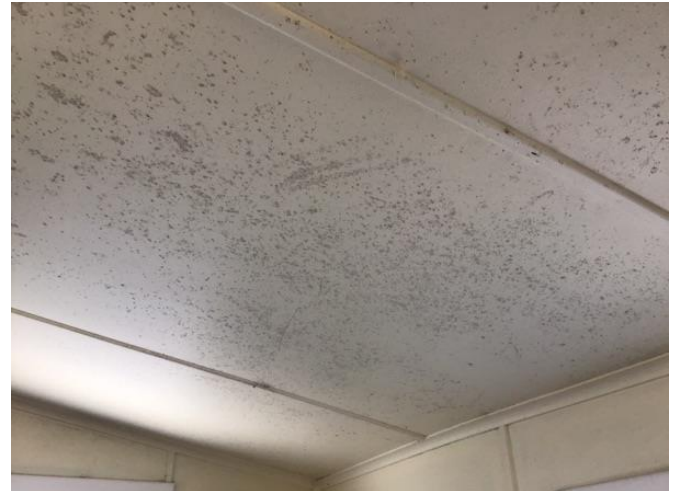
Toilet (Male) - Ceiling  
Taken : 10/12/2020

| Ceiling | ✓ | ✓ | | | ACM panels with heavy mould growth. Needs cleaning and repaint. Average condition. |

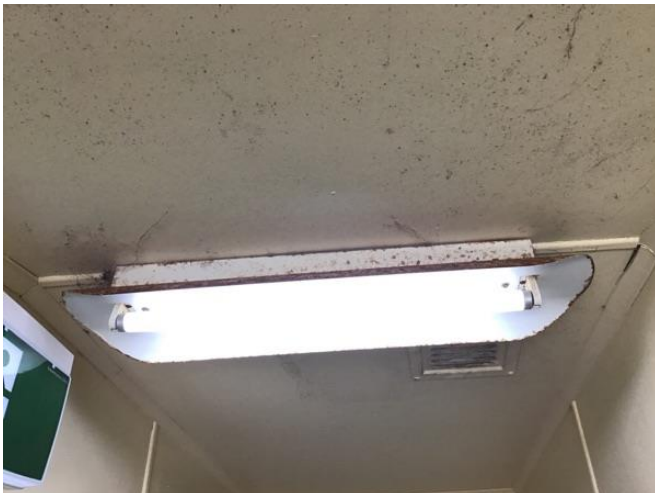
Toilet (Male) - Lighting  
Taken : 10/12/2020

| Lighting | | | ✓ | | 3x lights. Hall light needs replacing. Average to good condition. |

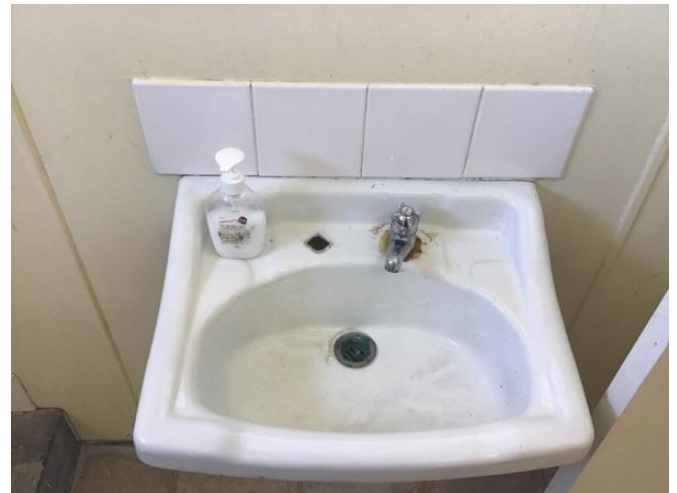
Toilet (Male) - Sink & Taps  
Taken : 10/12/2020

| Sink & Taps | | | ✓ | | 1x ceramic sink with cold tap. Stained. Poor condition. |

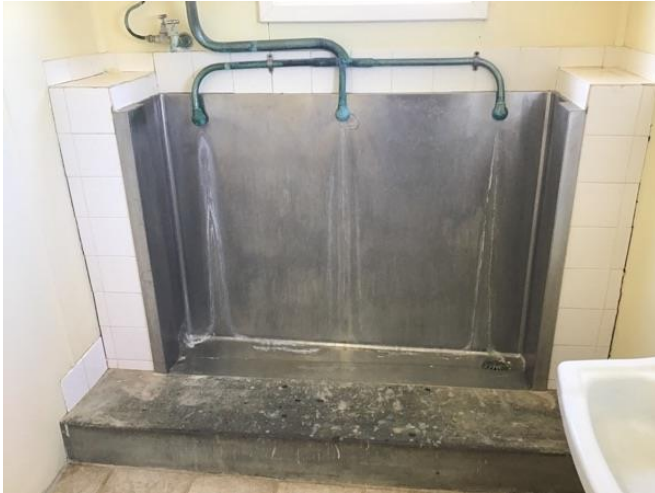
Toilet (Male) - Urinal  
Taken : 10/12/2020

| Urinal | | | ✓ | | Heavily water stained, with stained concrete plinth. Replace in next 2-5 years. Poor condition. |

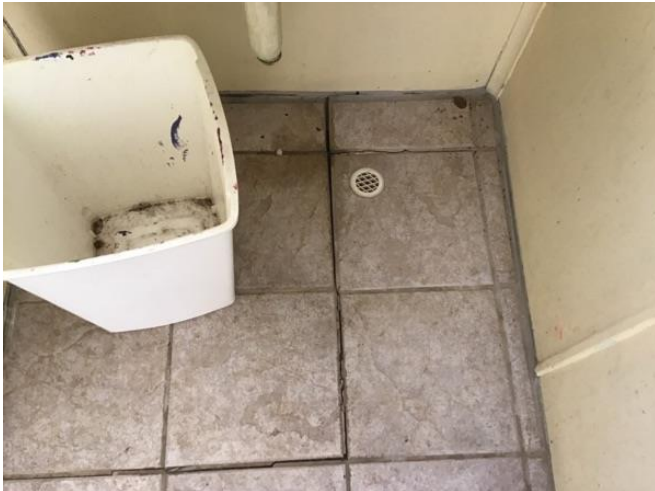
Toilet (Female) - Floors  
Taken : 10/12/2020

| Floors | | ✓ | | | Tiled, with failure occurring directly under sink, possibly due to water damage?<br>Requires investigation.<br>Average condition. |

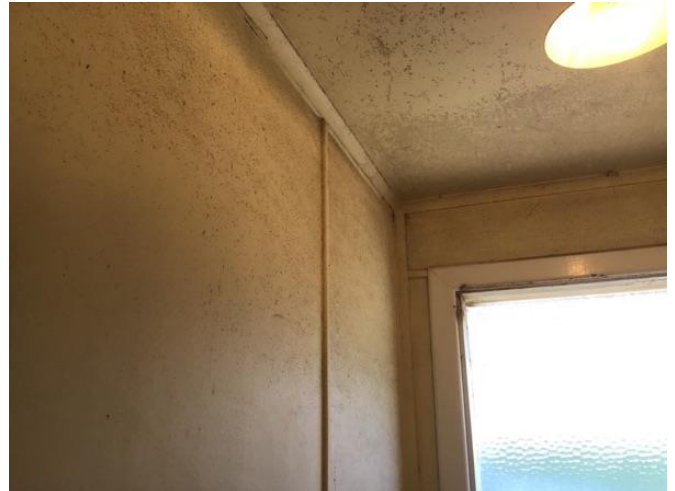
Toilet (Female) - Walls  
Taken : 10/12/2020

| Walls | ✓ | ✓ | | | ACM board, with mould staining. Requires treatment and repaint.<br>Average condition. |

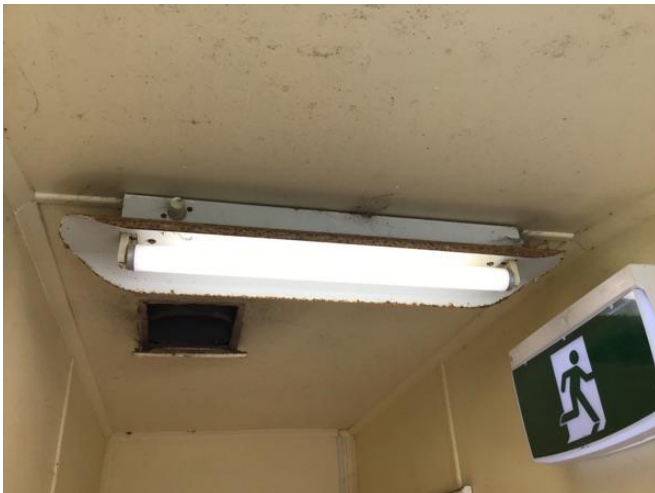
Toilet (Female) - Lighting  
Taken : 10/12/2020

| Lighting | | | ✓ | | 4x lights. All would benefit from renewal.<br>Poor condition. |

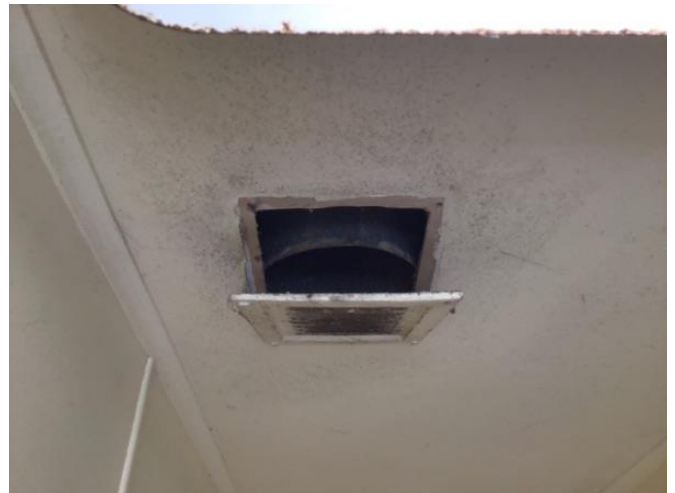
Toilet (Female) - HVAC  
Taken : 10/12/2020

| HVAC | | ✓ | | | 3x vents. Hall vent has collapsed.<br>Poor condition. |

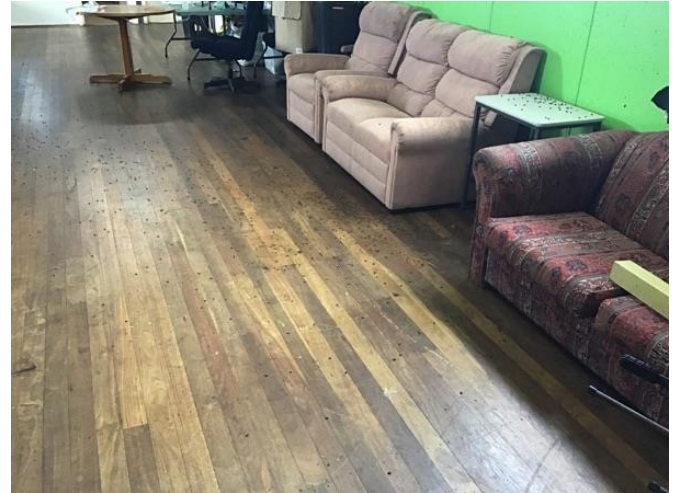
Meeting Room - Floor  
Taken : 10/12/2020

| Floor | ✓ | ✓ | | | Jarrah timber floor. Ideally would benefit from a sand and reseal.<br>Heavy bee build up from nest.<br>Good condition. |

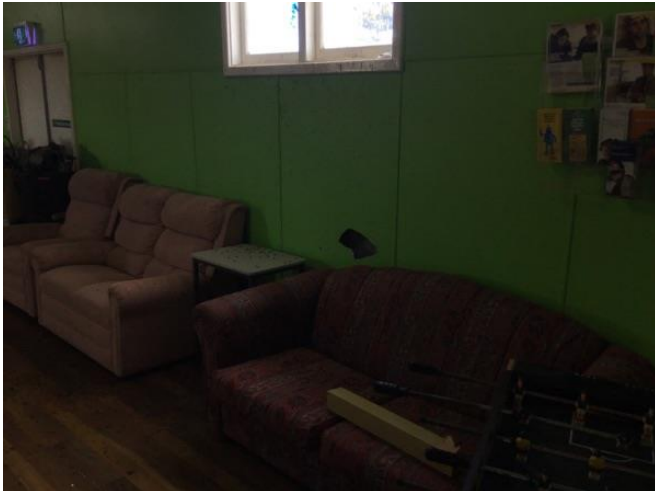
Meeting Room - Walls  
Taken : 10/12/2020

| Walls | | ✓ | | | ACM panels, with one area of impact damage noted, requires repair.<br>Good condition. |

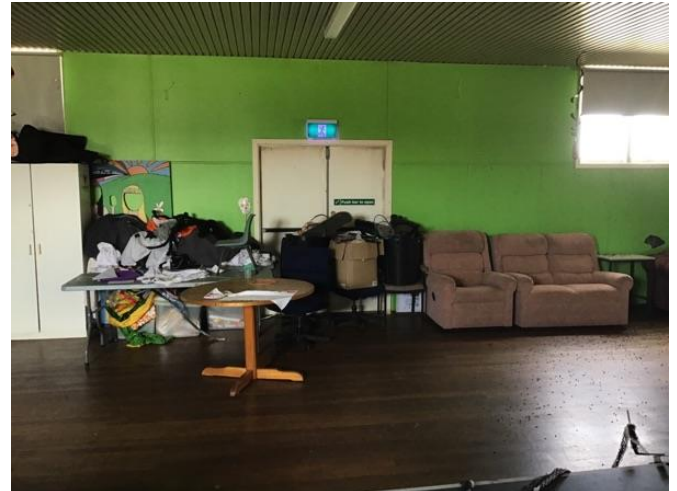
Meeting Room - Doors  
Taken : 10/12/2020

| Doors | | ✓ | ✓ | ✓ | 3x external door points. One emergency exit point is blocked.<br>All need work as per outside notes. |
