**LOCAL PLANNING SCHEME NO.7
DISTRICT ZONING SCHEME
APPLICATION FOR DEVELOPMENT APPROVAL**

Lot 4113 Wongonderrah Road, Nambung

Shawmac has been engaged by Image Resources to prepare the Traffic Impact Statement.

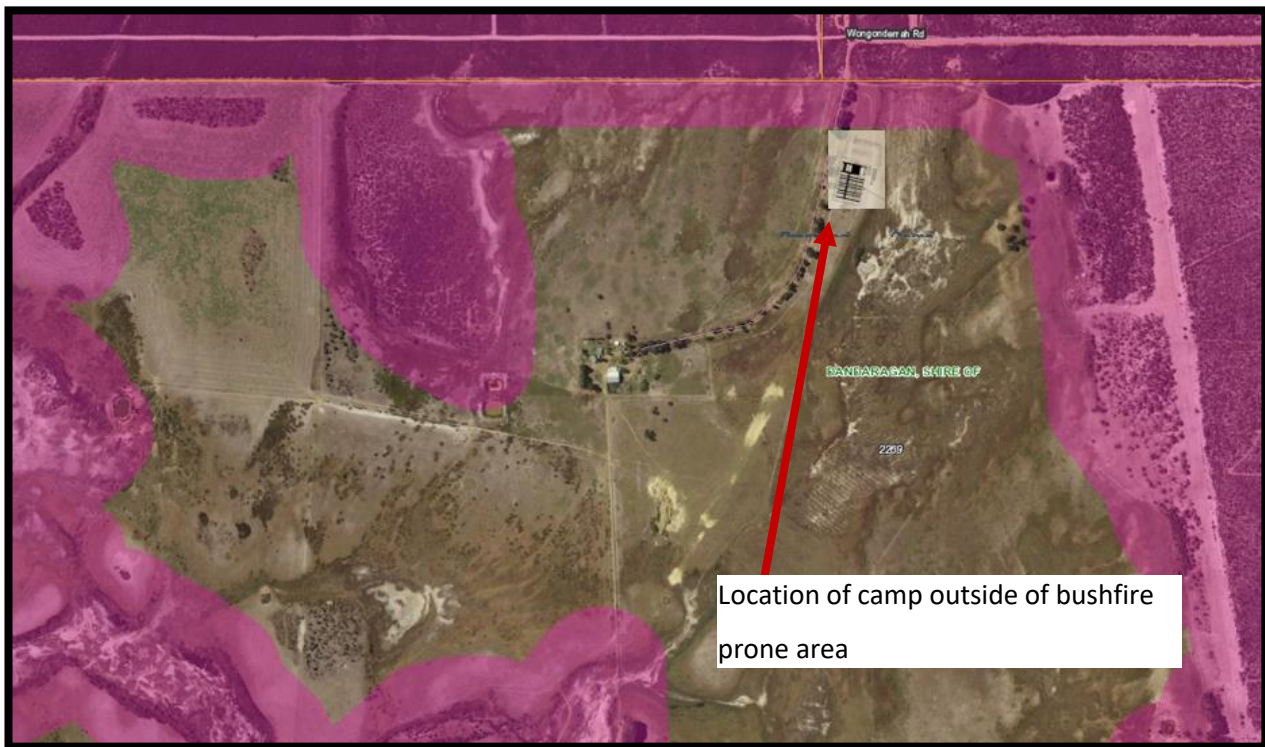
Figure 5: Bushfire prone mapping

The subject lot has been partially mapped as being bush fire prone. The proposed development has been sited so that it is not within the mapped zone and as such officers of the Shire of Dandaragan have advised that a BAL assessment is not required.

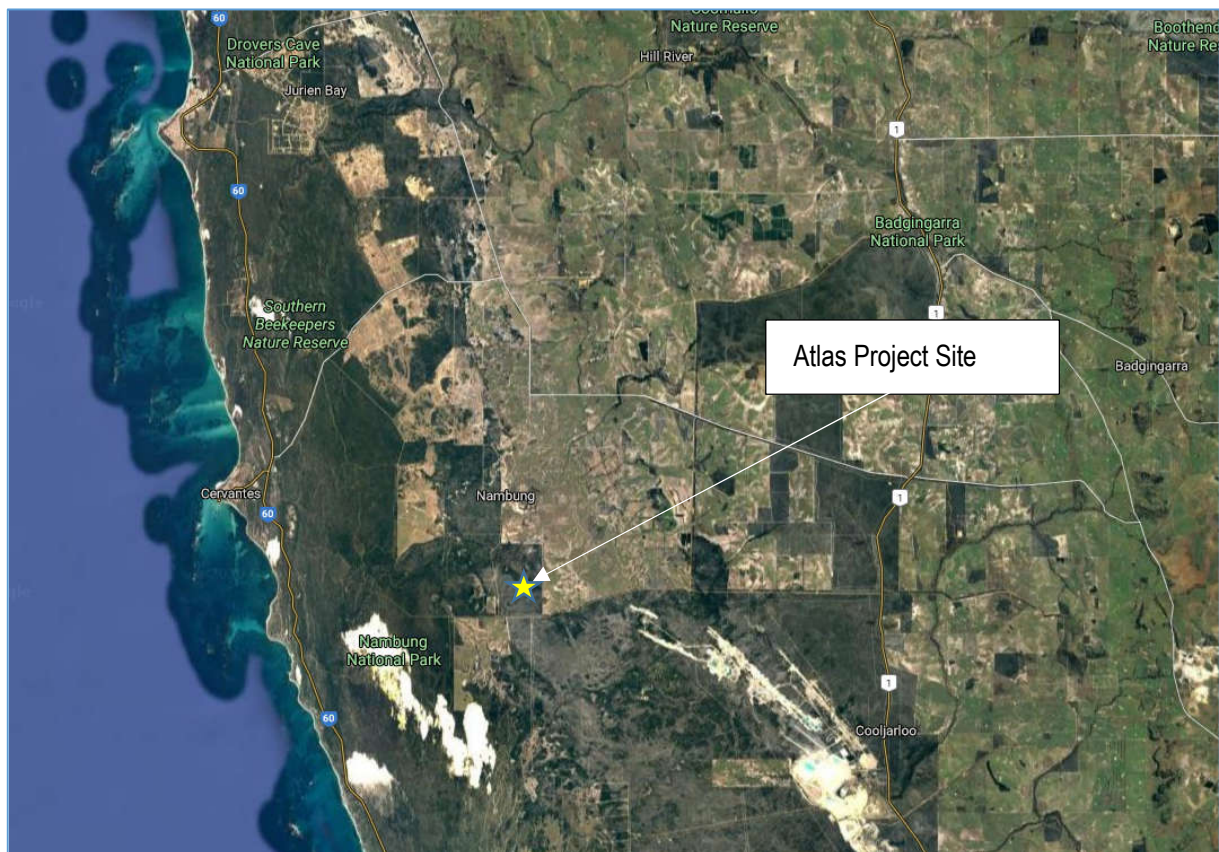
Figure 1: Project Site

Image Resources are intending to develop the Atlas Project in Cooljarloo as per **Figure 1**.

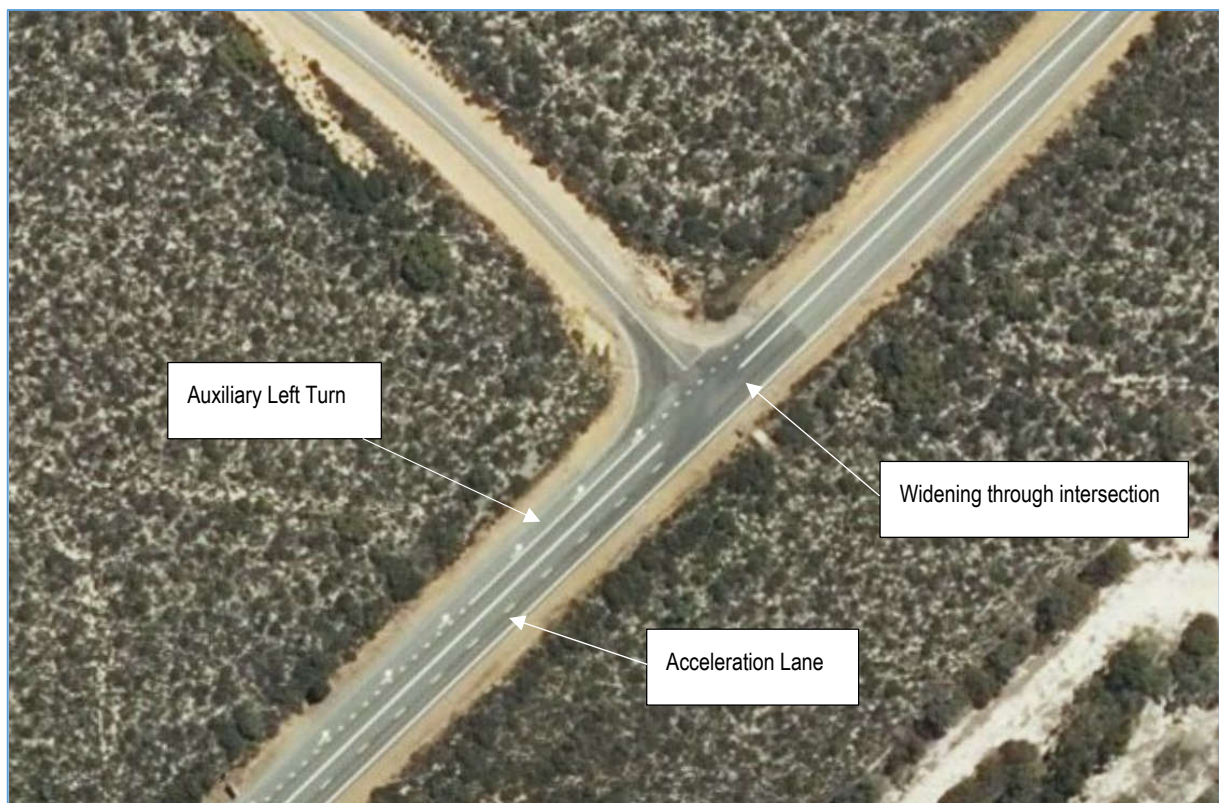
Figure 9: Brand Hwy & Bibby Road Intersection

As per **Figure 9**, the existing intersection has an auxiliary left turn treatment, a southbound acceleration lane and southbound lane widening through the intersection that allows through vehicles to pass right turning vehicles.

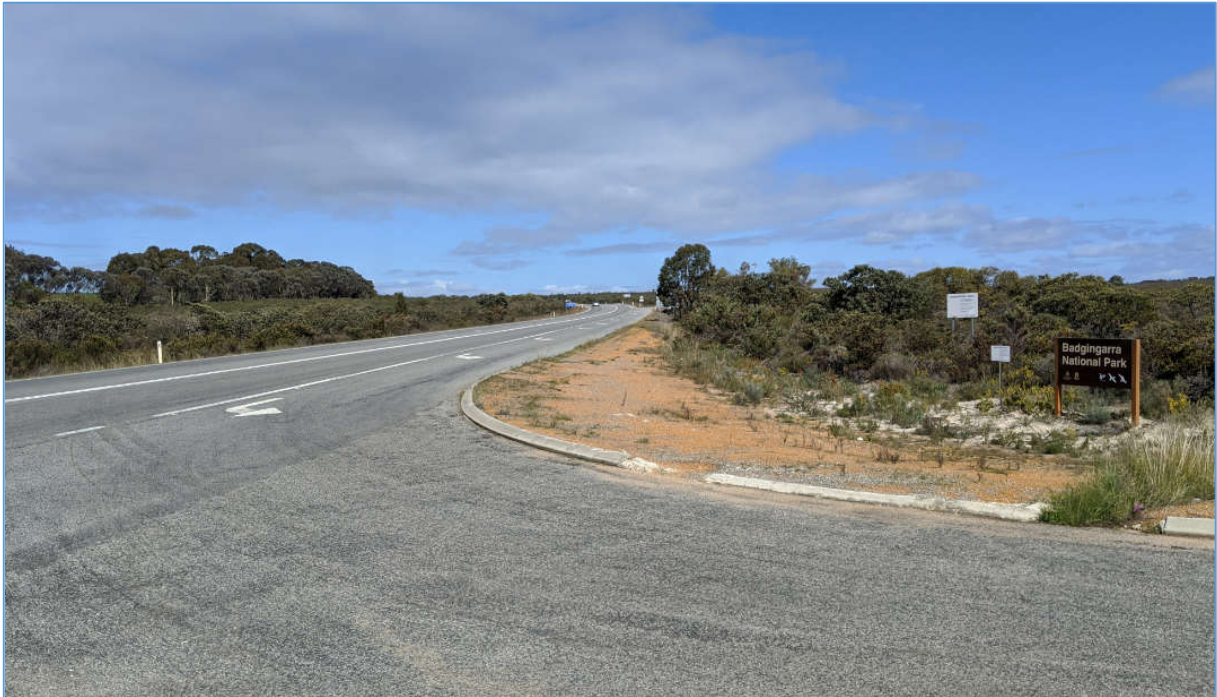
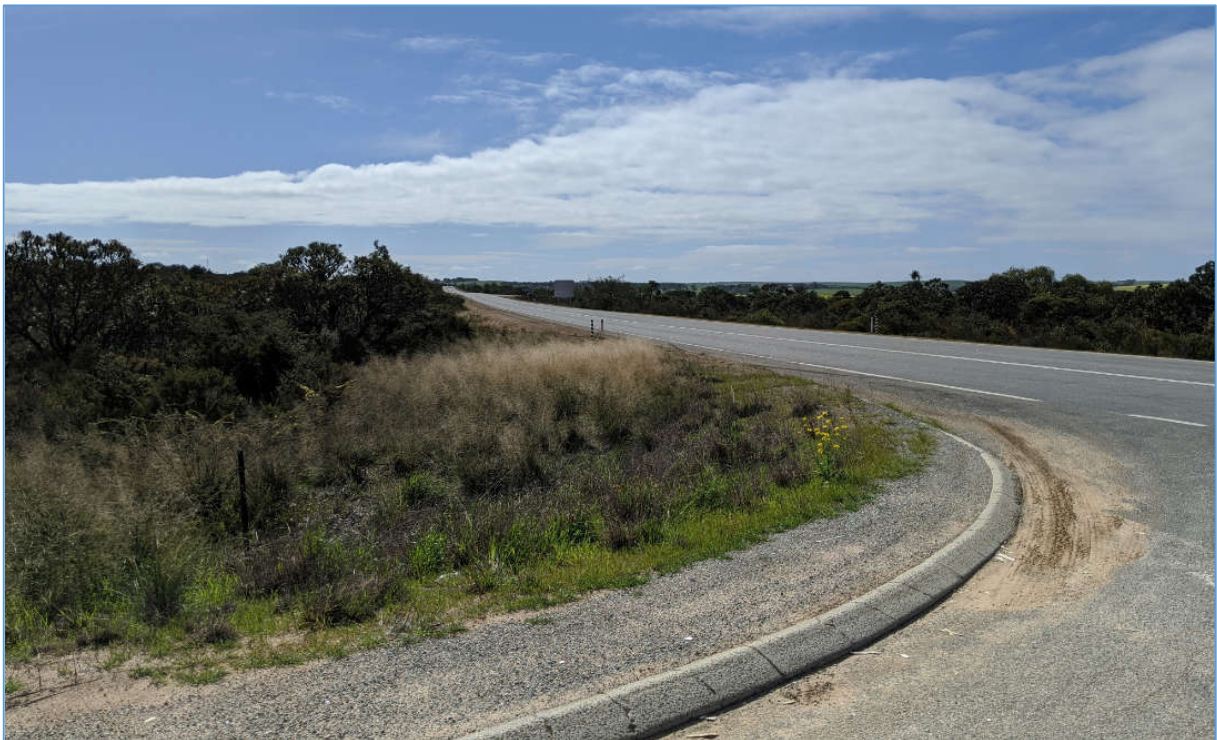
The Safe Intersection Sight Distance (SISD) has been assessed in accordance with Austroads Guide to Road Design Part 4A Equation 2 and the results are summarised in **Table 3**. The line-of-sight photos at the intersection are shown below in **Figure 10** and **Figure 11**.

Figure 10: Brand Highway / Bibby Road Intersection Looking South

Figure 11: Brand Highway / Bibby Road Intersection Looking North

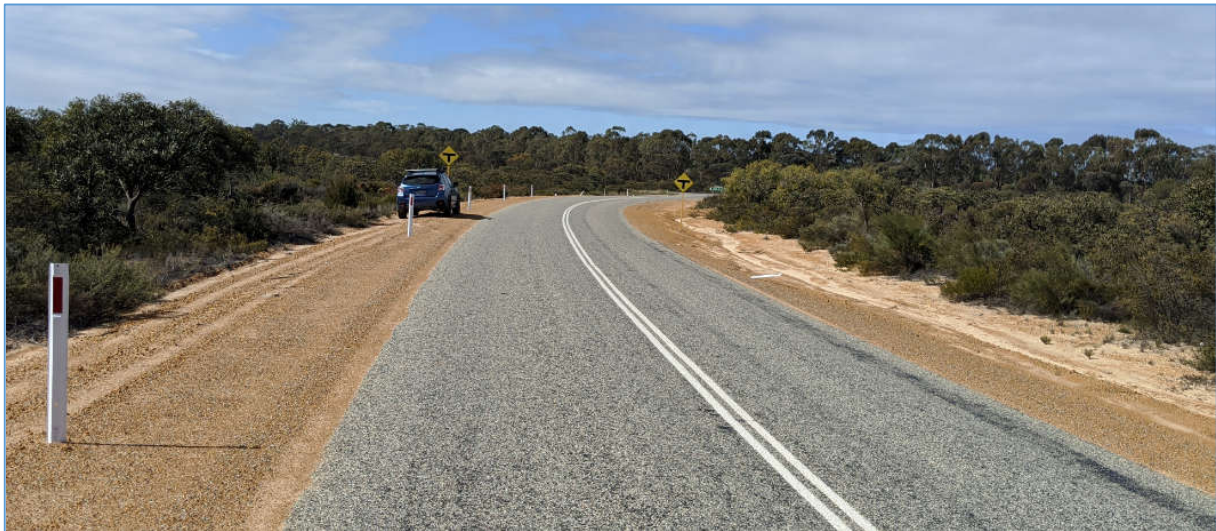
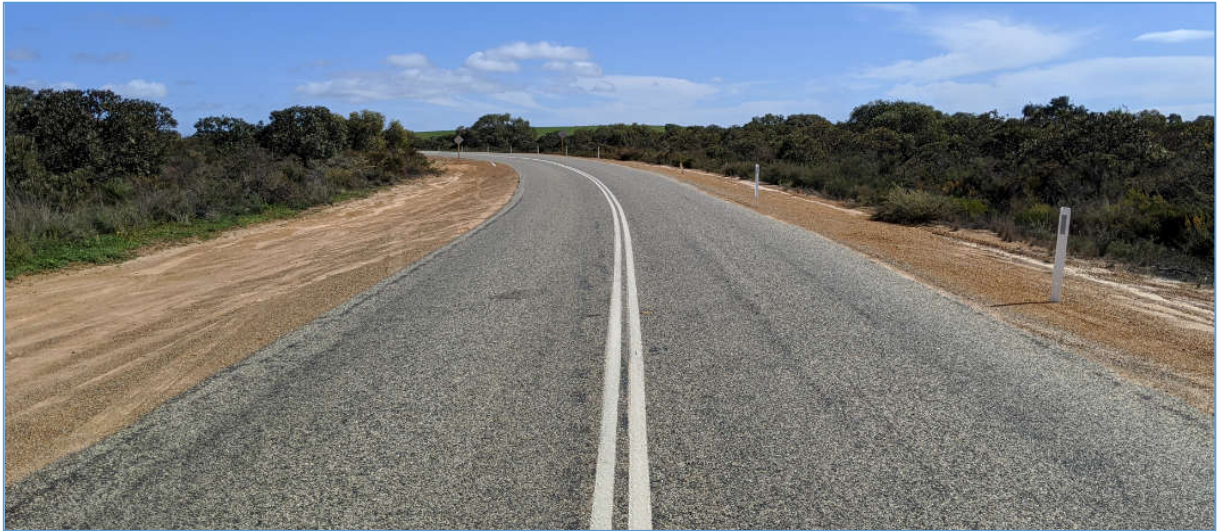
The required and available ASD at the intersection has been determined from Austroads Part 4A Equation 2 as summarised in **Table 4**.

Figure 12: Approach Sight Line to Brand Highway

Figure 13: Approach Sight Line from Brand Highway

The assessment indicates the ASD are below the requirements caused by the horizontal bend and existing vegetation.

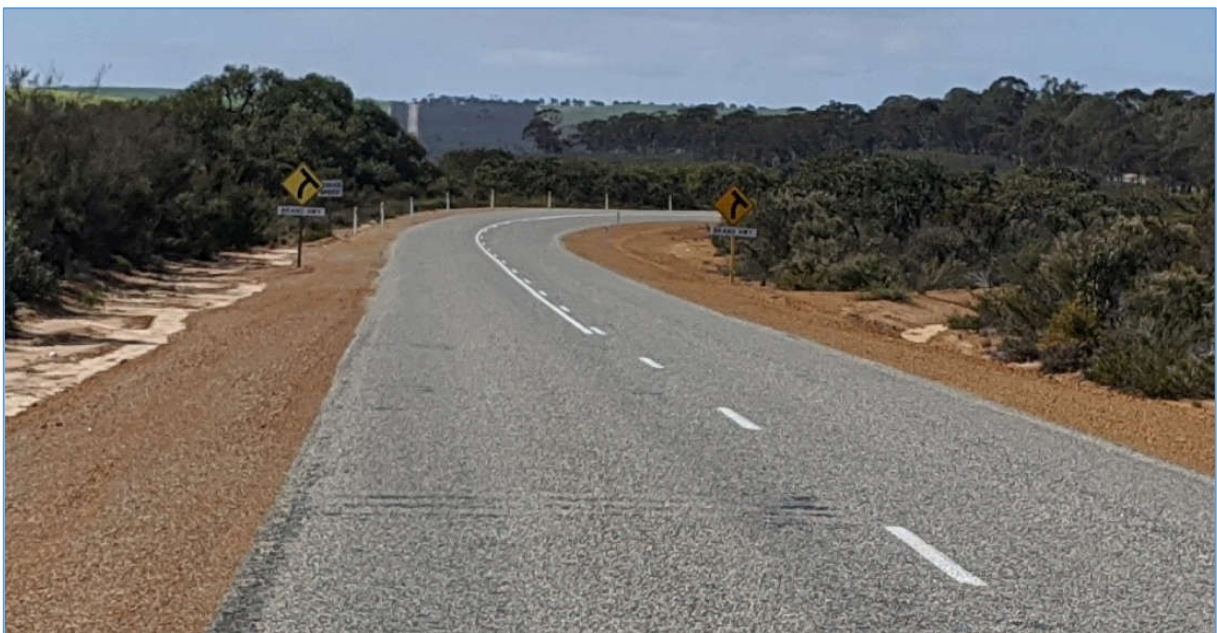
Figure 14: Intersection Warning Signage to Approach to Brand Highway

There is a warning sign 520m prior to the intersection warning of the intersection after the bend as per **Figure 14**.

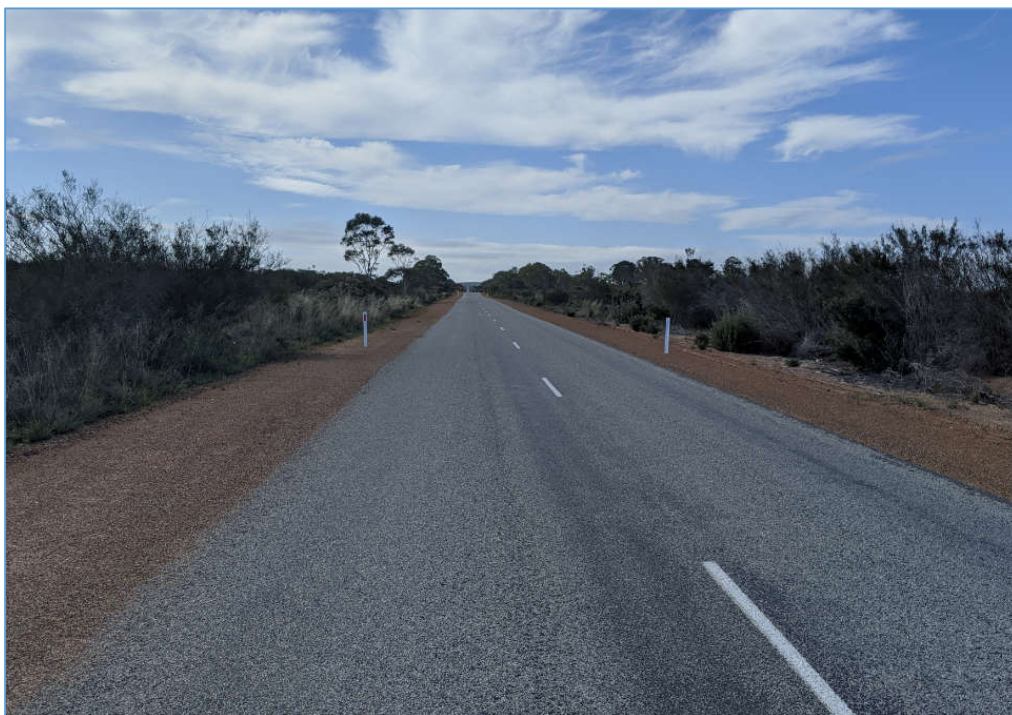
Figure 15: Typical Existing Bibby Road Formation

The road is considered to be in good condition and appears well maintained.

Refer **Figure 15** for a typical example of the existing formation of Bibby Rd.

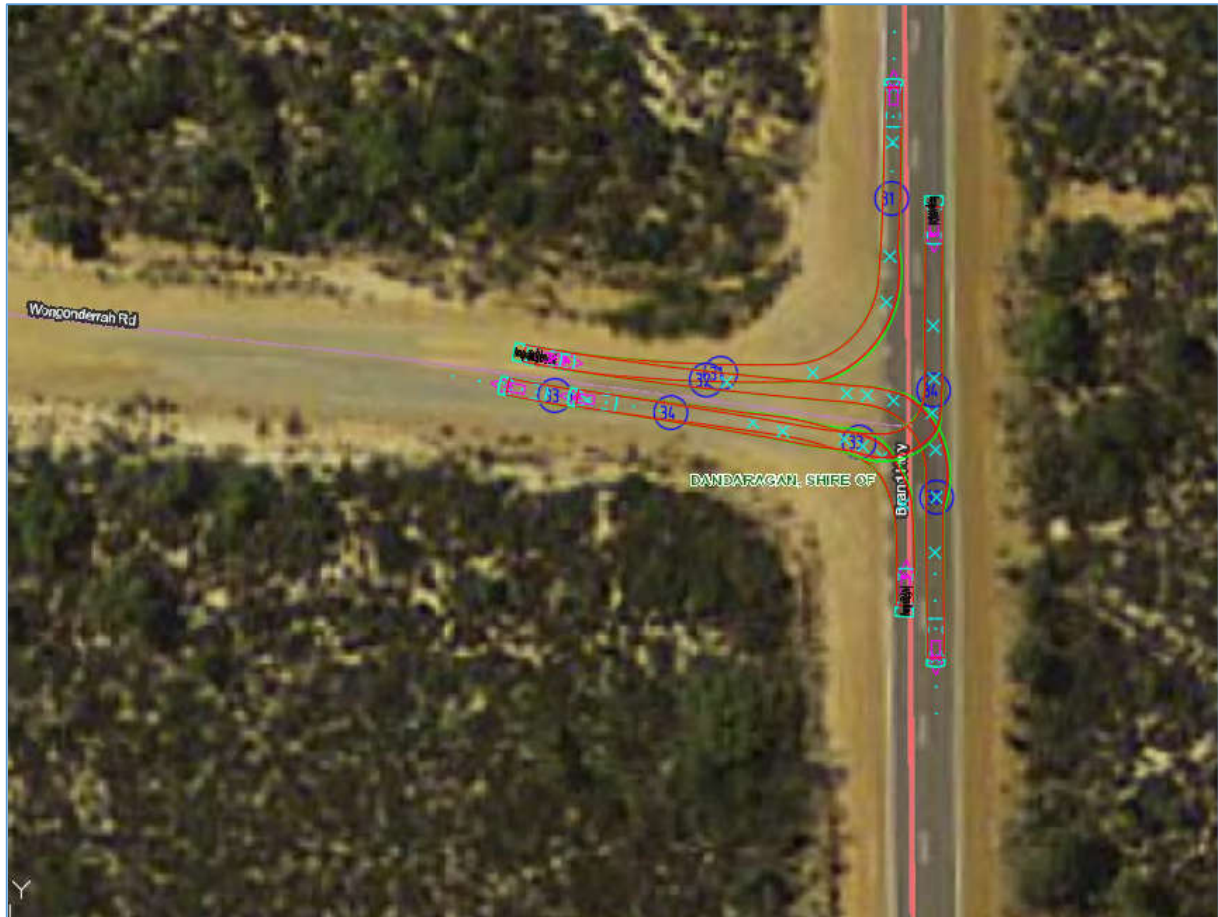
Figure 17: Swept Path Assessment

The current intersection is suitable for lane correct light vehicle movements as per **Figure 17**.

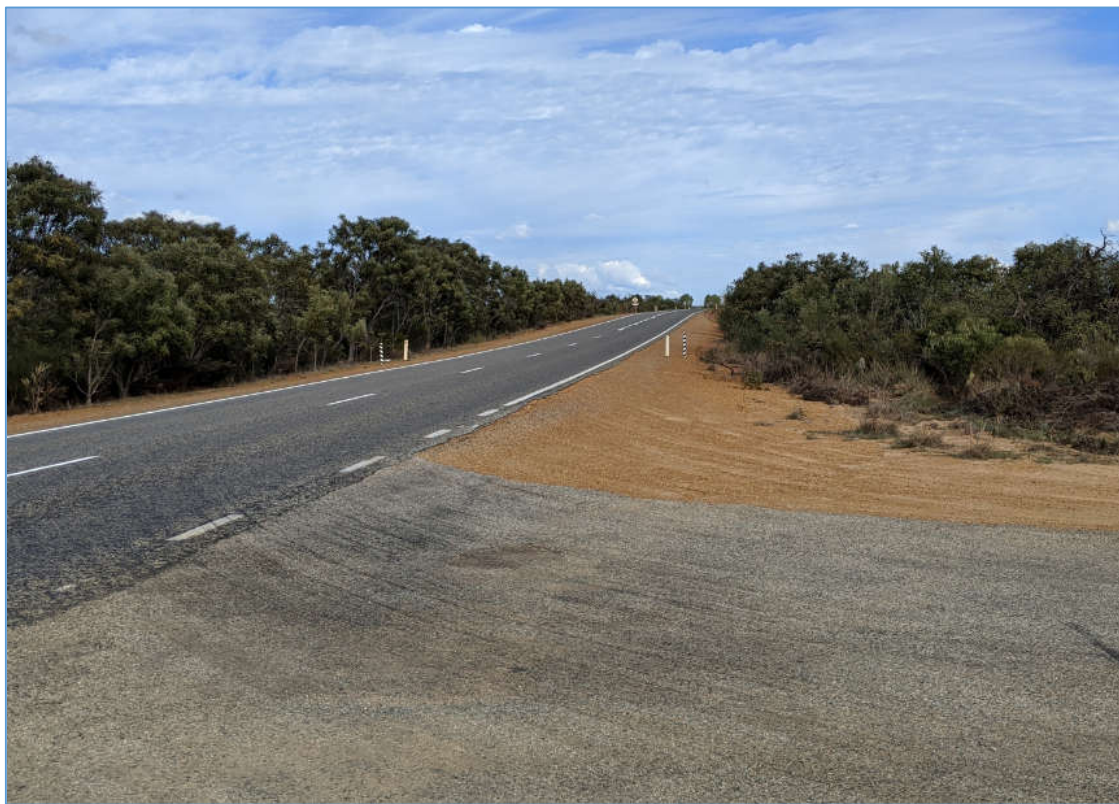
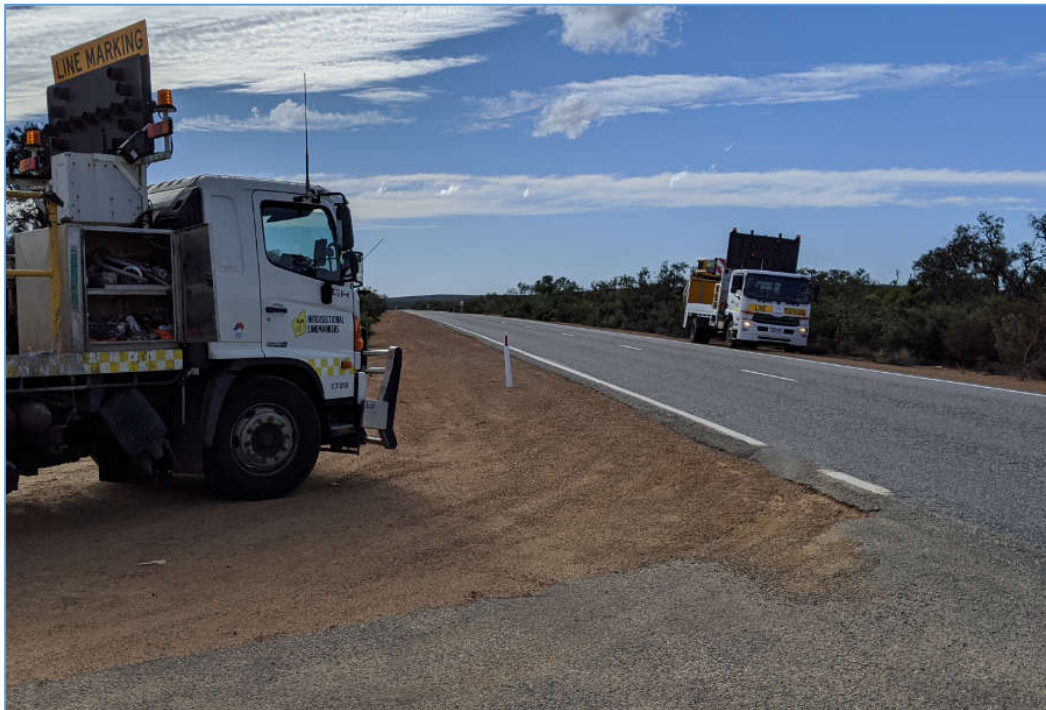
The Safe Intersection Sight Distance (SISD) has been assessed in accordance with Austroads Guide to Road Design Part 4A Equation 2 and the results are summarised in **Table 6**. The line-of-sight photos at the intersection are shown below in **Figure 18** and **Figure 19**.

Figure 18: Brand Highway / Wongonderrah Road Intersection Looking South

Figure 19: Brand Highway / Wongonderrah Road Intersection Looking North

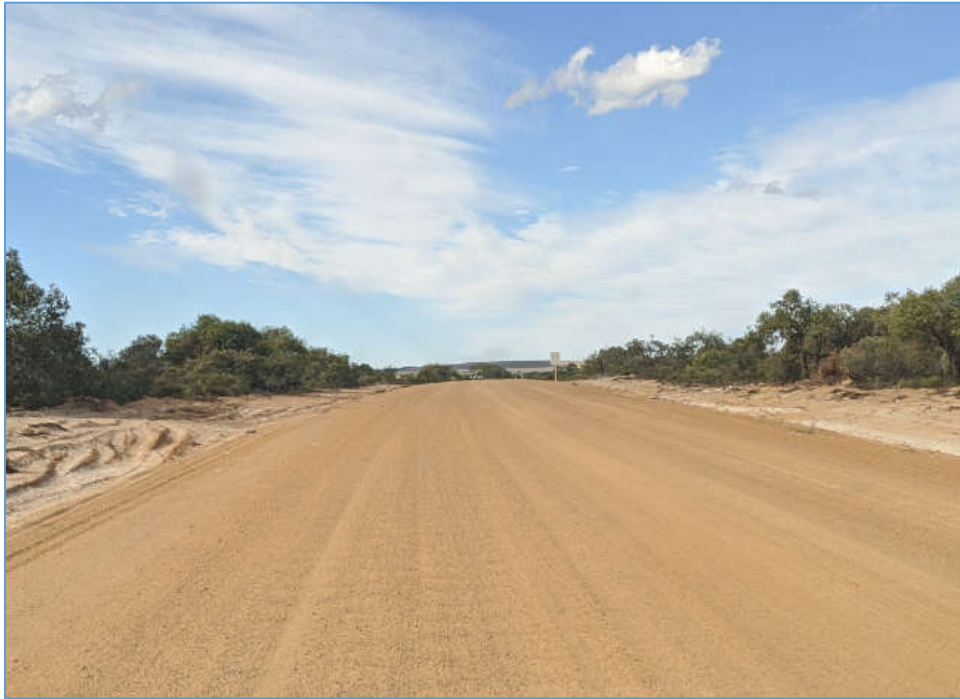
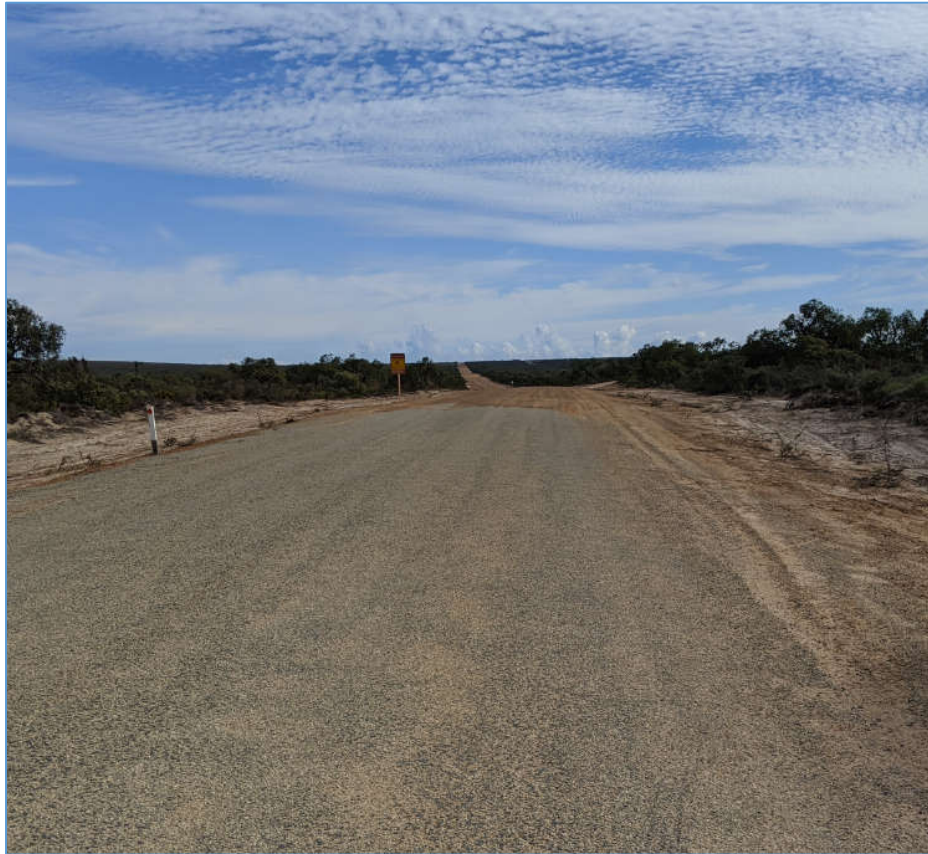
The required and available ASD at the intersection has been determined from Austroads Part 4A Equation 2 as summarised in **Table 7**. The estimated ASD has been calculated for both sealed and unsealed approaches for comparison as there is approximately 75m of seal at the intersection.

Figure 20: Approach Sight Line to Brand Highway – Prior to Crest

Figure 22: Sight Distance from Brand Highway

The assessment indicates the ASD are below the requirements for a car for both a sealed and unsealed road due to the sight obstruction caused by an existing crest. Therefore, to conform to the guidelines, consideration is to be made to regrading the approach to remove the crest obstruction and extending the extent of seal to improve sight distances.

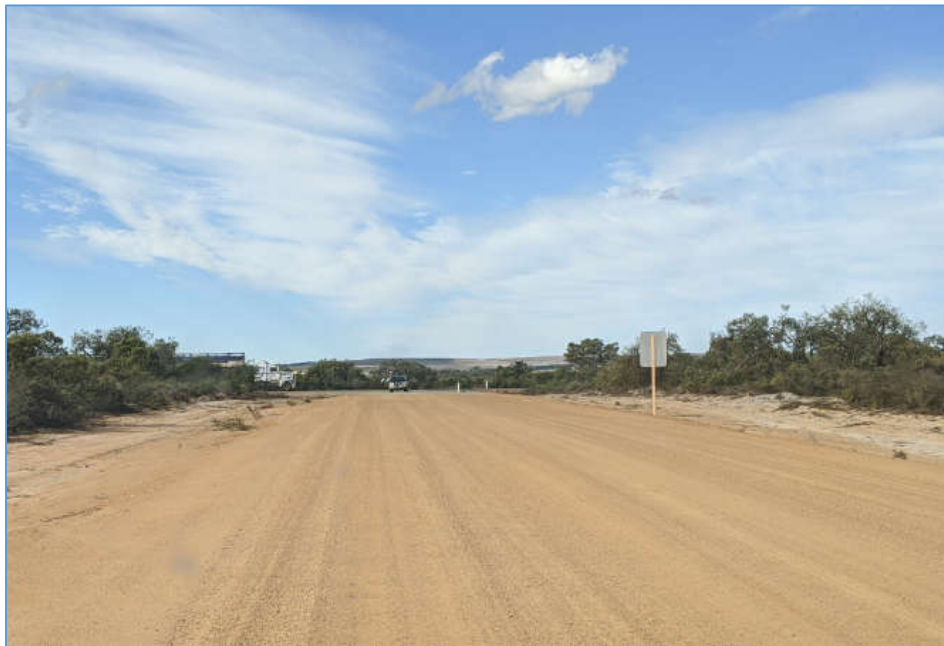
Figure 21: Approach Sight Line to Brand Highway– After Crest

Approach sight distance is shown in **Figure 20**, **Figure 21** and **Figure 22**.

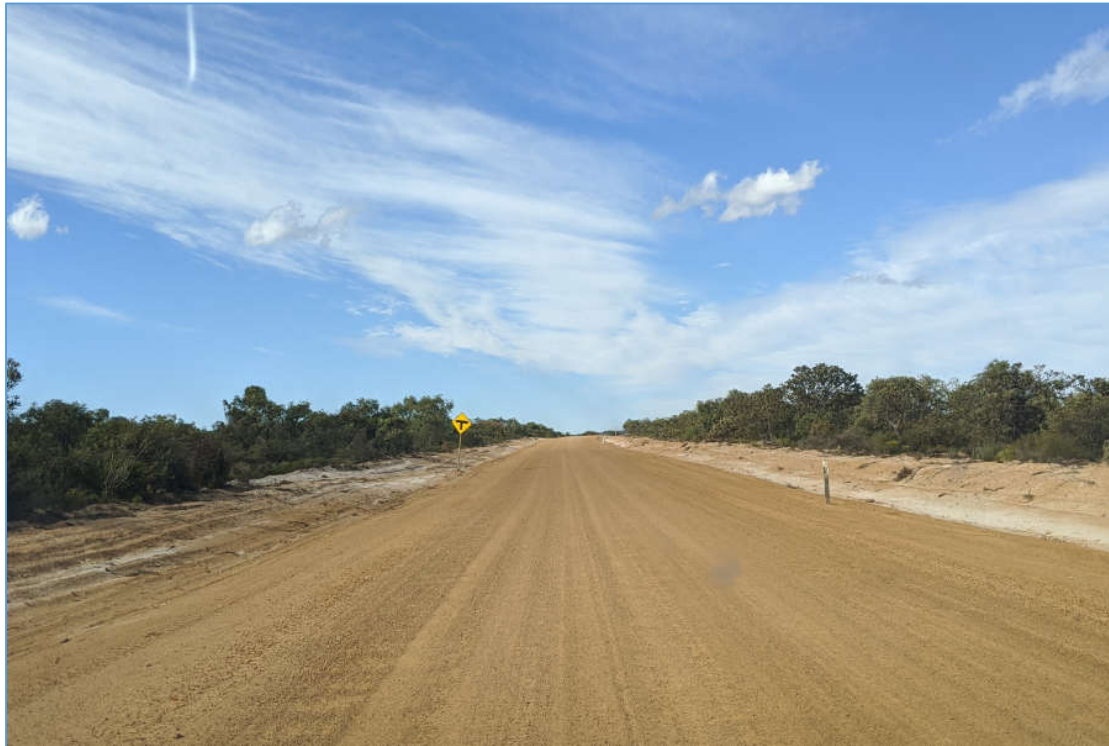
Figure 23: Wongonderrah/Brand Hwy Advance Intersection Warning Sign

- There is an expectation that vehicles would be travelling much slower than the allowed 110km/hr;
- Image Resources will be encouraging their personnel not to use this road; and
- There is already an existing advance warning sign prior to the intersection (refer **Figure 23** below).

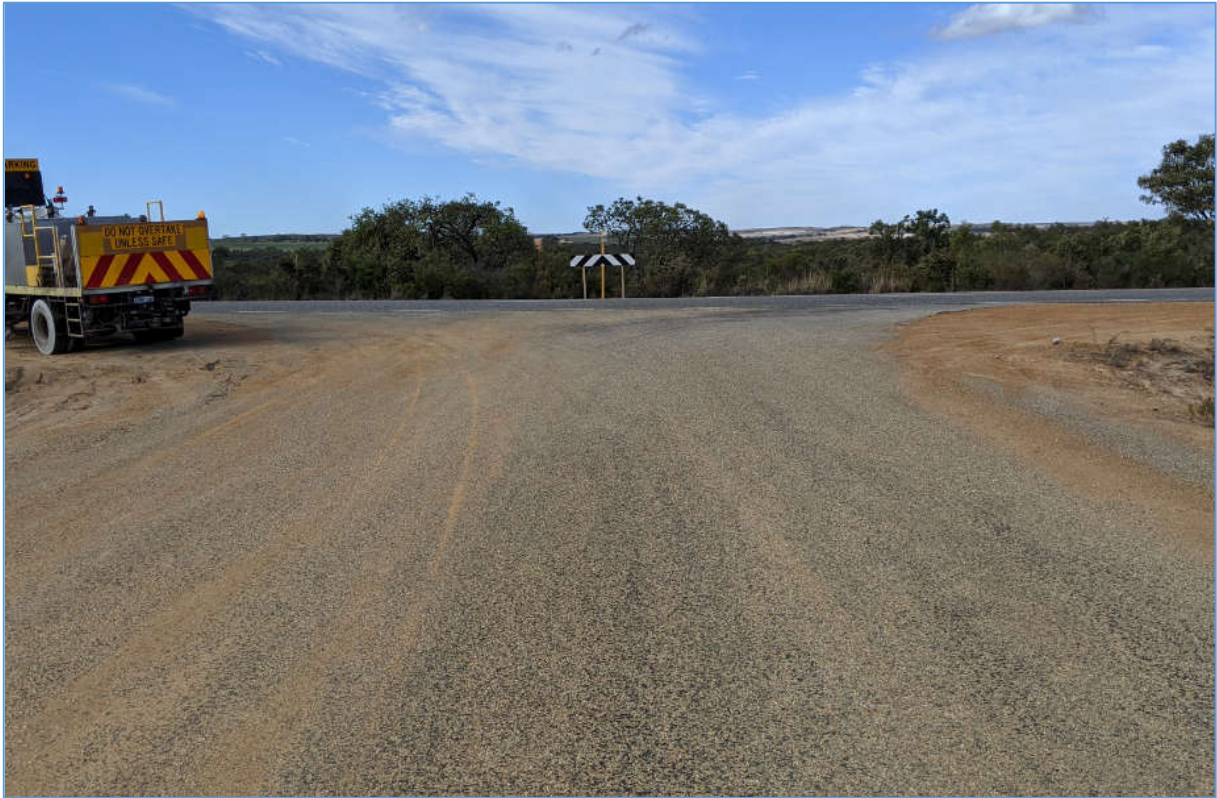
Figure 24: Existing Intersection Condition

The existing intersection is sealed for approximately 75m. The seal has some minor defects (flushing) and has some dust, however, is generally in good condition. Therefore, the existing condition is deemed suitable for the minor increase in traffic in terms of safety.

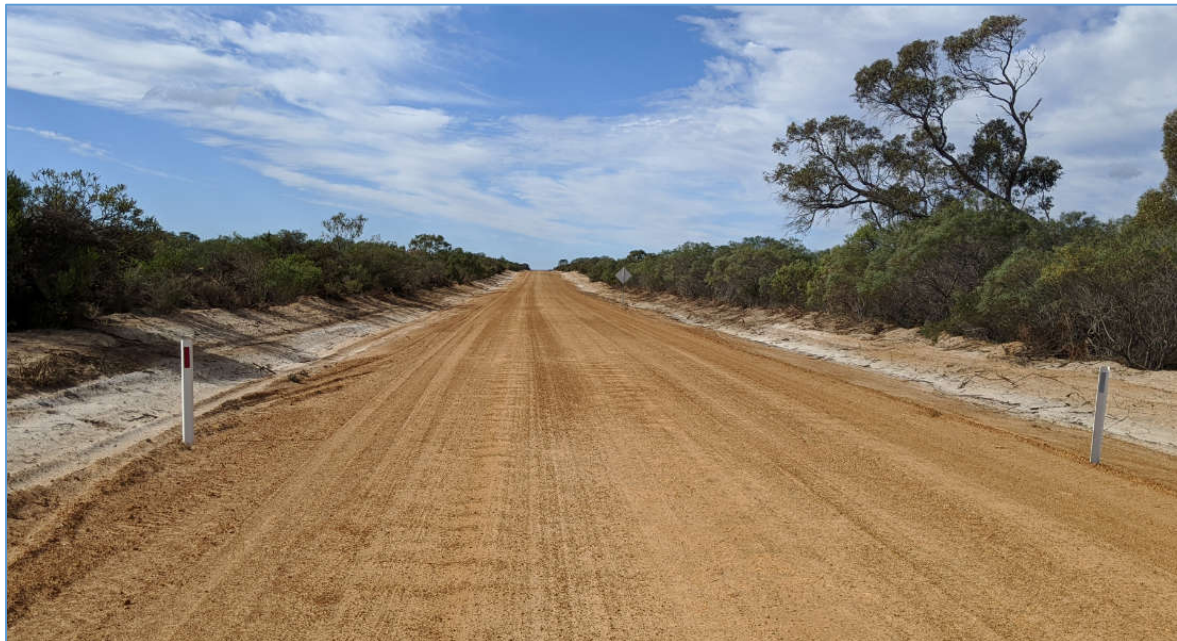
Figure 25: Typical Existing Wongonderrah Road Formation

Refer Figure 25 for a typical example of the existing formation of Wongonderrah Rd (SLK 0.00 to 22.70).

The road is considered to be in good condition when dry and appears to be well maintained by the Shire. It is noted that during and after rainfall events the condition of the road surface may change where sections may become difficult to drive at speed.

It is recommended that the camp traffic volumes along this road and the road condition be monitored.

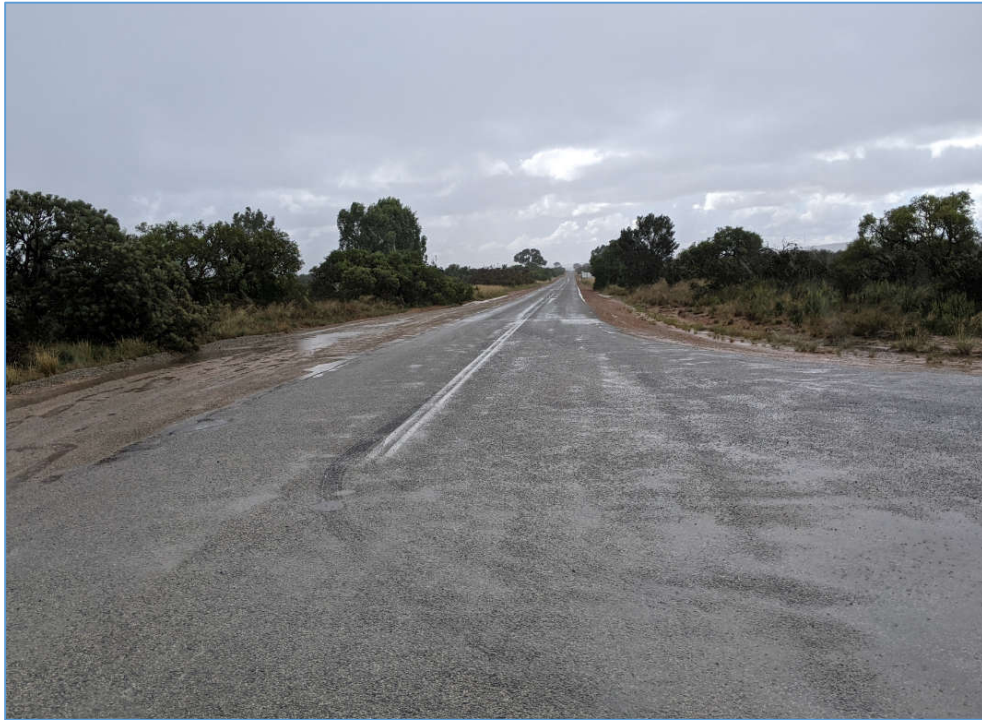
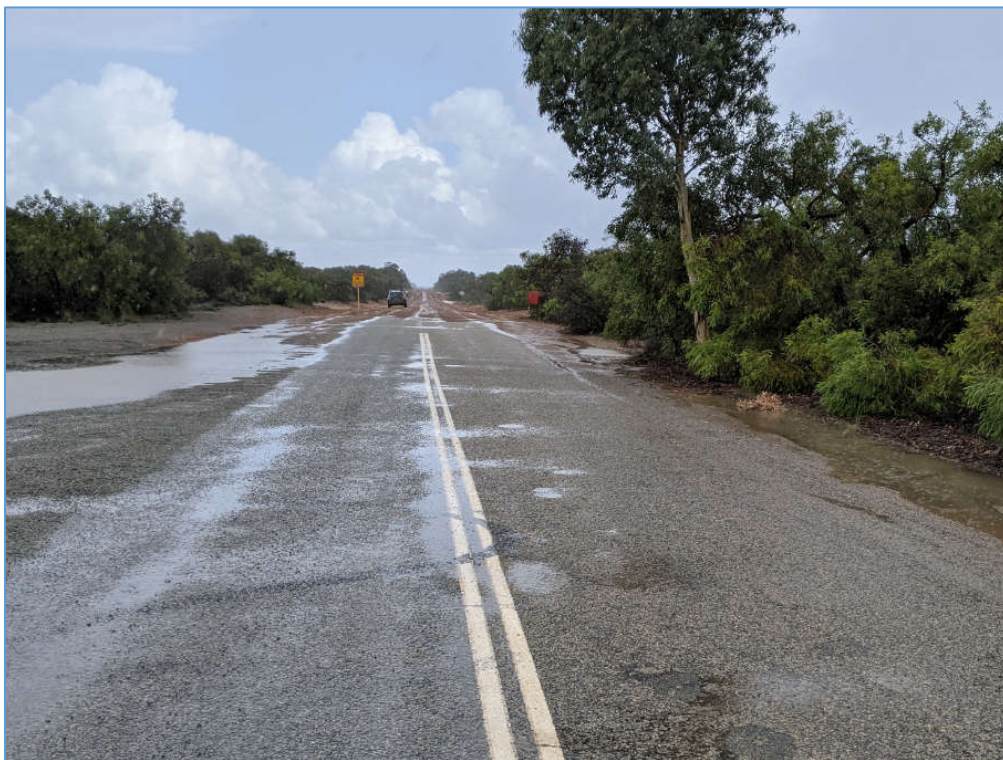
The Safe Intersection Sight Distance (SISD) has been assessed in accordance with Austroads Guide to Road Design Part 4A Equation 2 and the results are summarised in **Table 9**. The line-of-sight photos at the intersection are shown below in **Figure 28** and **Figure 29**.

Figure 28: Munbinea Rd (SLK 13.56) & Bibby Rd Intersection – Looking North

Figure 29: Munbinea Rd (SLK 13.56) & Bibby Rd Intersection – Looking South

Traffic Direction	Road Condition	Vehicle Type	Design Speed (km/h)	Coefficient of Deceleration	Decision Time (s)	Longitudinal Grade (NB / SB)	Required SISD (m)	Available SISD (m)
North	Unsealed	Trucks	100	0.23	3+2.5	-2%	340	+500
		Cars	110	0.22	3+2.5	-2%	406	+500
South	Sealed	Trucks	100	0.28	3+2.5	+1%	289	+500
		Cars	110	0.36	3+2.5	+1%	297	+500

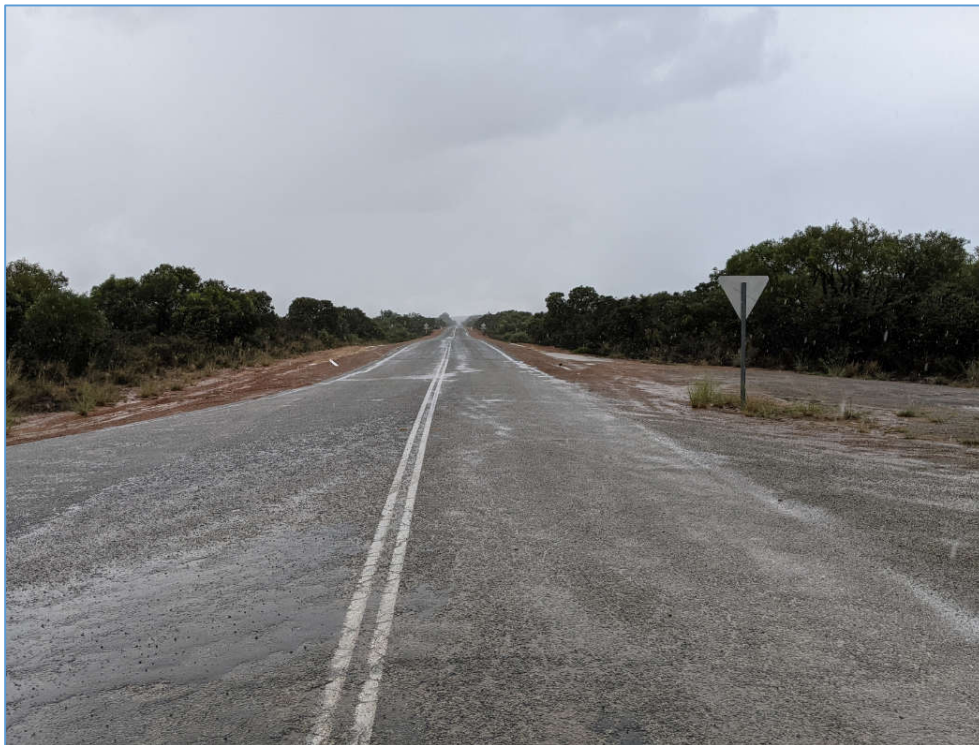
Figure 30: Munbinea Rd (SLK 13.56) & Bibby Rd Intersection – Looking East

The required and available ASD at the intersection has been determined from Austroads Part 4A Equation 2 as summarised in **Table 10**.

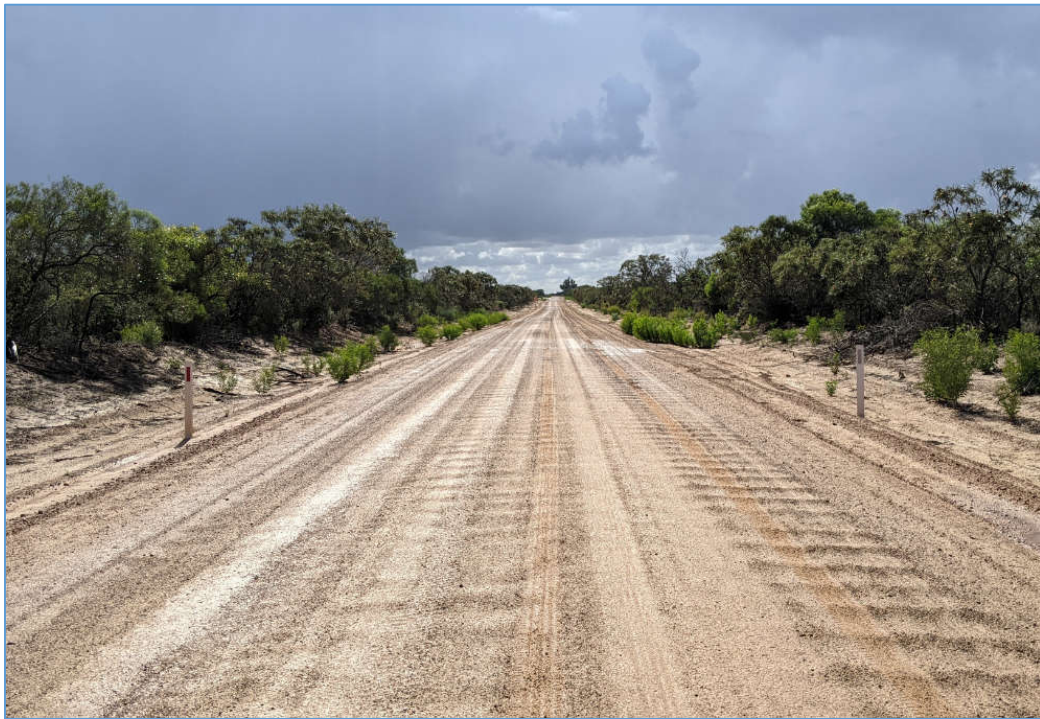
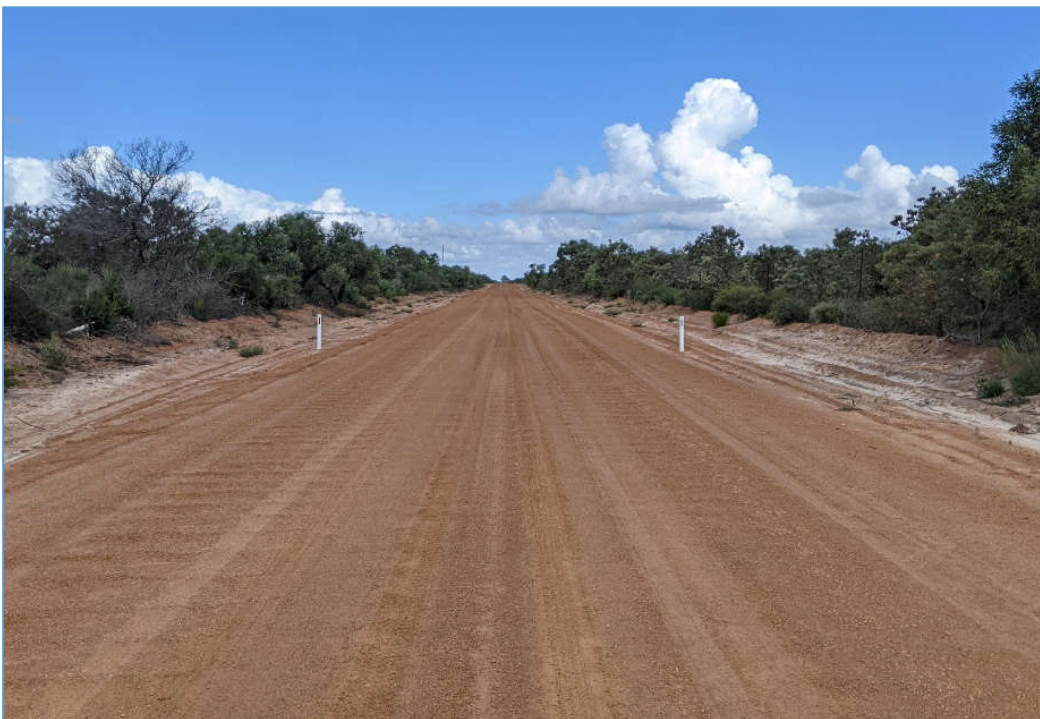
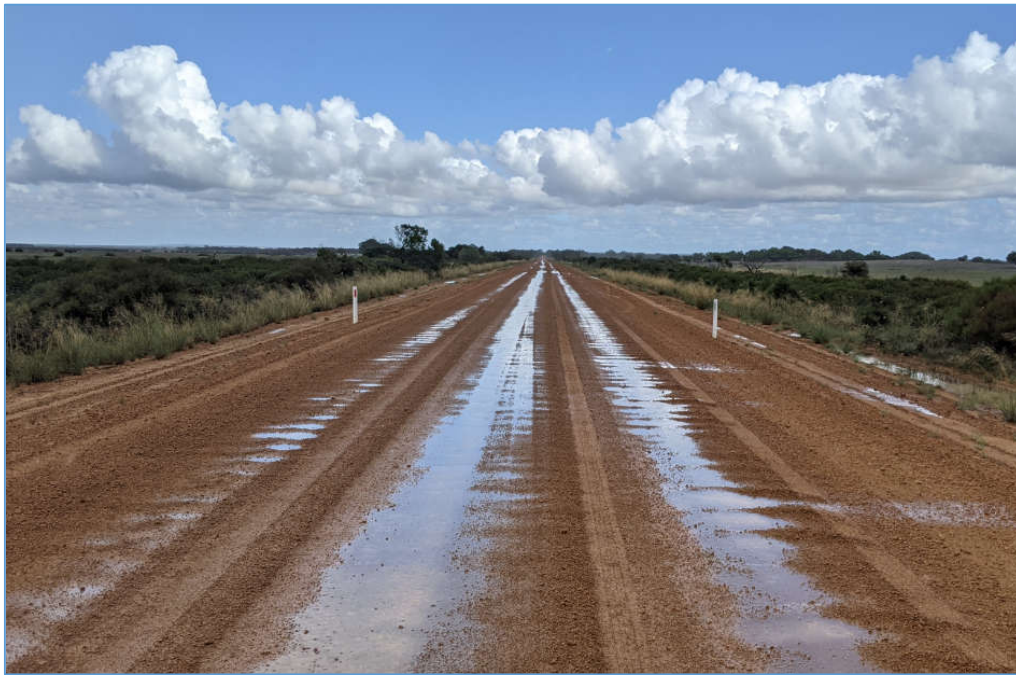
Refer **Figure 31**, **Figure 32** and **Figure 33** for a typical example of the existing formation of Munbinea Road (SLK 0.00 to 13.56).

Figure 31: Typical Existing Munbinea Road Unsealed Formation – Example 1 (SLK 0.21)

Figure 32: Typical Existing Munbinea Road Unsealed Formation – Example 2 (SLK 2.55)

Figure 33: Typical Existing Munbinea Road Unsealed Formation – Example 3 (SLK 9.90)

The road is considered to be in good condition when dry and appears to be well maintained by the Shire however, there are corrugations along the alignment during the most recent sight visit. It is noted that during and after rainfall, the road surface some sections may become slippery, soft and difficult to drive at speed.

In summary, there is an existing 200-300mm wearing course / basecourse along the road.

As this section of the road is on the truck haulage route for mining operations, it is understood that Image Resources are in discussions with the Shire on potential upgrades to the road. A monitoring and maintenance plan is also being considered to ensure the road condition remains safe for traffic.

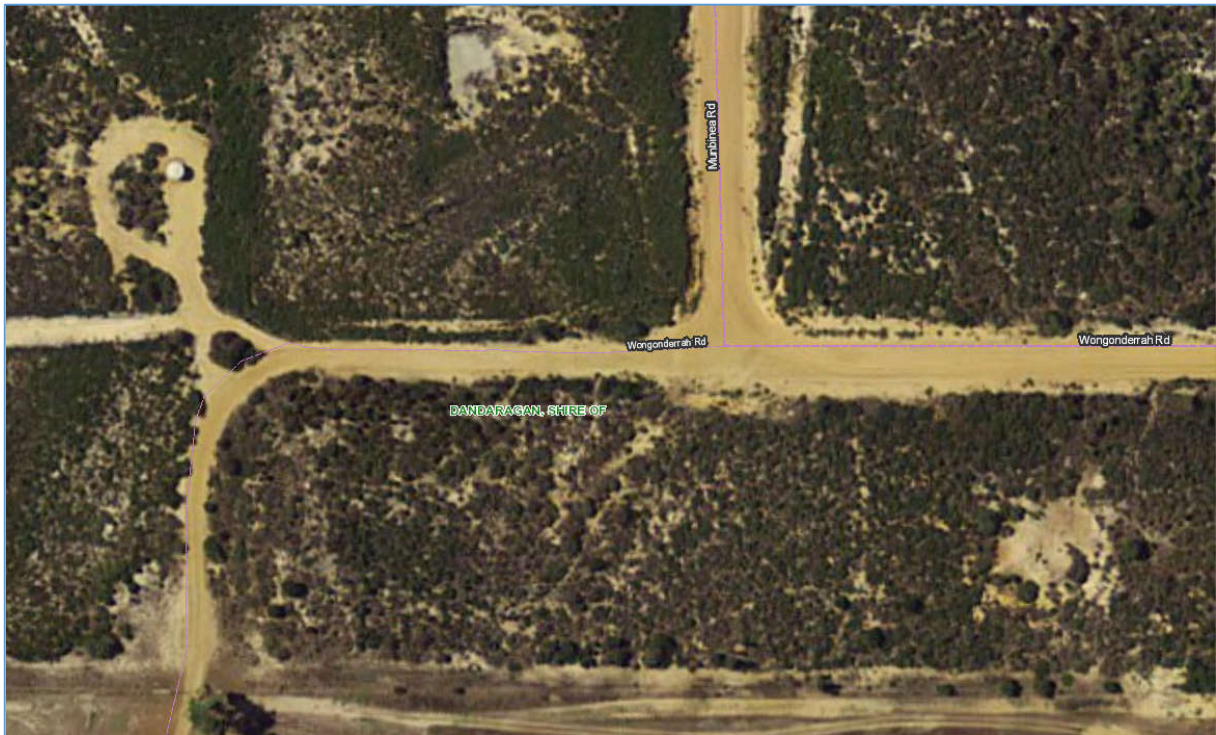
Figure 34: Munbinea & Wongonderrah Road Intersection

As per **Figure 24**, the existing intersection is a basic unsealed T intersection.

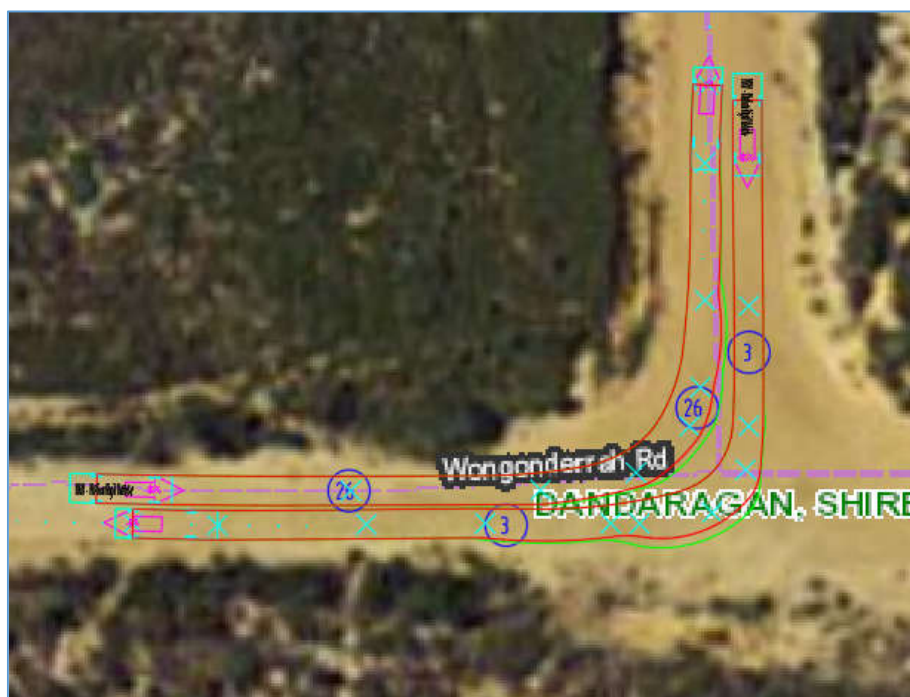
Figure 36: Munbinea Rd & Wongonderrah Rd Intersection Swept Paths – Shuttle Bus (8.8m vehicle)

The current intersection is suitable for light vehicle movements and the shuttle buses for lane correct movements as per **Figure 35** and **Figure 36**.
