**LOCAL PLANNING SCHEME NO.7
DISTRICT ZONING SCHEME
APPLICATION FOR DEVELOPMENT APPROVAL**

Lot 4113 Wongonderrah Road, Nambung

Shawmac has been engaged by Image Resources to prepare the Traffic Impact Statement.

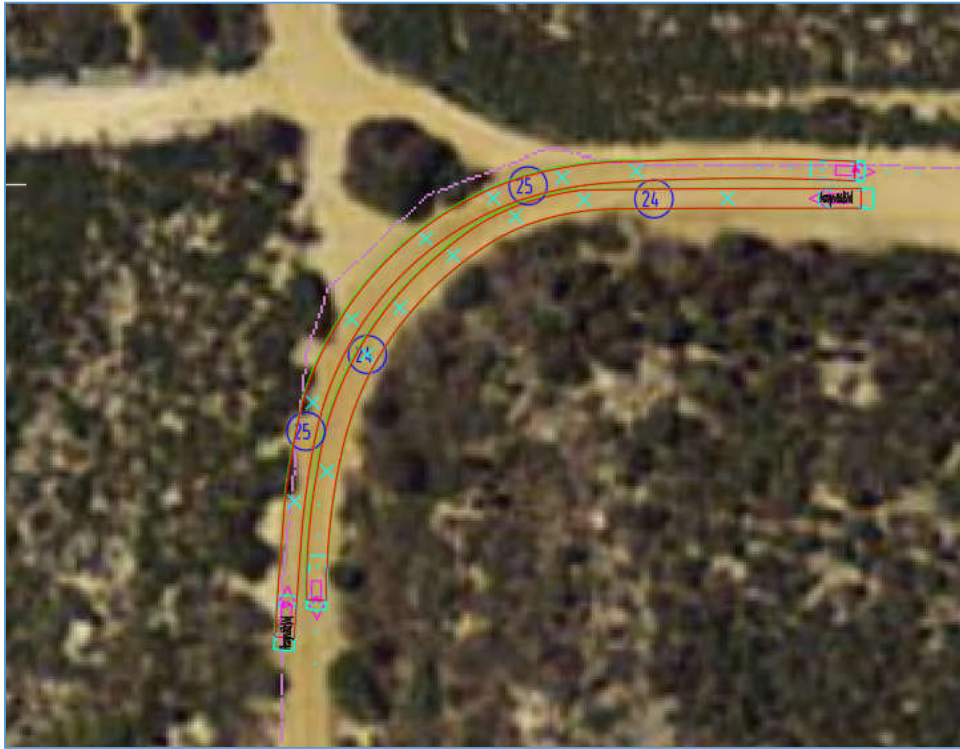
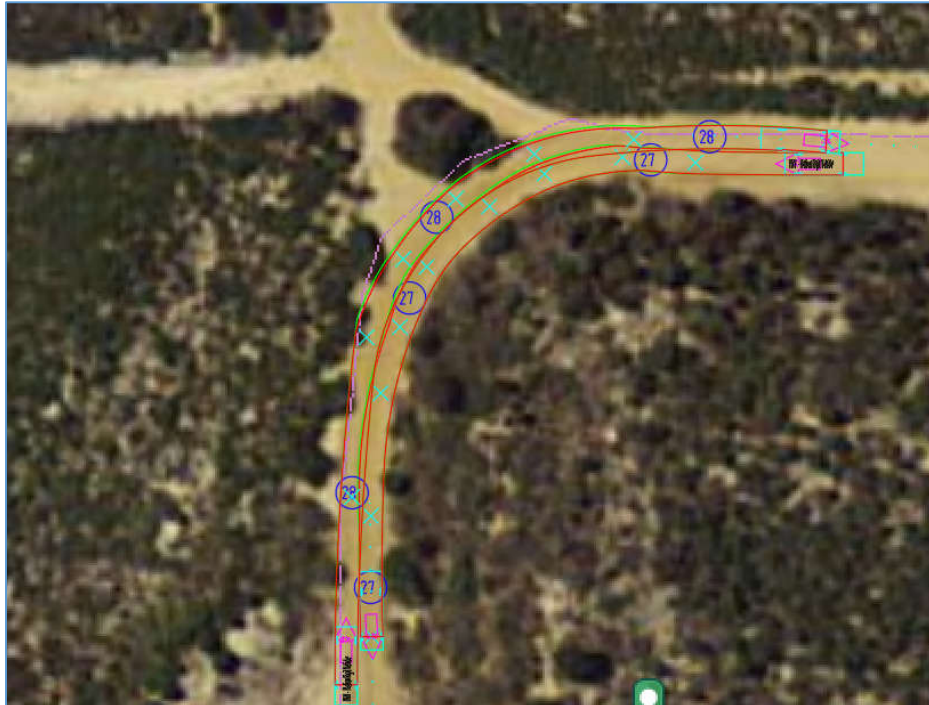
The access into the camp site has also been checked, in particular the bend at the end Wongonderrah Road, as per **Figure 37** and **Figure 38**. The swept path assessment, based on aerial imagery, indicates that the bend is too narrow for lane correct movements and therefore widening to allow lane correct movements should be considered.

Figure 37: Camp Access - Wongonderrah Rd Swept Paths – Light Vehicles

Figure 38: Camp Access - Wongonderrah Rd Swept Paths – Shuttle Bus (8.8m vehicle)

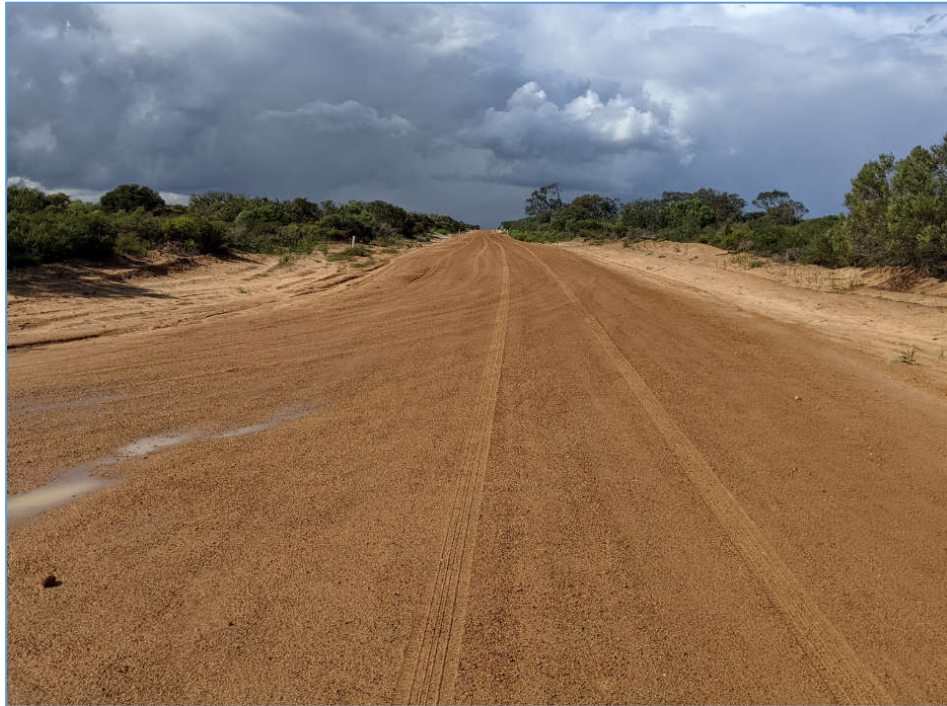
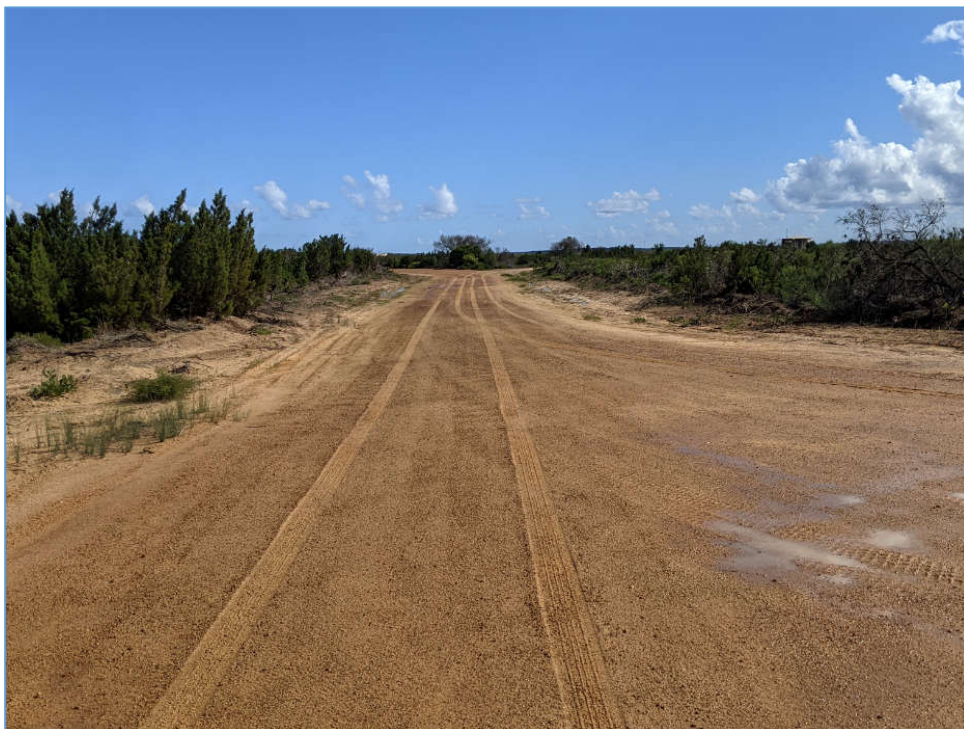
The Safe Intersection Sight Distance (SISD) has been assessed in accordance with Austroads Guide to Road Design Part 4A Equation 2 and the results are summarised in **Table 11**. The line-of-sight photos at the intersection are shown below in **Figure 39** and **Figure 40**.

Figure 39: Munbinea Rd (SLK 0.00) & Wongonderrah Rd Intersection – Looking East

Figure 40: Munbinea Rd (SLK 0.00) & Wongonderrah Rd Intersection – Looking West

Traffic Direction	Road Condition	Vehicle Type	Design Speed (km/h)	Coefficient of Deceleration	Decision Time (s)	Longitudinal Grade (NB / SB)	Required SISD (m)	Available SISD (m)
West	Unsealed	Trucks	100	0.23	3+2.5	-2%	340	+500
		Cars	110	0.22	3+2.5	-2%	406	+500
East	Unsealed	Trucks	50	0.27	3+2.5	0%	84	110
		Cars	50	0.27	3+2.5	0%	84	110

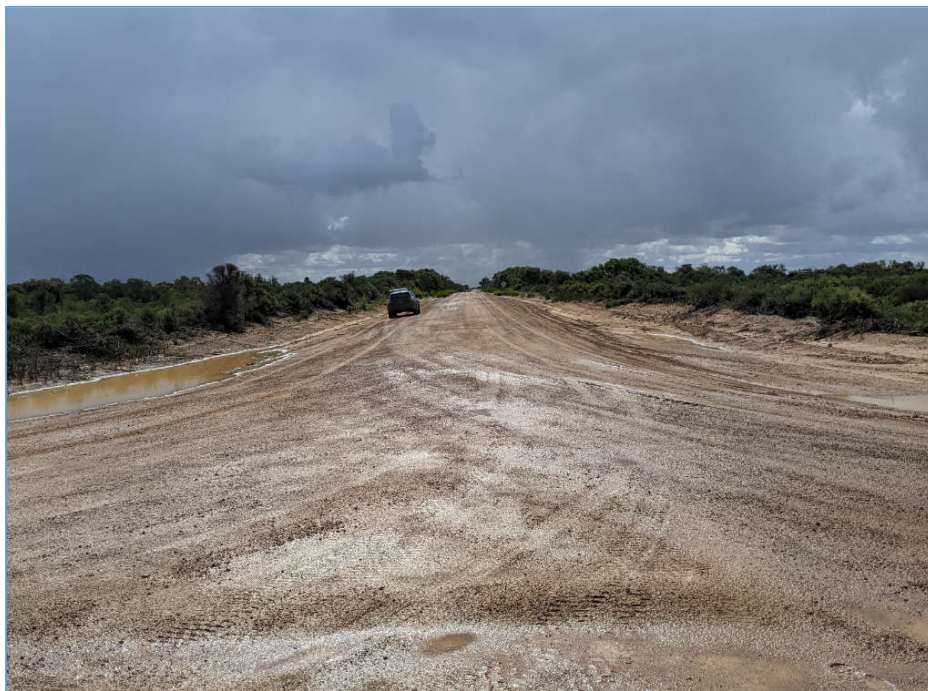
Figure 41: Munbinea Rd (SLK 0.00) & Wongonderrah Rd Intersection – Looking North

The required and available ASD at the intersection has been determined from Austroads Part 4A Equation 2 as summarised in **Table 12**.

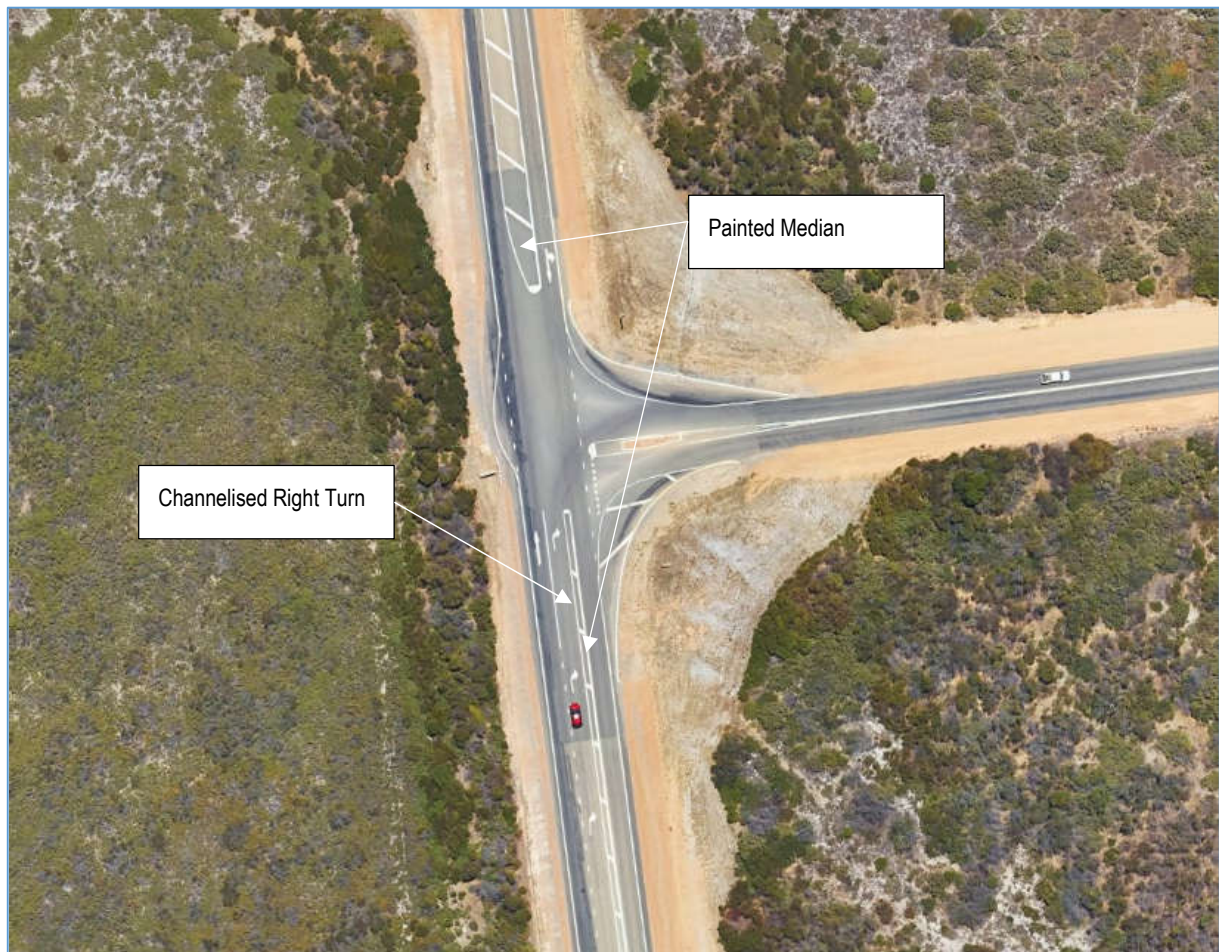
Figure 42: Jurien Road & Indian Ocean Drive Intersection

As per **Figure 42**, the existing intersection has a channelized right turn and a painted median.

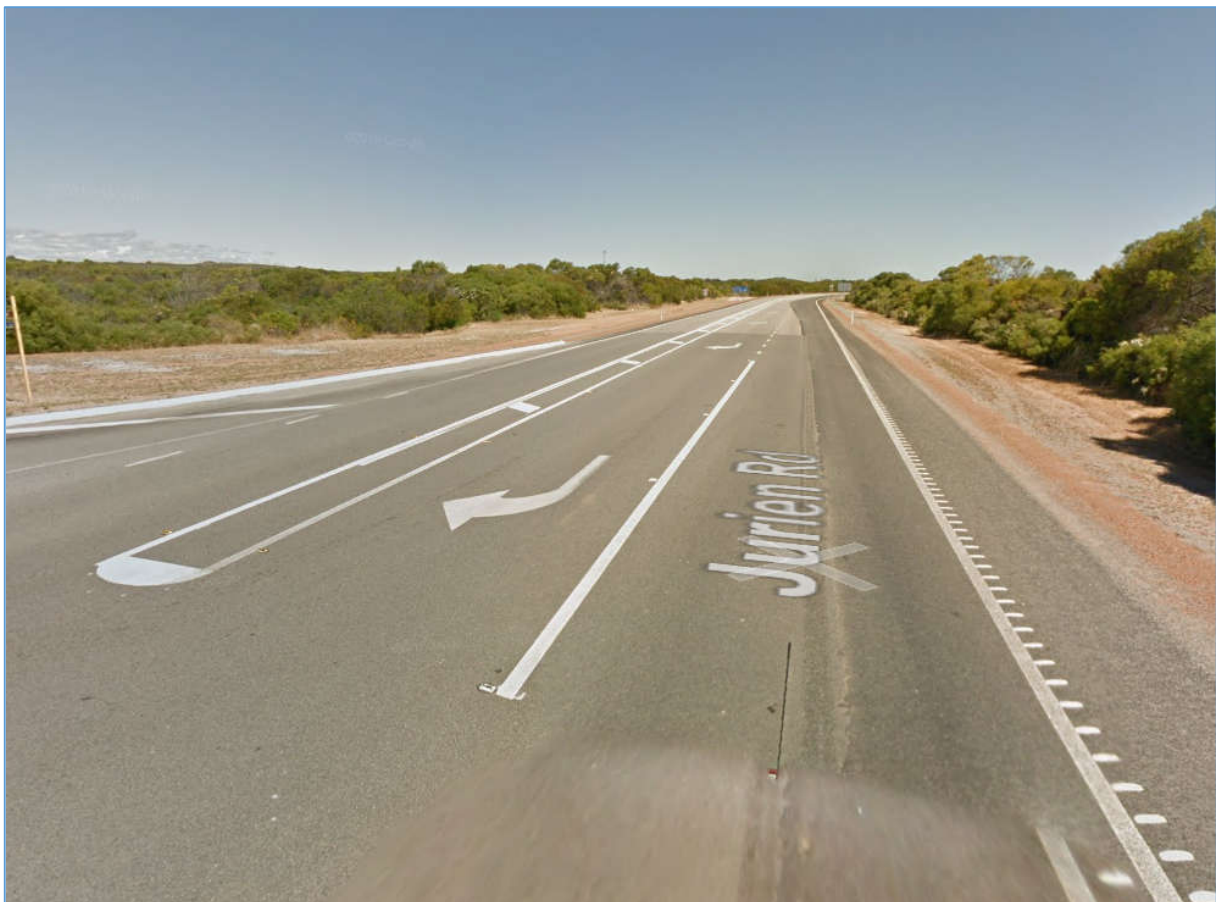
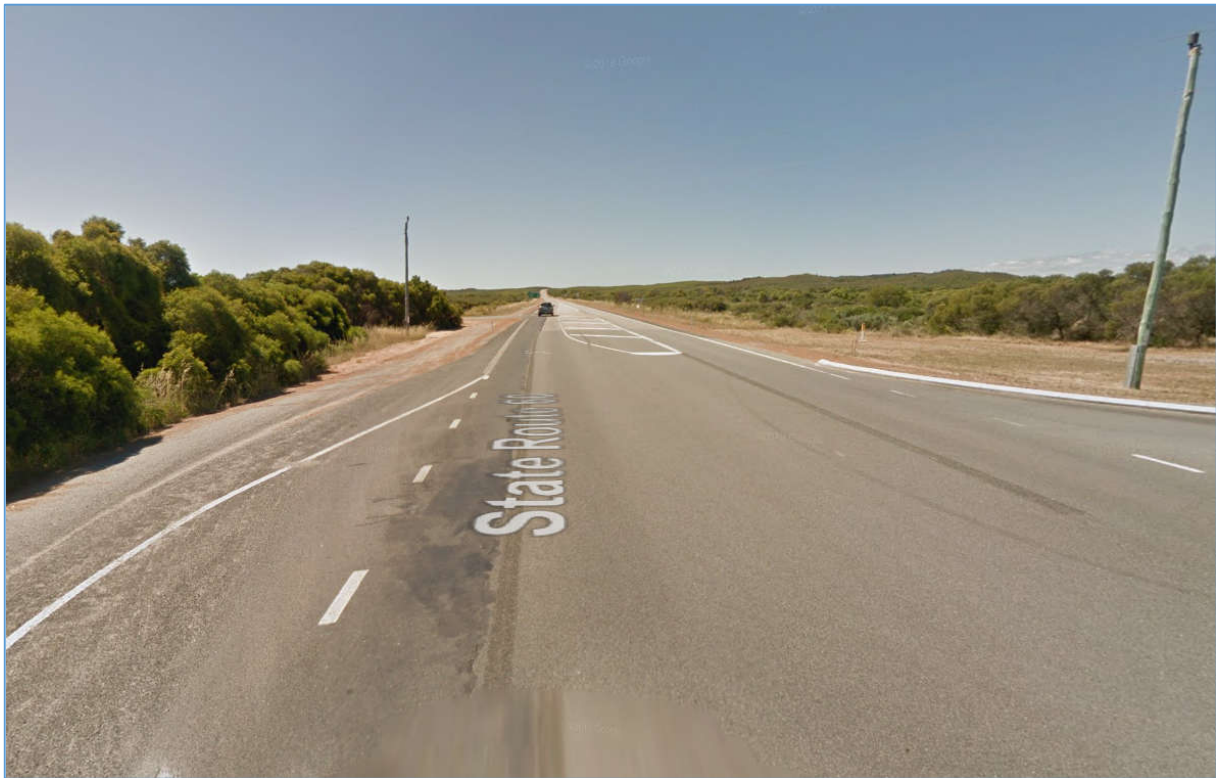
The Safe Intersection Sight Distance (SISD) has been assessed in accordance with Austroads Guide to Road Design Part 4A Equation 2 and the results are summarised in **Table 14**. The line-of-sight photos at the intersection are shown below in **Figure 43** and **Figure 44**.

Figure 43: Jurien Rd / Indian Ocean Drive Intersection Looking South

Figure 44: Jurien Rd / Indian Ocean Drive Intersection Looking North

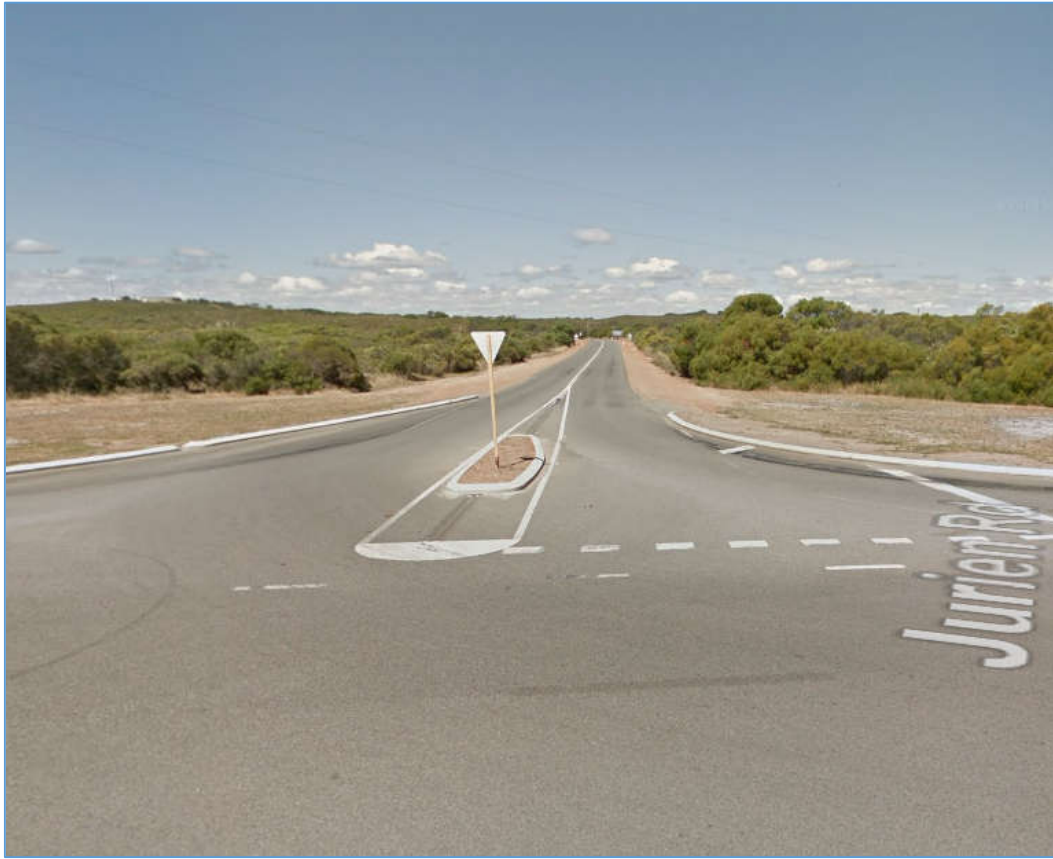
Figure 45: Approach Sight Line for Jurien Road Intersection from Indian Ocean Drive

The required and available ASD at the intersection has been determined from Austroads Part 4A Equation 2 as summarised in **Table 15**.

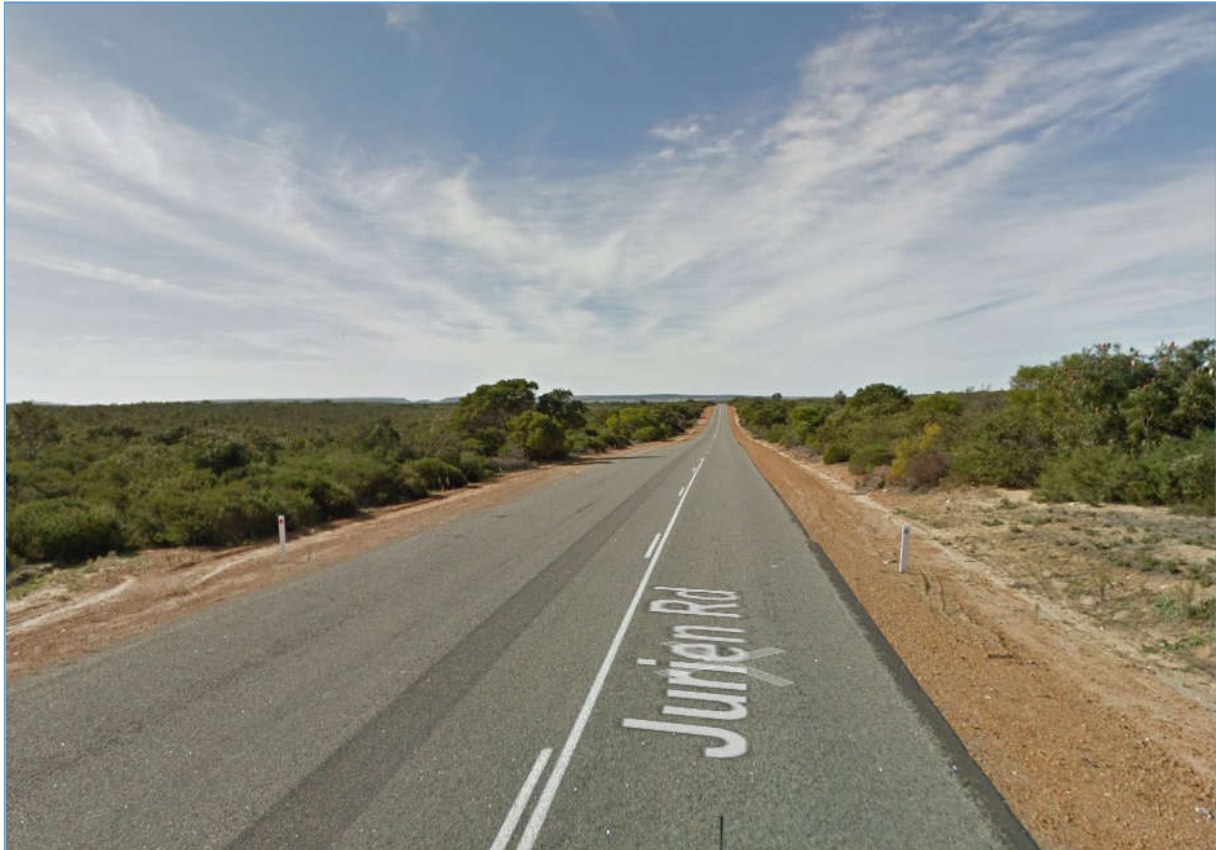
Figure 46: Typical Existing Jurien Road Formation

The road is considered to be in good condition and appears well maintained.

Refer **Figure 46** for a typical example of the existing formation of Jurien Road.

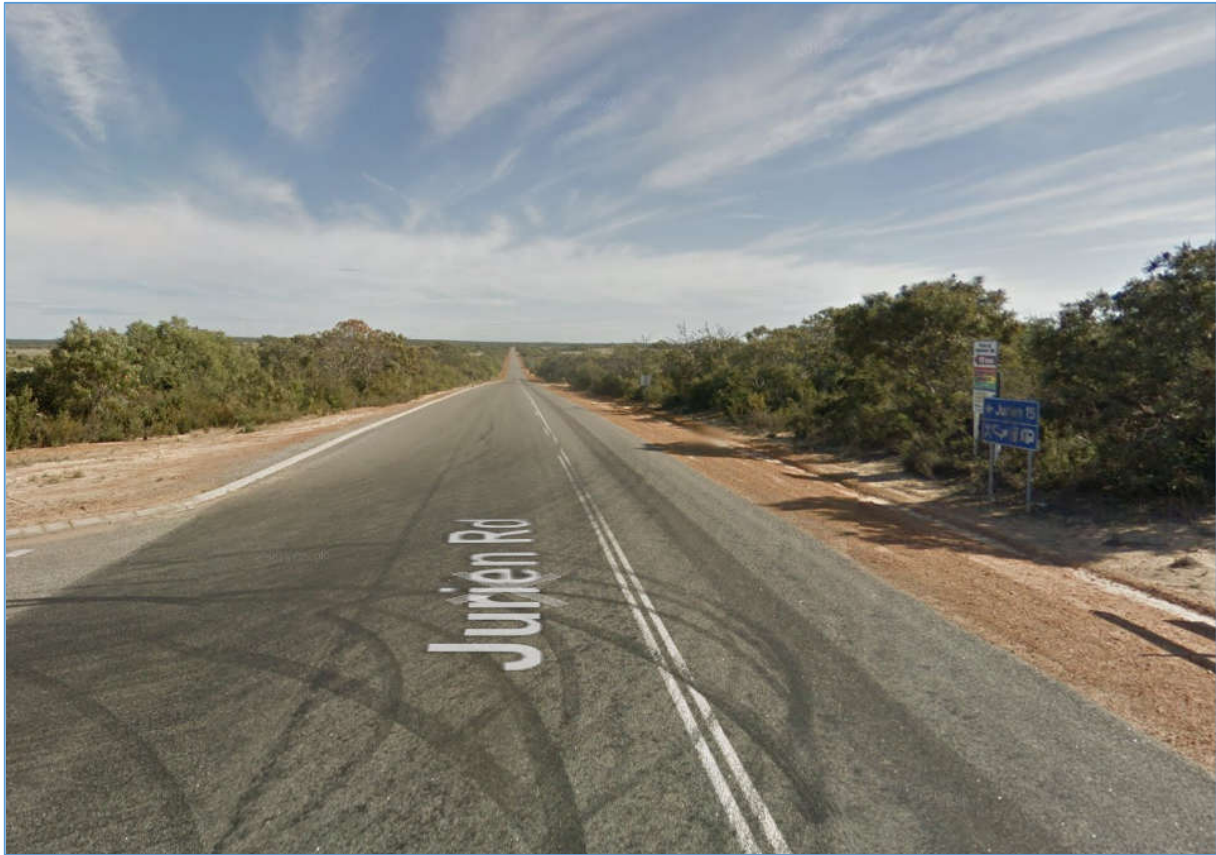
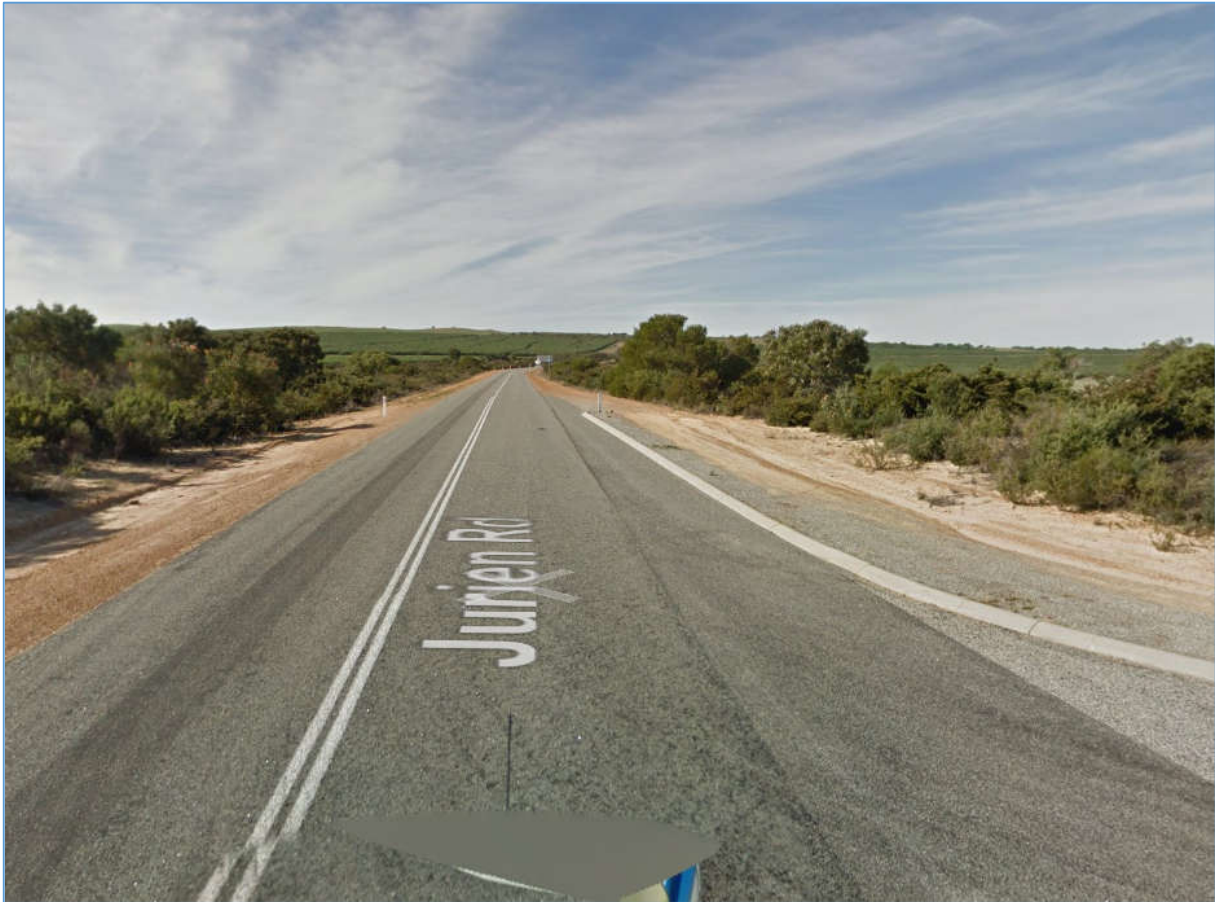
Design Part 4A Equation 2 and the results are summarised in **Table 17**. The line-of-sight photos at the intersection are shown below in **Figure 48** and **Figure 49**.

Figure 48: Jurien Rd / Munbinea Road Intersection Looking West

Figure 49: Jurien Rd / Munbinea Road Intersection Looking East

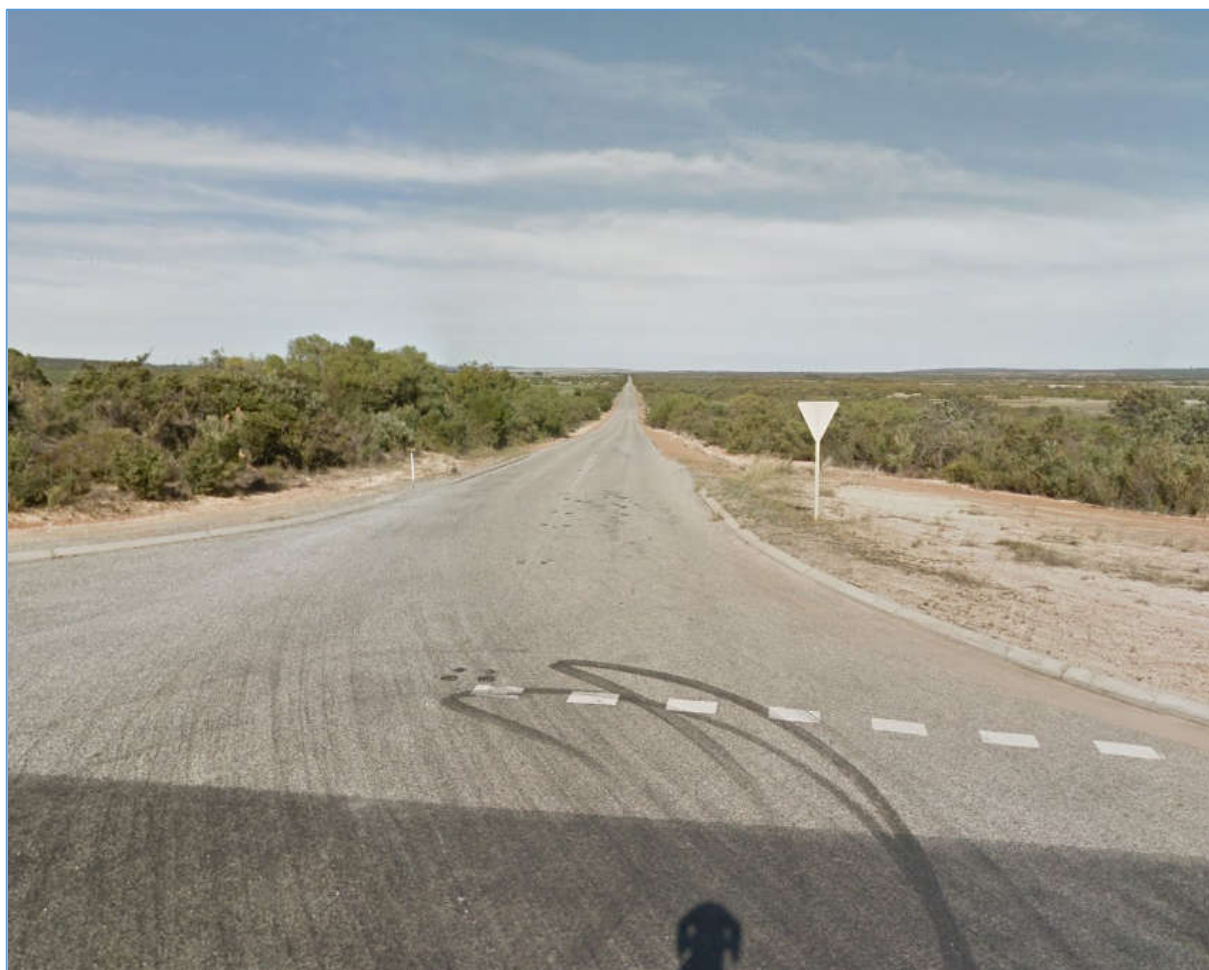
Figure 50: Approach Sight Line from Jurien Road

The required and available ASD at the intersection has been determined from Austroads Part 4A Equation 2 as summarised in **Table 18**.

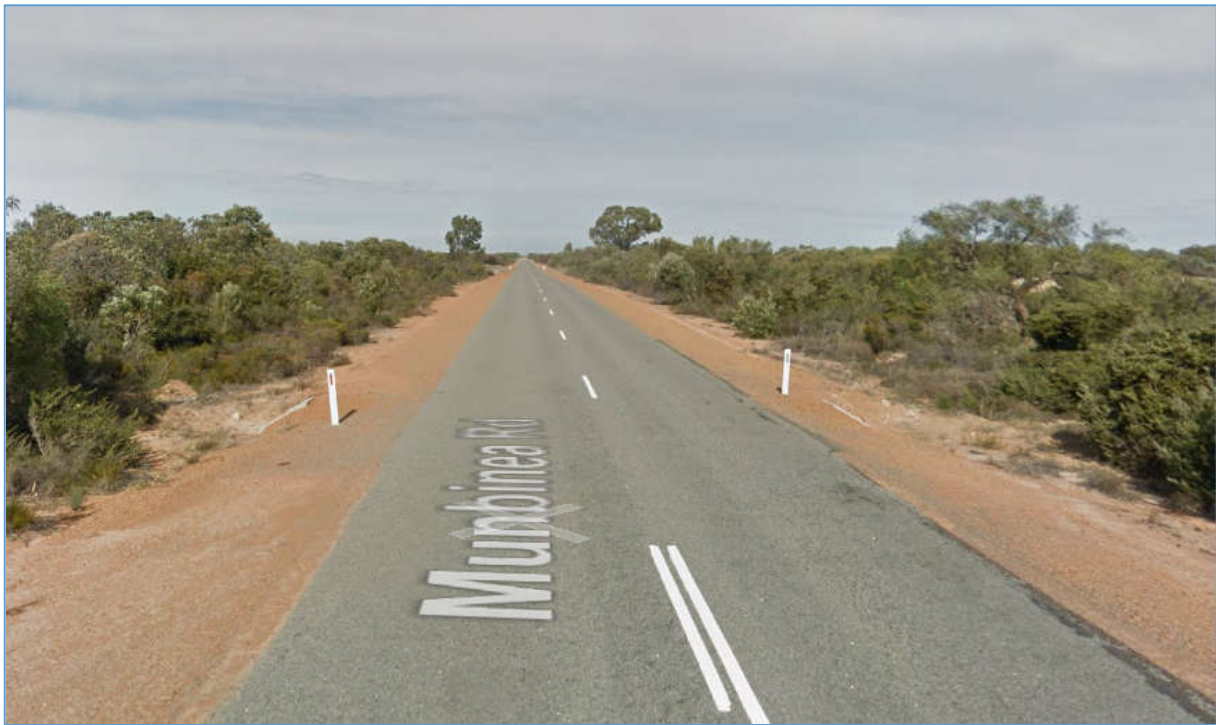
Figure 51: Typical Existing Munbinea Road Formation

The road is considered to be in good condition and appears well maintained.

Refer **Figure 51** for a typical example of the existing formation of Jurien Road.

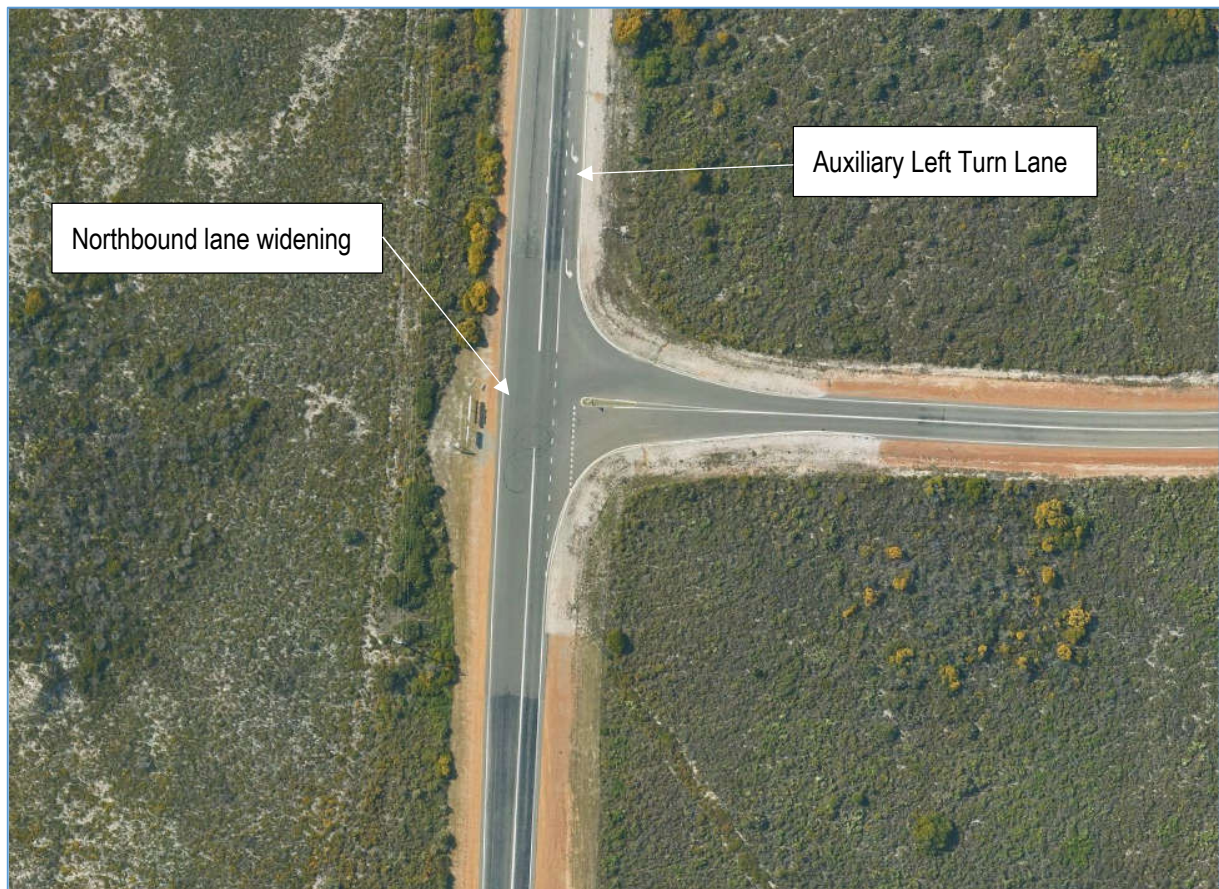
Figure 52: Cervantes Road & Indian Ocean Drive Intersection

As per **Figure 52**, the existing intersection has an auxiliary left turn treatment and northbound lane widening through the intersection that allows through vehicles to pass right turning vehicles.

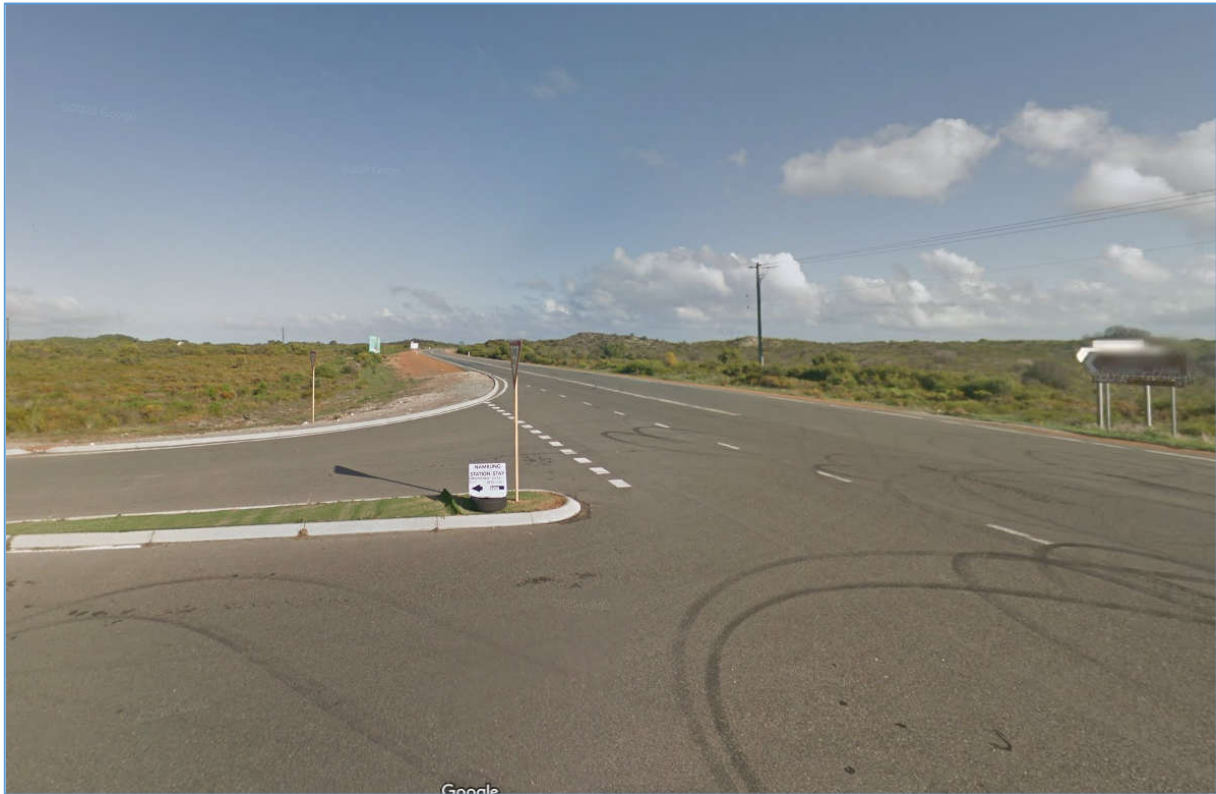
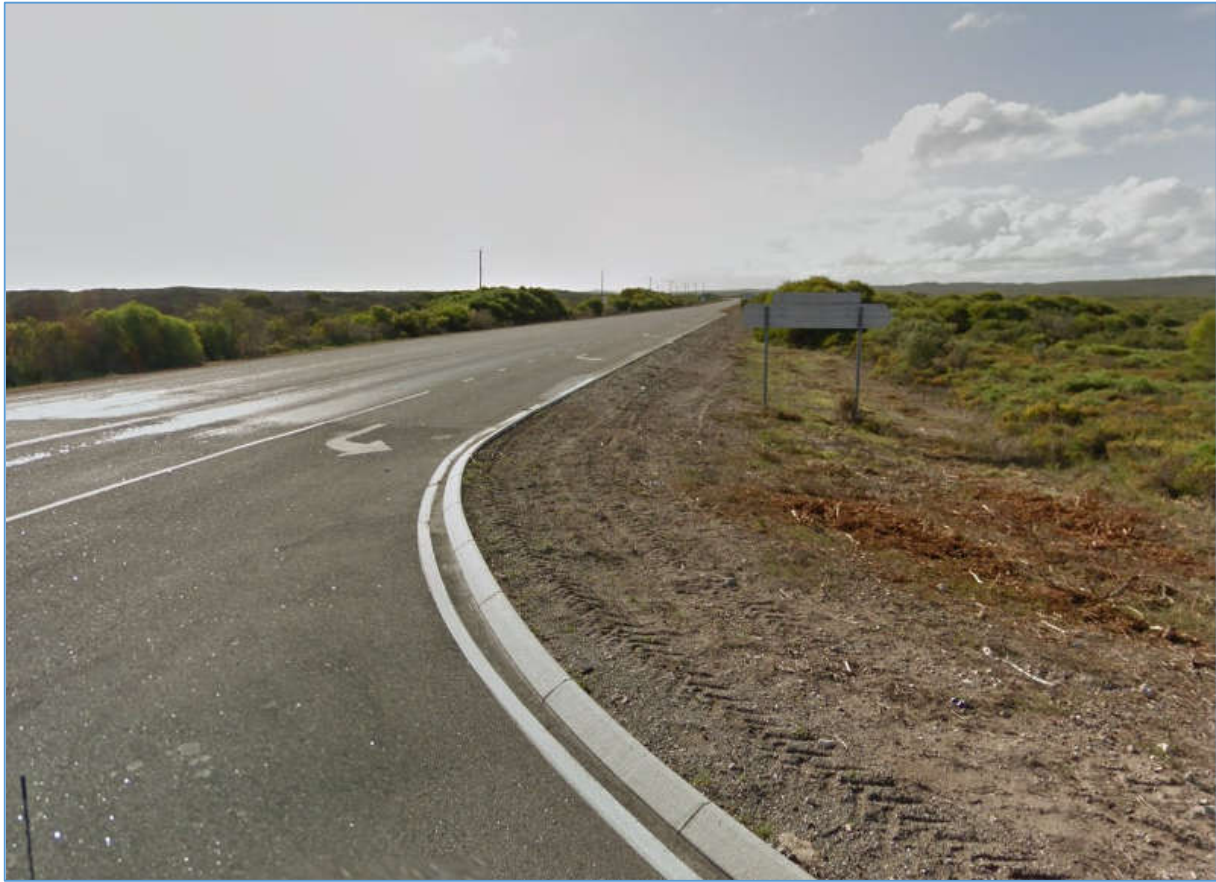
The Safe Intersection Sight Distance (SISD) has been assessed in accordance with Austroads Guide to Road Design Part 4A Equation 2 and the results are summarised in **Table 20**. The line-of-sight photos at the intersection are shown below in **Figure 53** and **Figure 54**.

Figure 53: Cervantes Rd / Indian Ocean Drive Intersection Looking South

Figure 54: Cervantes Rd / Indian Ocean Drive Intersection Looking North

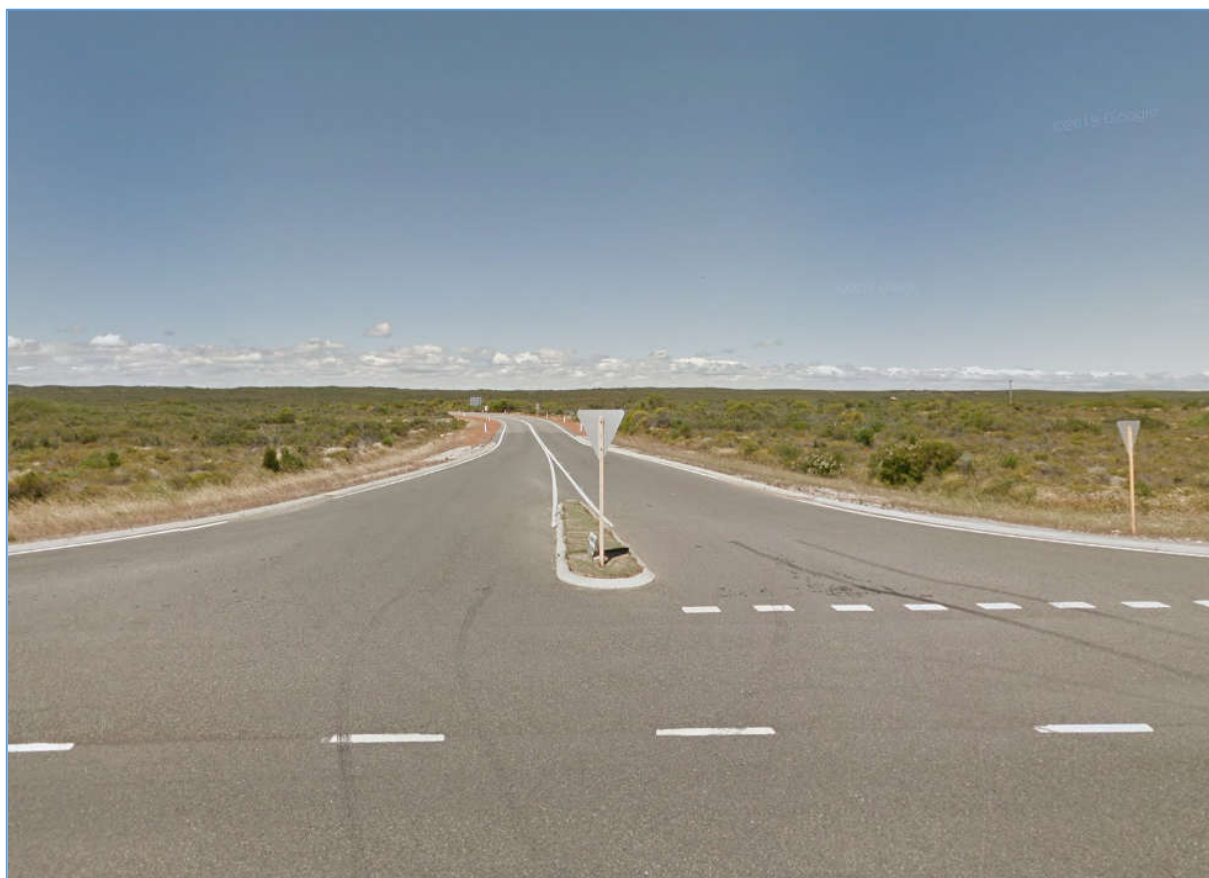
Figure 55: Approach Sight Line along Cervantes Road from Indian Ocean Drive

The required and available ASD at the intersection has been determined from Austroads Part 4A Equation 2 as summarised in **Table 21**.

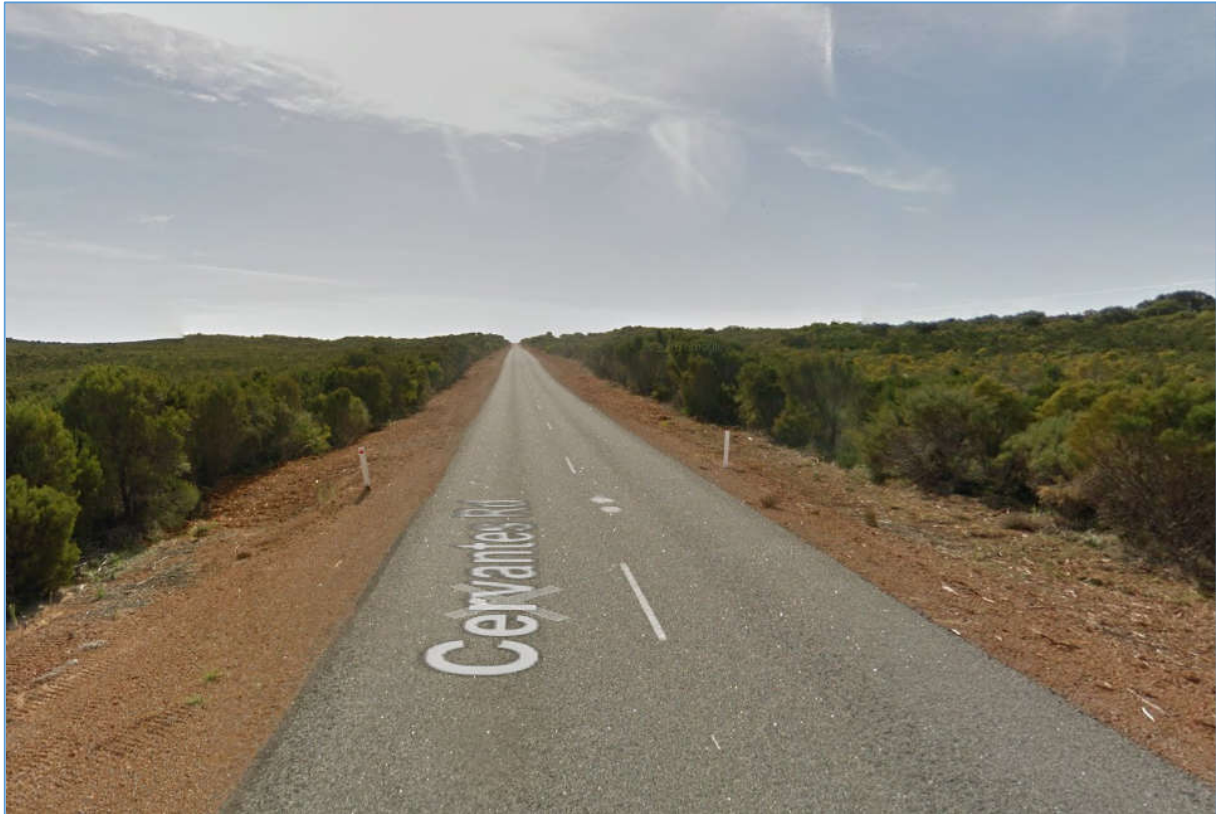
Figure 56: Typical Existing Cervantes Road Formation

Refer **Figure 56** for a typical example of the existing formation of Cervantes Road.

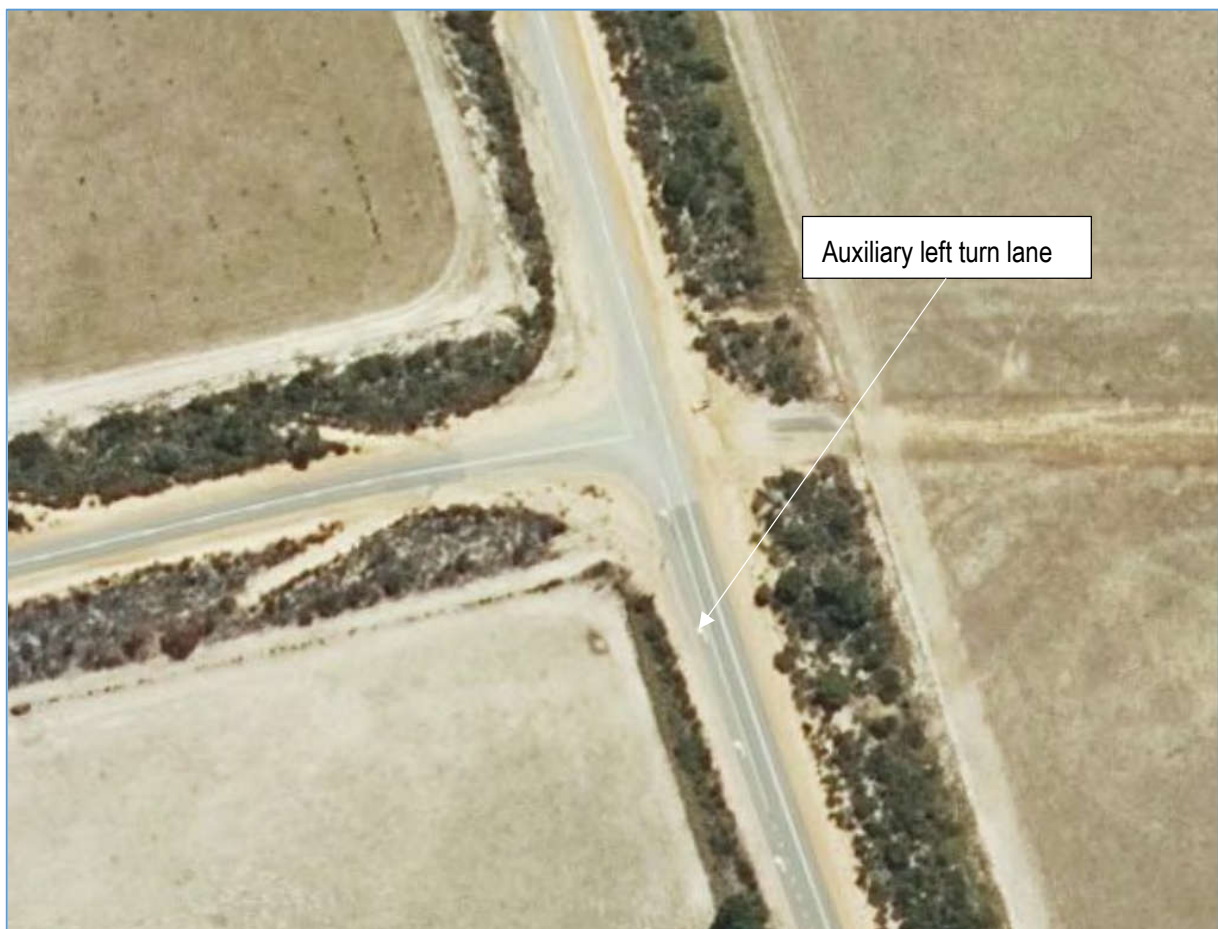
Figure 57: Cervantes Road & Munbinea Road Intersection

As per **Figure 57**, The existing intersection is a basic sealed T intersection with an auxiliary left turn lane.

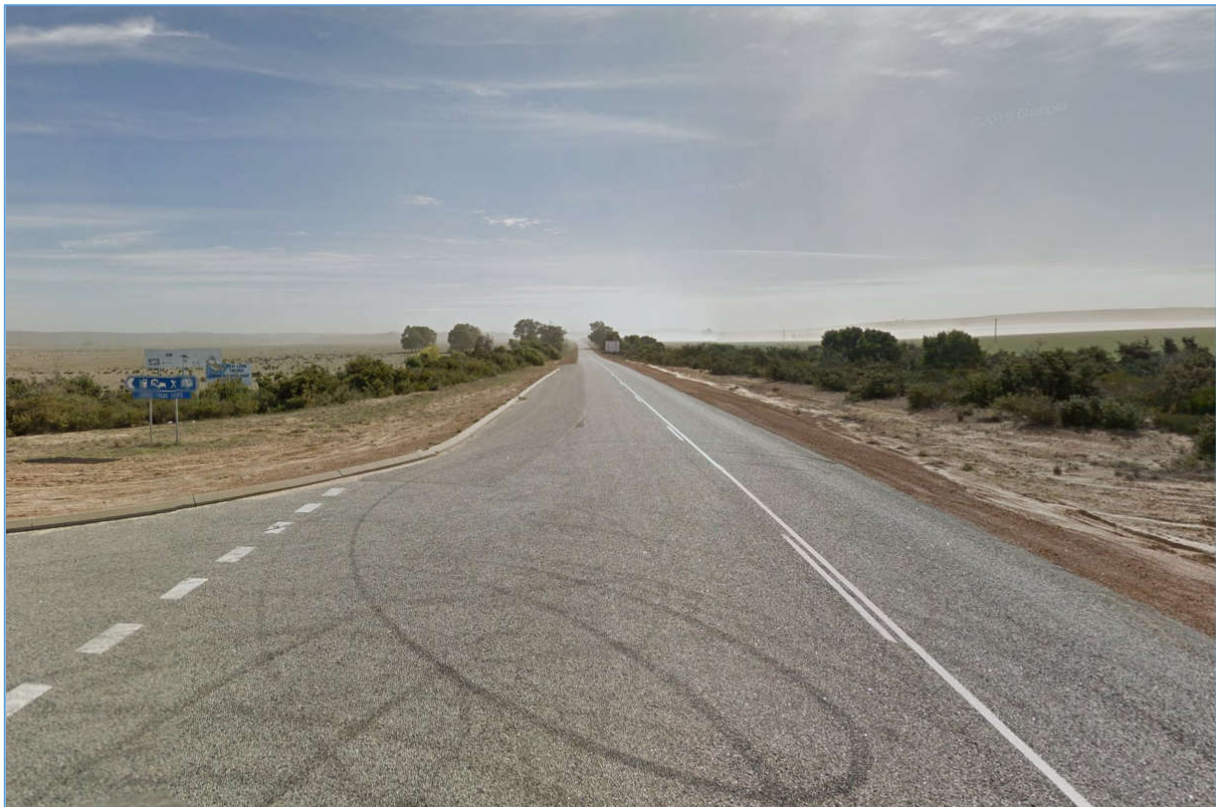
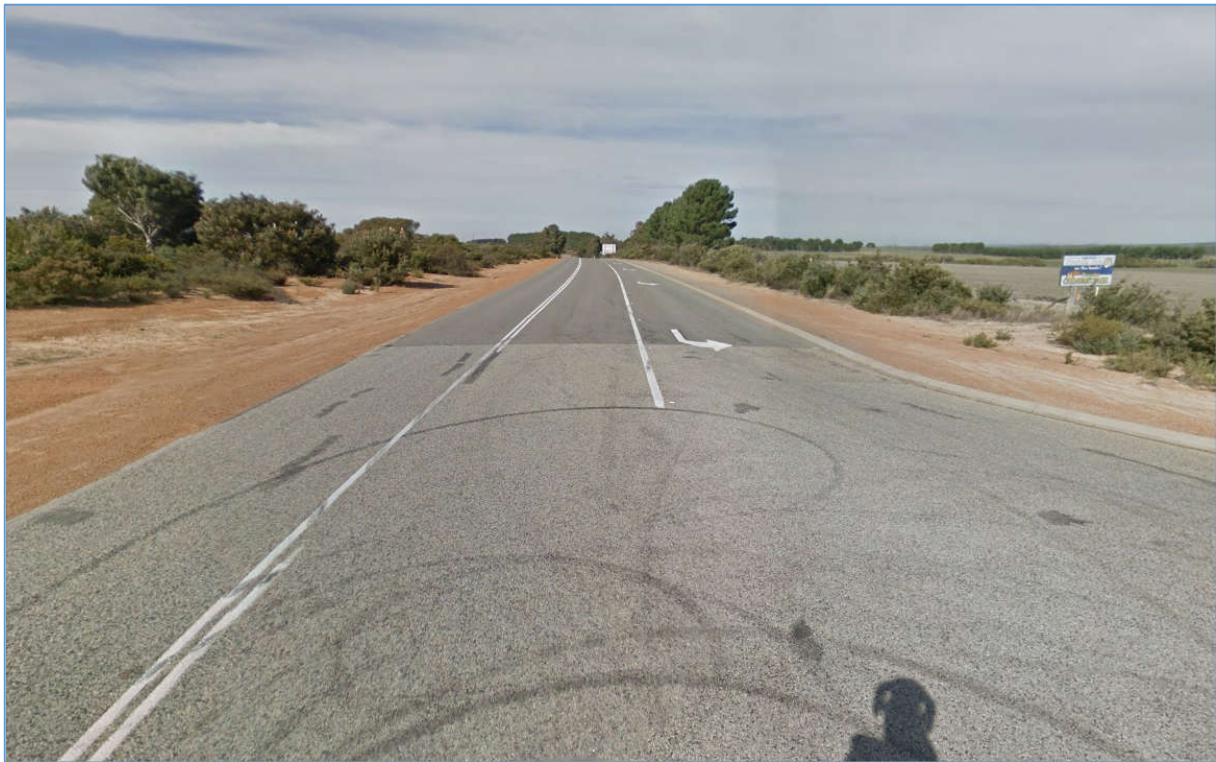
The Safe Intersection Sight Distance (SISD) has been assessed in accordance with Austroads Guide to Road Design Part 4A Equation 2 and the results are summarised in **Table 22**. The line-of-sight photos at the intersection are shown below in **Figure 58** and **Figure 59**.

Figure 58: Cervantes Rd / Munbinea Road Intersection Looking North

Figure 59: Cervantes Rd / Munbinea Road Intersection Looking South

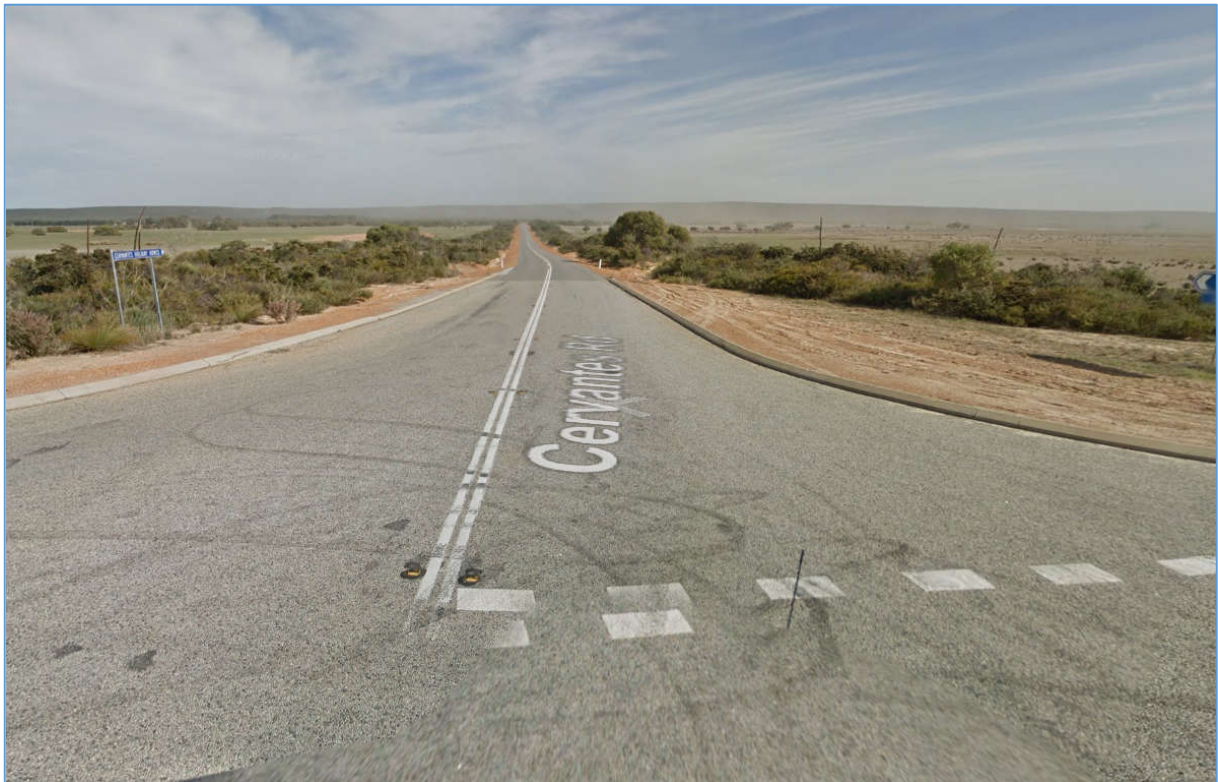
Figure 60: Approach Sight Line Cervantes Road from Munbinea Road

The required and available ASD at the intersection has been determined from Austroads Part 4A Equation 2 as summarised in **Table 23**.
