# Coastal Recreational Track Management Master Plan for the Shires of Coorow, Dandaragan & Gingin

Site Assessment Tables

March 2025 REV-B

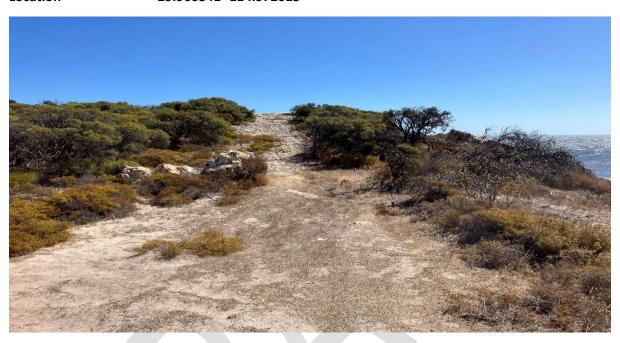
Limestone Headland South of Leeman with rock barricading moved by track users

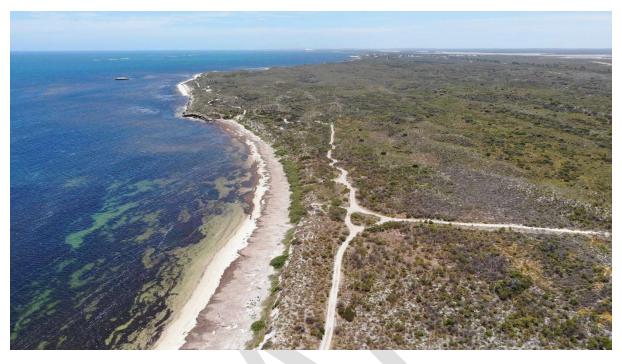
Webb Island area (CW02)

Looking North toward Webb Island showing local tracks

Description	Limestone headland main feature of the area. To the South steep fore dune into ocean with vehicle track on top. To the North a small embayment leading into low limestone bench and cliff.
Access	Access is by coastal tracks from IOD. Southern track runs along top of very steep and high foredune. North track cuts through a heavily eroded dune that access had been restricted to previously.
Attractions and features	Prominent limestone head land that is popular for fishing and ocean views. Small embayment with sandy beach for swimming is located nearby on the Northern edge.
Recreational use	Medium due to the cliff risk and limited beach access in the area. Track on
suitability	top of fore dune is a risk of creating a mobile dune system with degradation
assessment	of vegetation on dune ridge top.
Development potential	Low. Dune system is not suitable for high rate of vehicle traffic use of the coastal track as surface is not durable and subject to erosion. An old inland track in the southern section should be designated as the Southern access for the area. Northern access follows the coast on a lower dune system with limestone shelfs. Duplicate track and coast entry point s need to be closed off.

Recommendation	Site Protection (SP): Move Southern access track to old inland track and away from crest of foredune. Reinstate bollards to stop access through eroding dune on North access track.  Site Development (SD): Develop old inland track on south access to area. Close foredune ridge top track and rehabilitate and revegetate. Reinstate bollards in eroded dune and educational signage install on access changes.

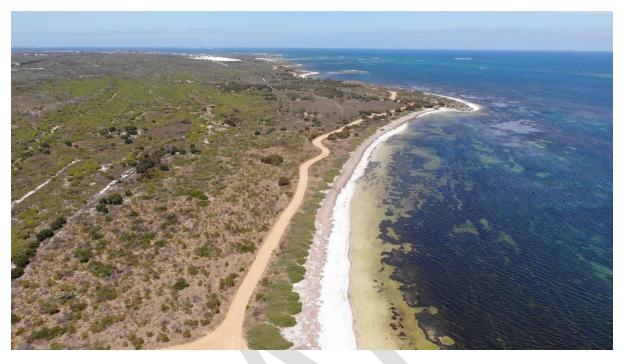
Little Anchorage Bay (CW03)

Little Anchorage Bay looking South from mid-point of bay

Description	Long embayment with narrow beach. Limestone head land at Southern and Northern ends. Very low coastal dune and vegetation on Southern end subject to storm surge inundation.
Access	Southern end by gravel road. Northern end by coastal tracks
Attractions and features	Ocen views, sections of sandy beach with shallow waters.
Recreational use	Medium due to narrow beach and low foredune subject to storm
suitability	inundation. Shallow waters of the bay make it family friendly for swimming.
assessment	Seaweed build up can significantly reduce the useability of the beaches and
	bay especially after a storm front.
Development	Low. Due to narrow beach and low coastal dune being subject to frequent
potential	storm surge inundation.
Recommendation	Site Protection (SP): Delineate pedestrian and vehicle movements.
	Rehabilitation and revegetate high risk storm surge areas to build resilience
	to storm damage.

Site Development (SD): Low development potential due to very low
	foredune being breached by storm surges. Educational signage on use of
	the area. Delineate pedestrian and vehicle use area. Reduce the number of vehicle access points to 2.

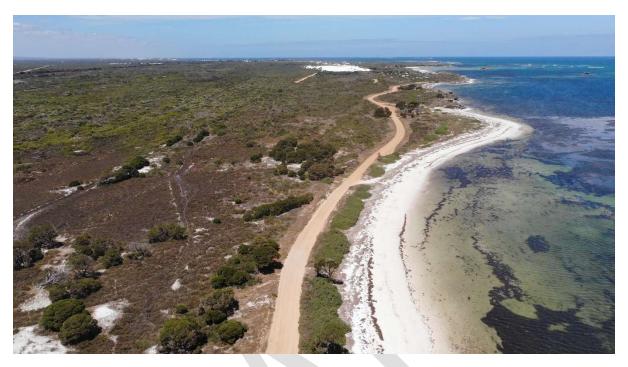
Lipfert Island area. (CW04)

**Looking South from Lipfert Island**

Open section of coastline near Lipfert Island. Southern end has a low
limestone headland. Northern end has a low limestone point. Long section
of very narrow sandy beach. Southern ends is backed by very low dune
structure while the Northern end has a moderately high dune structure.
Access is via gravel formed road with coastal tracks to the beach. The road
is set quite close to the coast in this section.
Long sandy beach. Low coastal dune making easy access at Southern end.
Small dune near Northern end. Ocean views out to Lipfert Island.
Medium. Mostly due to Narrow beach along most of the section of coast.
Southern end has wider beach section and more suited to recreational use
for swimming and fishing with shelter behind headland.
Low due to narrow beach and the access road being very close to the coast
in this section. With very low dunes in this area it is subject to storm surges
and subsequent damage to vegetation and man made structures.

Site Protection (SP): Rehabilitate and revegetate tracks in Southern end of
Lipfert Island area.
Site Development (SD): Education signage on area use. Delineate vehicle
and pedestrian use areas. Protect landscape and vegetation from storm
surge degradation.

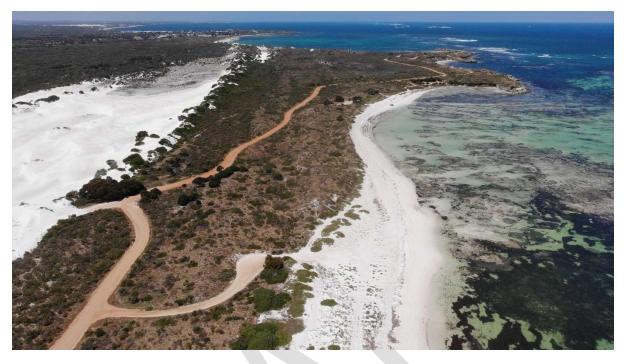
Billy Goat Bay showing multiple track growth at entry

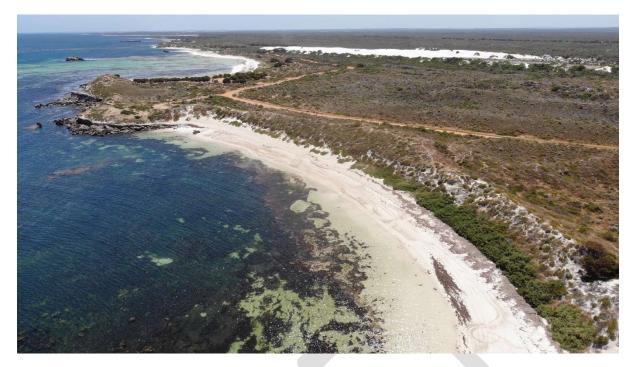
Harrop Inlet. Beach has been used by hoons leaving skid marks along the entire beach.

Description	Very small embayment with limestone headlands at each end.
Access	4WD track at south end. Access subject to seaweed build up and tidal
	movements. Foot traffic down dunes at North end causing erosion. Vehicle
	Hoon activity on beach.
Attractions and	Small partly sheltered bay. Good fishing and swimming beach.
features	
Recreational use	Medium due to the variability of steep access to beach by foot or 4WD
suitability	vehicle. Beach has very limited capacity due to narrow beach backed by
assessment	steep coastal dune.
Development	Low. Due to the small size of the inlet, it cannot sustain a high level of
potential	human use. Excessive use will lead to loss of vegetation in surrounding
	dunes leading to accelerated erosion forces.
Recommendation	Site Protection (SP): rehabilitate and revegetate high erosion risk
	pedestrian tracks.
	<b>Site Development (SD):</b> Install education signage at both ends of the inlet.

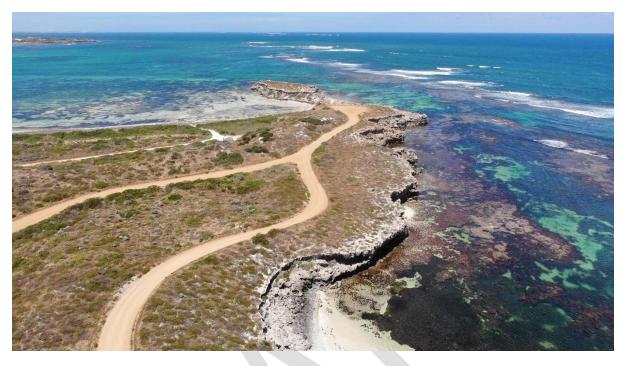
Pont Louise (CW07)

#### **Point Louise overview**

Description	Limestone headland
Access	Formed road/track with wayfinding signage
Attractions and	Outlook over ocean and coastline from elevated position.
features	
Recreational use	High due to durable surface and formed dirt road/track. Risk of fall from
suitability	limestone cliff face and falling objects near base of cliff.
assessment	
Development	Maintain. Popular location for local and visitors for views and fishing.
potential	
Recommendation	Site Protection (SP): Install educational signage. Exclude foot traffic from
	fragile vegetation areas and high risk areas.
	Site Development (SD): Install educational signage. Delineate areas of use.

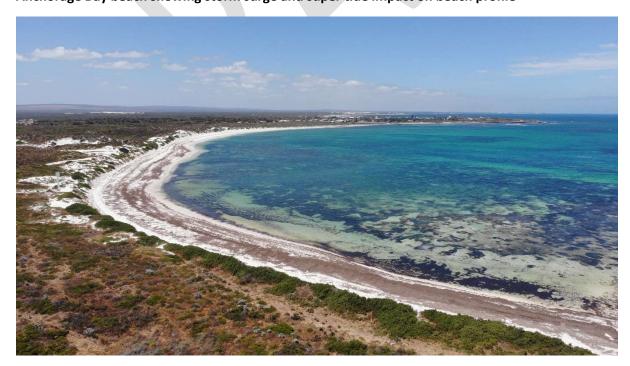
Anchorage Bay Northern end showing seaweed build up and impact on beach track movement

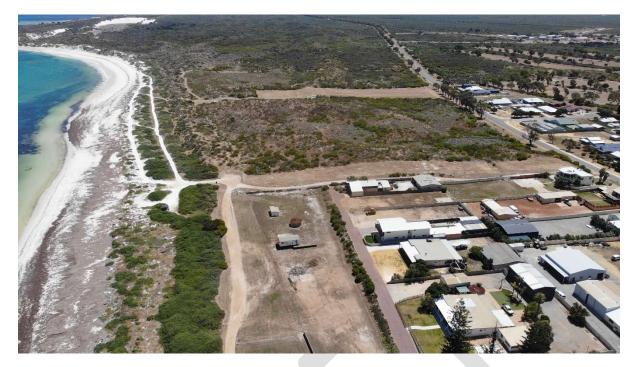
Anchorage Bay Southern end showing multiple track growth to drive around seaweed build ups.

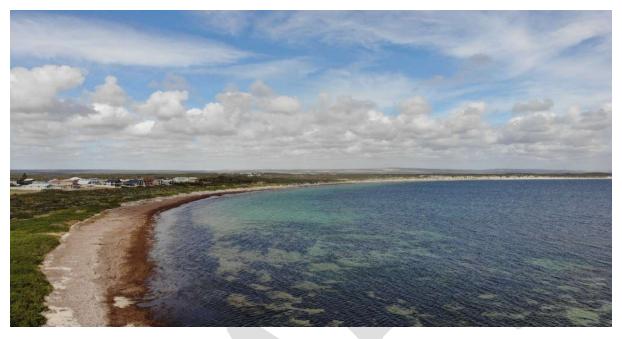
South Bay Northern end looking back around bay. Seaweed build up moves beach entry point south eastward. South bay has a very narrow beach backed by high steep dunes leaving a narrow beach to drive on.

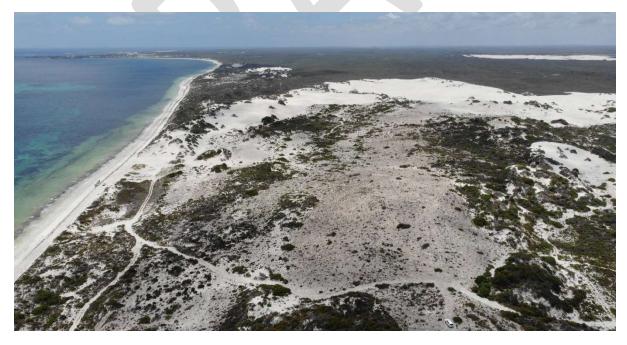
South Bay midpoint looking North. Limited tracks from here to Green Head. Driving on the beach to Green Head can be difficult with high tides, storm surges and seaweed build up.

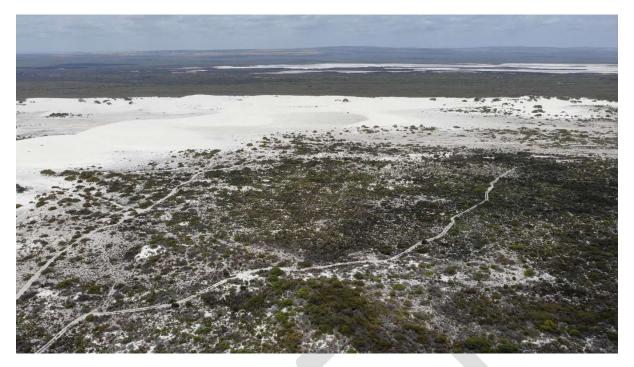
Inland tracks from South Bay midpoint. Mining lease dunes are used by 4WD's even though it is signed as a no entry area. Access track to IOD is partly blocked by an earth bund which is driven over by 4WD users. Tracks to the South join to Sandy Cape tracks through DBCA reserve.

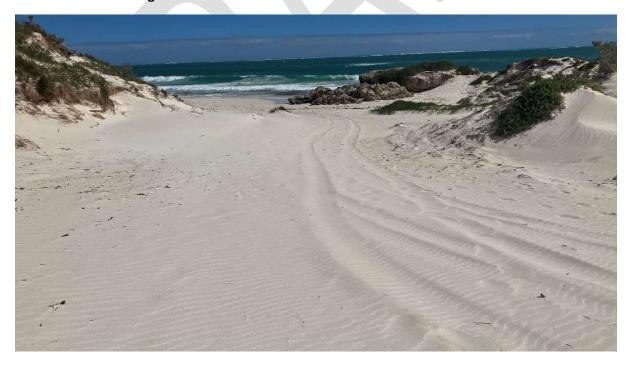
High energy wind erosion path on Sandy Cape. Looking directly into prevailing wind direction. Vehicle and pedestrian use has prevented natural reestablishment of vegetation.

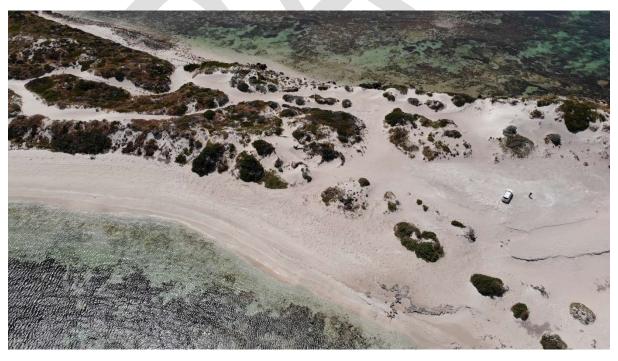
Noth Head narrow neck showing extent of erosion due to loss of vegetation. Bed rock is exposed in the right side of picture. It is estimated that approximately 100,000 tonnes of sand has been lost from this area in the last 50 years. Historical photos of the area were used to make this estimate of sand loss.

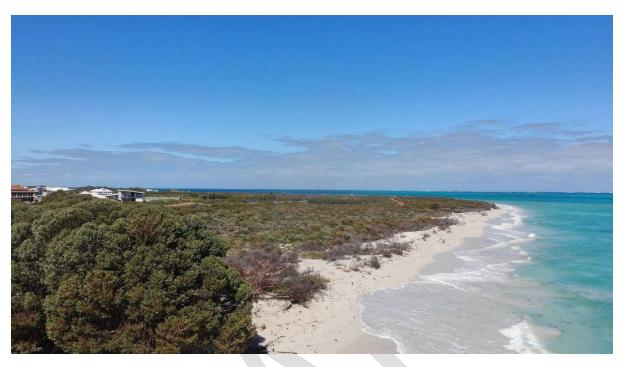
Looking South East from Shingle Ave access track. Good example of narrow winter beach backed by short steep dune.

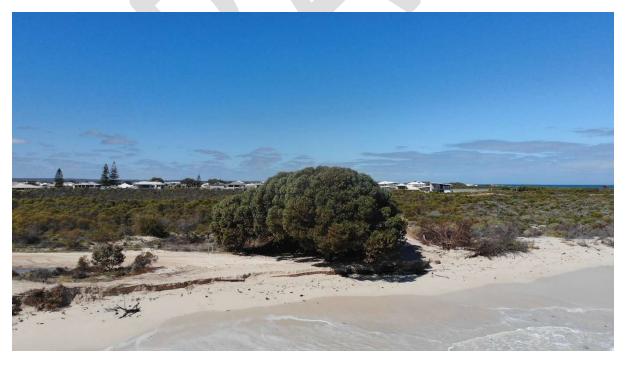
Severe erosion at Shingle Ave access track after combined super tide and storm surge.

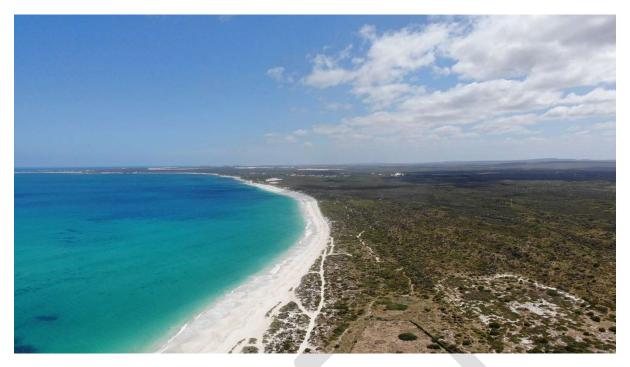
Overview of coastal tracks North of Jurien Bay. Multiple tracks in the lower section of picture are a result of seaweed build up North of the Jurien Bay Marina pushing beach access further along the beach to get past the seaweed deposits.

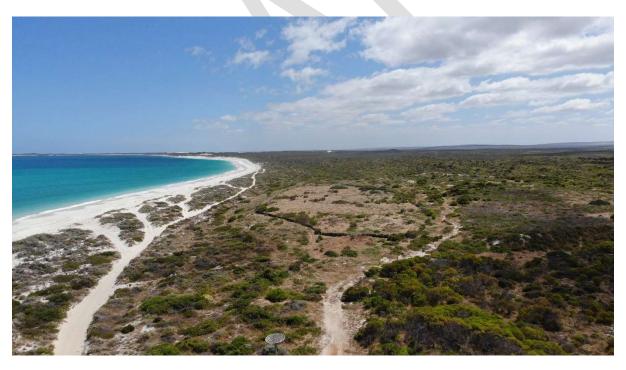
Overview of coastal tracks North of Jurien Bay. Multiple beach entry points need to be closed and one entry point past typical seaweed build point should be left open.

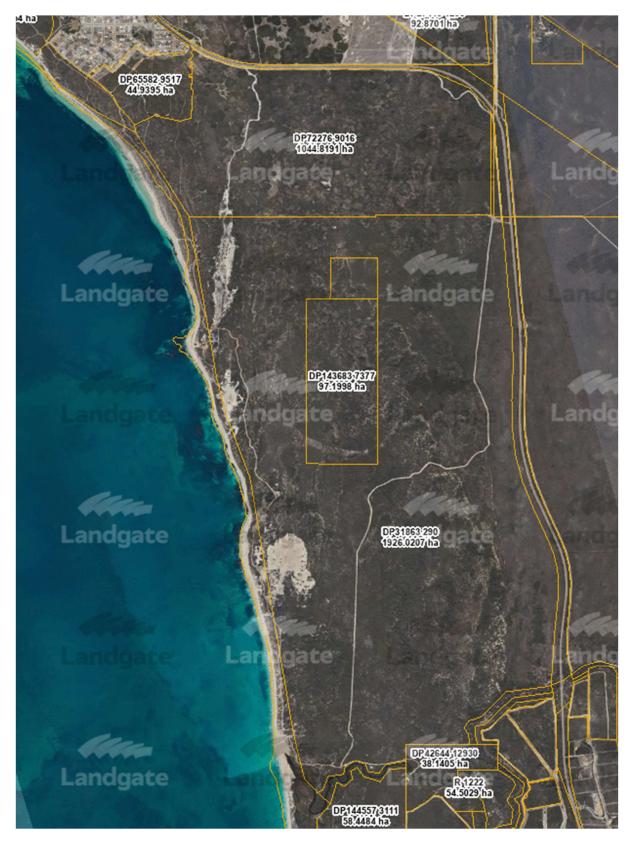
Landgate Map Viewer extract of Lot Boundaries in the Booka Valley area. Coastal tracks in this area are through private property.

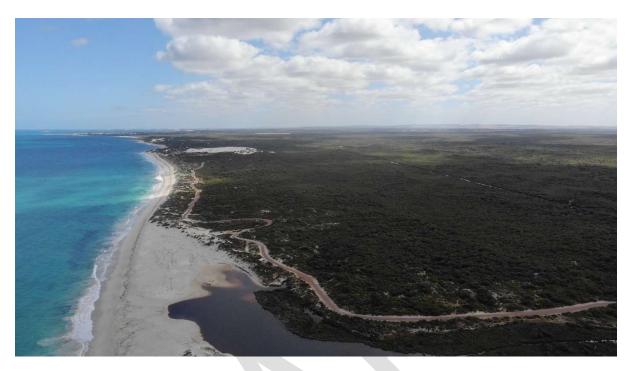
Looking North from Hill river Mouth. Turquoise Coast Path limits vehicle coast track development activity in this area.

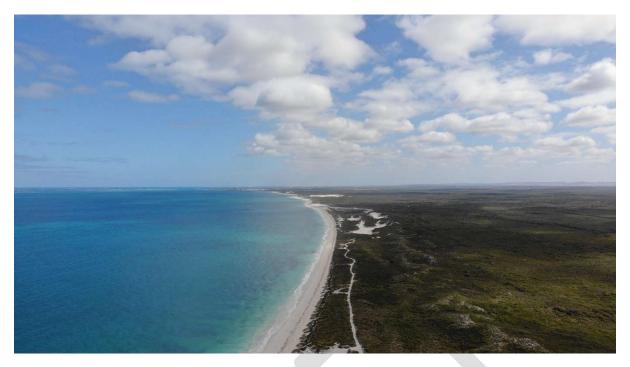
Overview of Hill River Coastal track from the Hill River Beach Car Park looking North. Multiple access and stopping points need to be closed due to the high erosion risk of the coastline in this area. The stopping points are regular used for illegal camping.

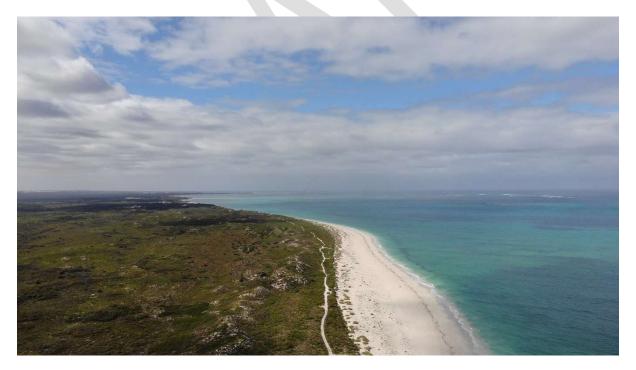
View looking South from Hill River Beach car park. Coastal track has limited beach access points and does not present a high erosion risk in the coastal dune system.

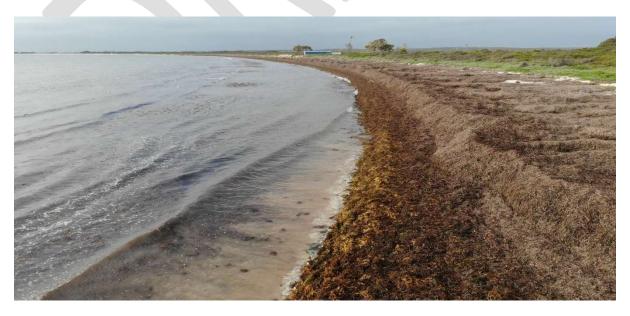
Large deposit of seaweed restricting beach access for vehicles and pedestrians. Vehicle beach access point should be located past the end of typical seaweed deposit boundary. Beach access track should be managed to prevent multiple tracks branching off the main track.

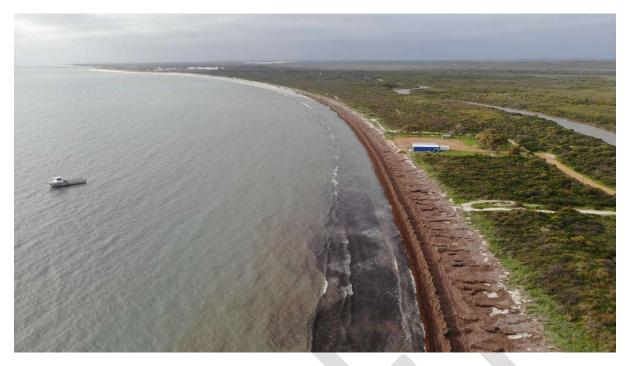
Overview of typical seaweed deposit North of Cervantes that beach access point needs to allow for.

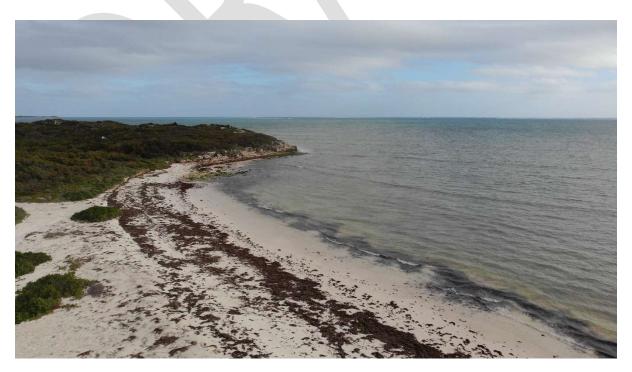
Hansen Bay Southern end. Popular illegal camping location with 4WD users. Multiple tracks lead into this area. Popular fishing location.

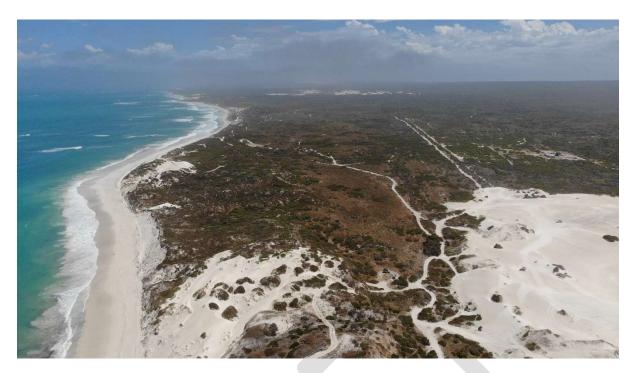
Lancelin Coast North of Off Road Vehicle Area showing numerous tracks on Crown Land and Private Property.

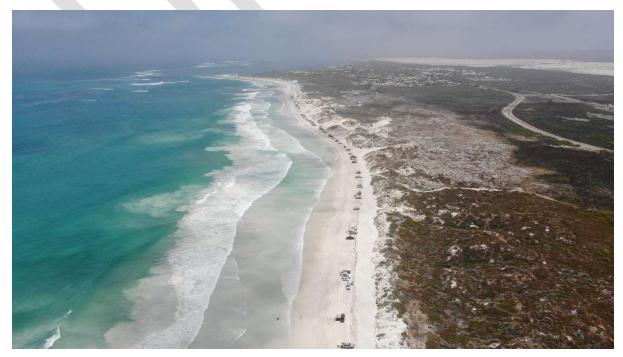
# Lancelin Back Beach holiday recreational vehicle activity.

hazardous to vehicle users.
Recommendation	Site Protection (SP): Rehabilitation of dune near beach entrance, exclude
	vehicles from dune system.
	Site Development (SD): Delineation of pedestrians and vehicles.
	Educational signage on use of area.

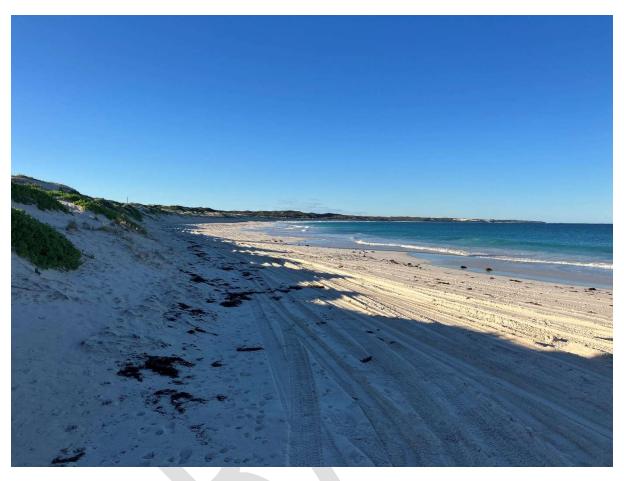
Typical beach profile south of Lancelin. Interspersed with limestone headlands that are bypassed by using coastal tracks. Mining leases are located near coastal tracks and users often enter active mining leases even when they are signed posted as Do Not Enter.

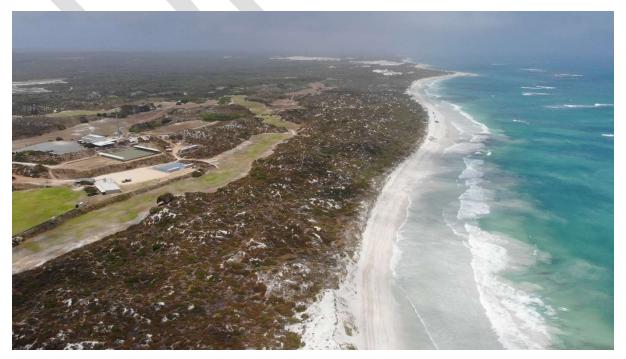
Looking South toward Fence Reef. Coastal dunes natural form retained by limited access from land side to the coast.

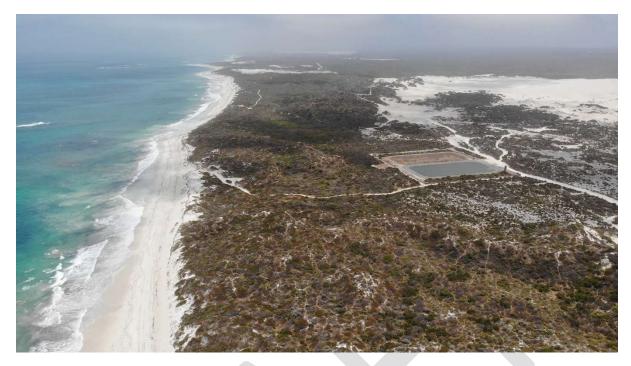
Looking North toward Fence Reef. Coastal track development through dunes and mining leases. Track marking through this area would reduce track multiplication.

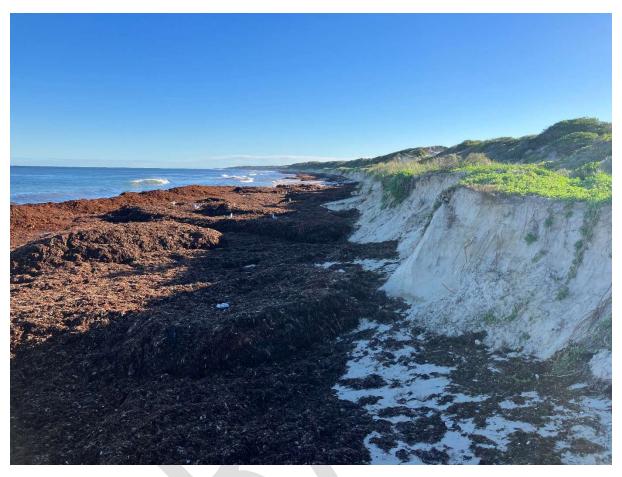
Looking North from Ledge Point Groyne. Area where seaweed builds up close to Ledge Point. Further North the beaches tend not to have large seaweed build ups. The Coastal track between Ledge Point and Lancelin is often used as an alternative Lancelin access road.

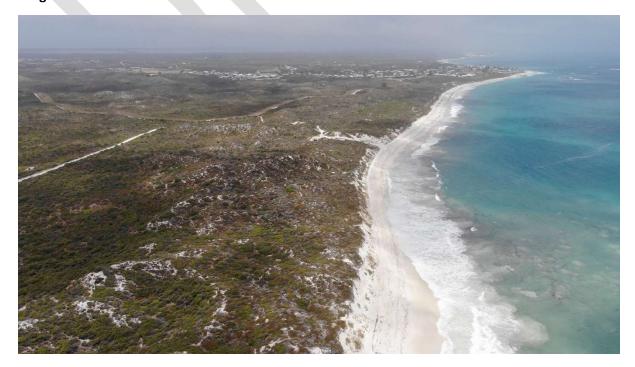
Ledge Point North looking South to Ledge Point. Very steep foredune restricts coastal access in this area. Best access points need to be marked and other points closed off.

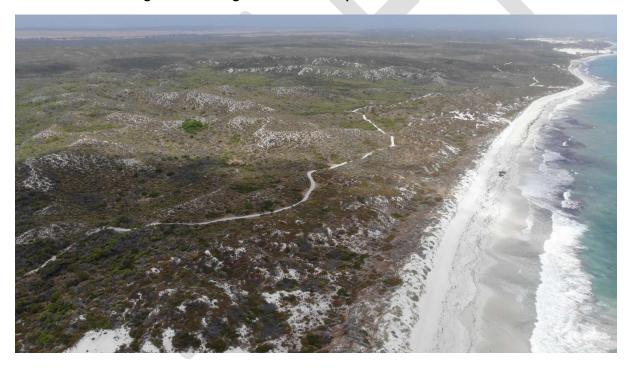
South Ledge Point looking South to Manakoora Sand Patch. Coastal track growth limited in the area by steep coastal dunes and reasonable good trafficable beach.

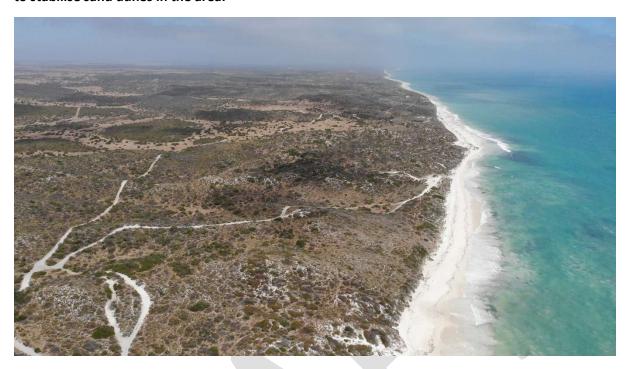
Tracks South of Manakoora Sand Patch before turning inland into private property to access Breton Bay and Indian Ocen Drive

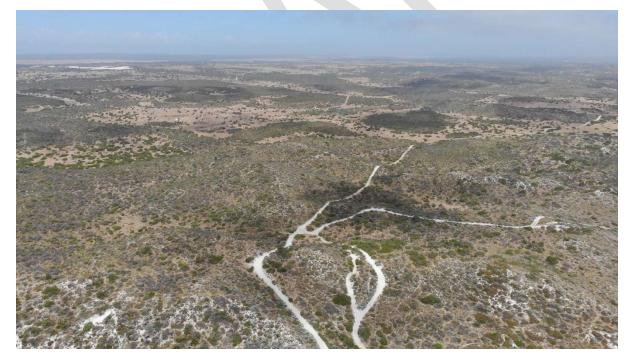
Inland Tracks to Breton Bay and Indian Ocean Drive through private property. Some coastal track users ignore landowner signs and gates restricting access to private property.

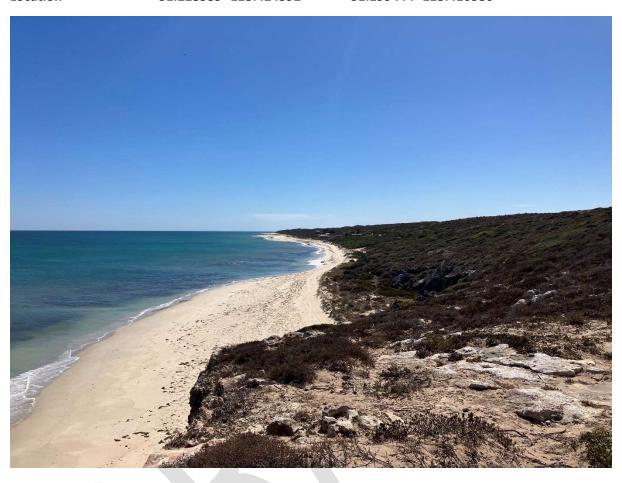
Looking North from Mission Beach area. Narrow Beaches with limestone headlands and steep dunes and limestone cliffs backing the beach. Coastal tracks are sandy with areas of limestone bedrock sections. Beach entry/exit points are very limited.

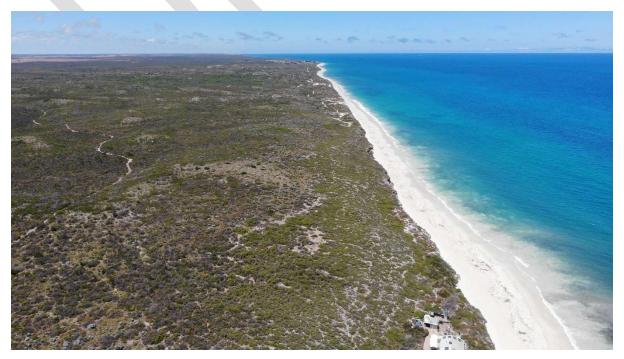
Looking South from Eagles Nest Bluff to Mission Beach (Rail Carriages). Beach access constrained by limestone cliffs and very steep beach entry points. Inland tracks encroaches on private property.

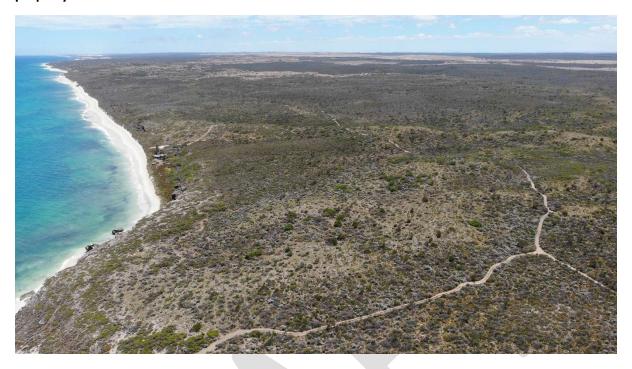
Looking North from Eagles Nest Bluff toward Breton Bay. Inland track location is historically developed. Track encroaches on private property in sections. Beach access constrained by limestone cliffs and very steep beach entry points.

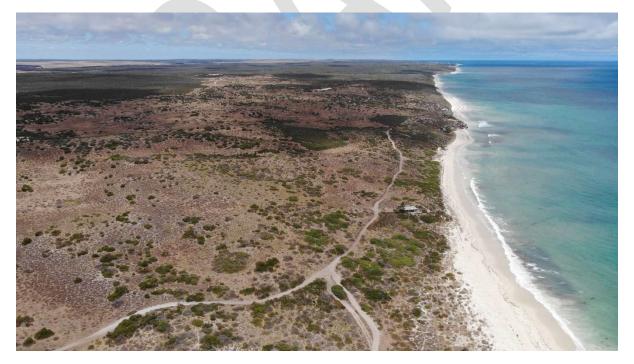
Looking South from Breton Bay toward Eagles Nest Bluff. Track encroaches on private property through this area. Beach access South of here is limited by limestone cliffs and very steep beach entry points.

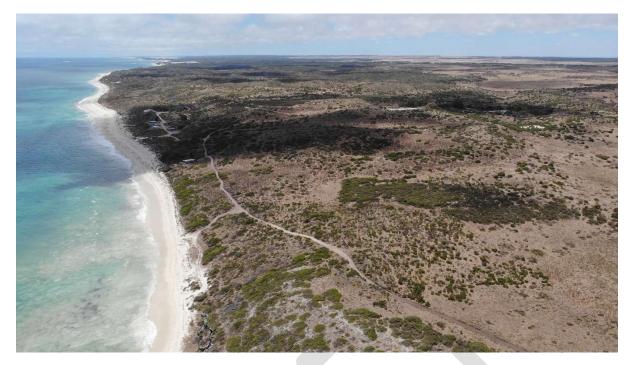
Breton Bray looking North towards Manakoora Sand Patch. Beach access limited by steep coastal dunes. Beach travel determined by tides, limestone headlands and beach sand conditions. Access from the East is through private property. Track users often ignore No Entry to Private Property signs and gates. These are regularly vandalised.

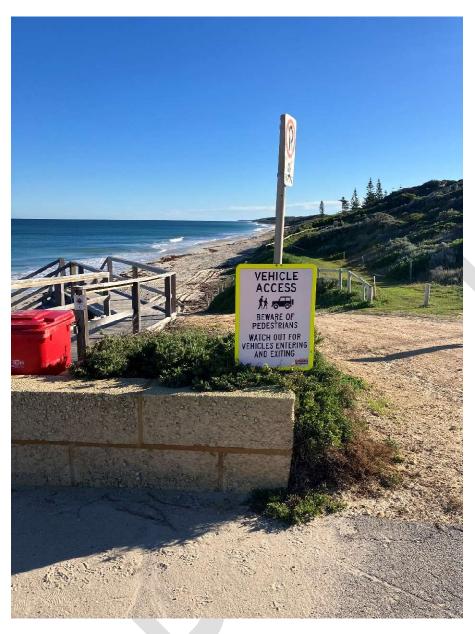
Sea Bird Beach entry point looking North. Dual use area as pedestrians and vehicles are not separated on beach. Limited options on this beach to separate pedestrians and vehicles.

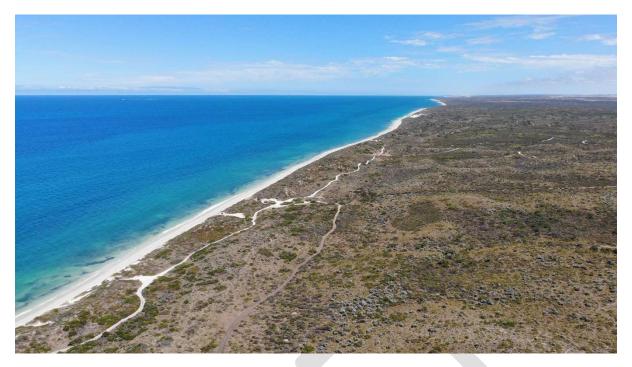
Coastal Tracks North from Seabird. Track marking required to reduce multiple tracks and beach entry points in the area.

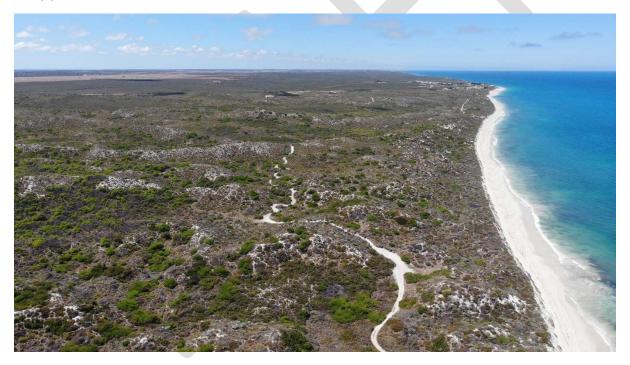
Looking South from Mission Beach area towards Seabird. Steep coastal dunes limit beach entry point through this area. Dunes system structure has also limited track growth.

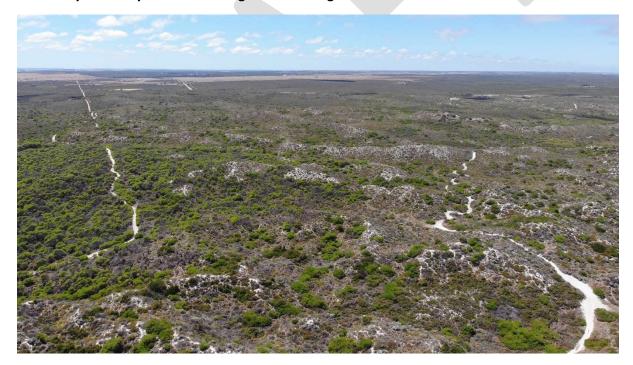
Looking South East from Mission Beach area. Track on the left of picture is access through private property. Track on the right of picture is Coastal access track from Seabird.

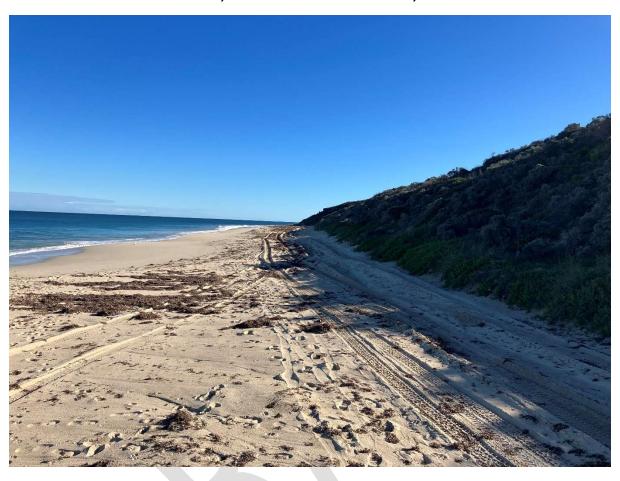
Guilderton Beach looking North. Limestone headlands and tides limit beach travel. Beach is narrow and backed by steep dunes with limited entry/exit points

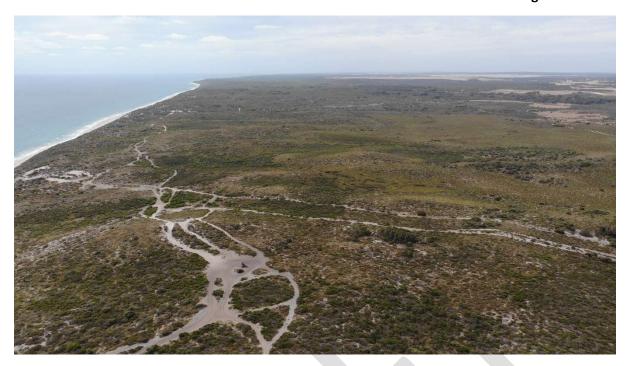
Network of tracks North of Guilderton Lighthouse leading to Seabird to the North. Opportunities to define a main track through landscape to allow vegetation to rehabilitate the area.

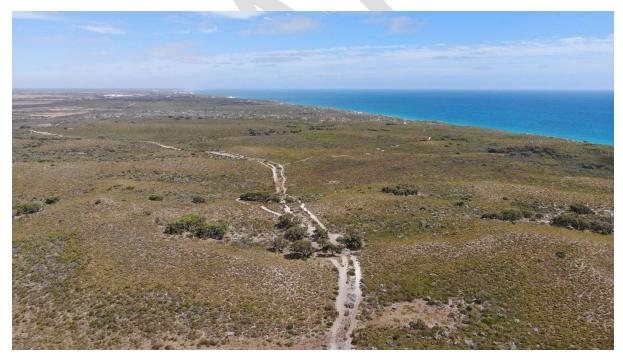
Inland Coastal tracks Leading to Guilderton Lighthouse and coast. Track marking will reduce track multiplication in the area.

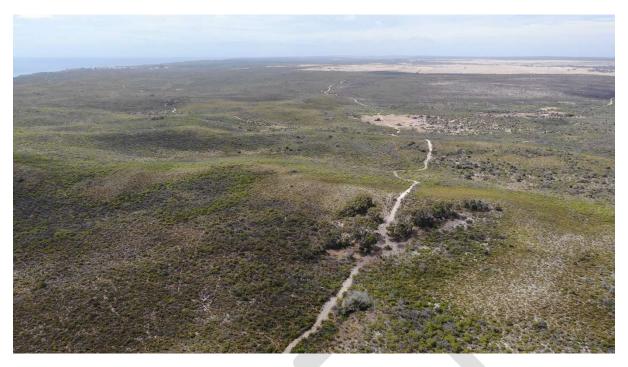
View of inland tracks looking North West to Seabird. Track marking will reduce track multiplication in the area.

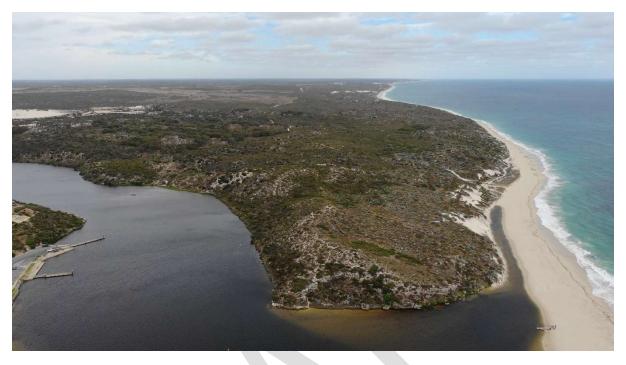
Moore River Mouth. Coastal track users travel North from Wilbinga along the beach to access the Guilderton South Bank Dunes.

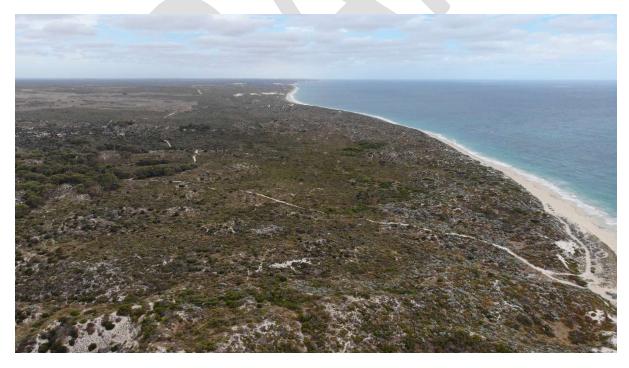
Coastal tracks from the beach east into the Guilderton South Dunes. Sand boarding on the Guilderton South Dunes is popular recreational activity. Sand boarders use 4WD to access the dunes and to stay in the area.
