## Jurien Hall

### HERITAGE OPTIONS – SUMMARY OF COMMUNITY SURVEY

# Routine Inspection Report

**Date:** Thursday, 10 December 2020

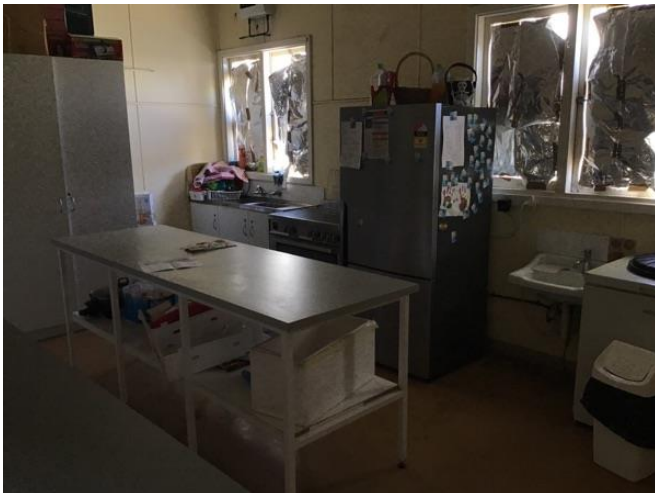
Kitchen/Lunchroom - Sink & Taps  
Taken : 10/12/2020

| Sink & Taps | ✓ | ✓ | ✓ | | 1x old stainless steel sink. Rear edge needs new silicon. Cold tap is seized. Needs cleaning. Average condition.<br>1x ceramic sink, poor condition, and 1x splashback tile has failed, replace. |

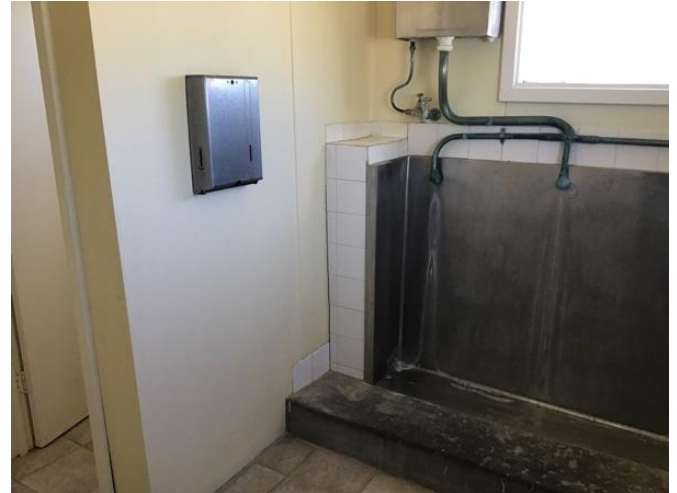
Toilet (Male) - Floors  
Taken : 10/12/2020

| Floors | | | | | Tiled. Single movement crack noted, average condition. |
